OFFICE OF WATER QUALITY INSPECTION REPORT

AFIN: **57-00423** | PERMIT #: **AR0036692** | DATE: **6/15/2022**

City of Mena WWTP Photographer: Amy Beck Witness: NA Office of Water Quality Photographic Evidence Sheet Date: June 15, 2022 Time: 1244 Photo #: 1

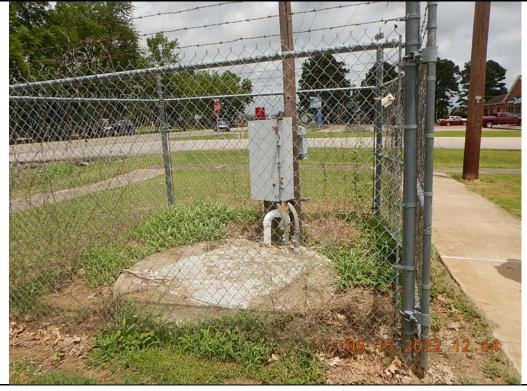
Description: Mena School pump station.

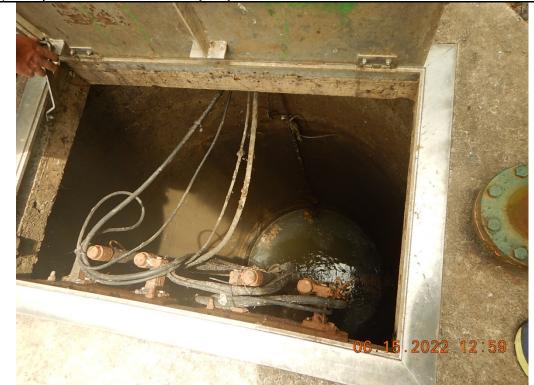
Photographer:	Amy Beck	Date:	June 15, 2022	Time:	1259
Witness: NA				Photo #:	4

Description: Wet well for Mena Lake pump station.
