RE: Inspection conducted on May 10, 2023
AFIN 60-01071
Permit Number 0031-SCYW

**Office of Land Resources
Regulated Waste Operations
Compost Inspection Form**

Site Name	City of Little Rock Compost Yard	County	Pulaski	AFIN	60-01071
Facility Address	10803 Ironton Cutoff, Little Rock, AR	Phone #	501-888-4493	Permit #	0031-SCYW
Permittee Address	10803 Ironton Cutoff, Little Rock, AR	Email Address	ncharles@littlerock.gov	PDS #	125971
Date	5/10/2023	Entry Time	1152	Exit Time	1455
Classification	X	Y – Yard Waste		O – Source Separated Organic Waste	
				S – Mixed Solid Waste

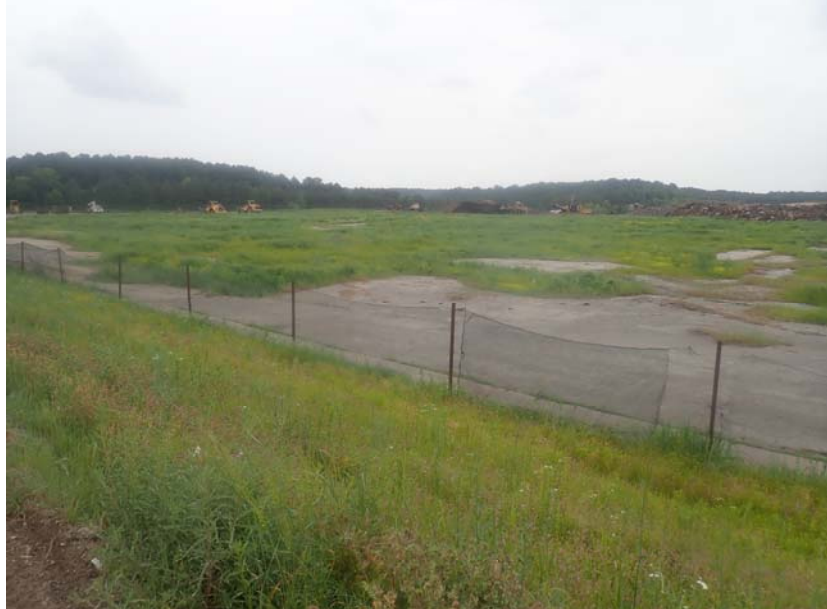
Location	City of Little Rock Compost Yard	Permit	0031-SCYW	AFIN	60-01071
Photographer	Kim Davenport, Inspector	<i>KD</i>	Witness	N/A	
Photo #	1	Of	4	Date	5/10/2023
Description	Operational change: The western half of the compost yard is vegetated and no longer in use.

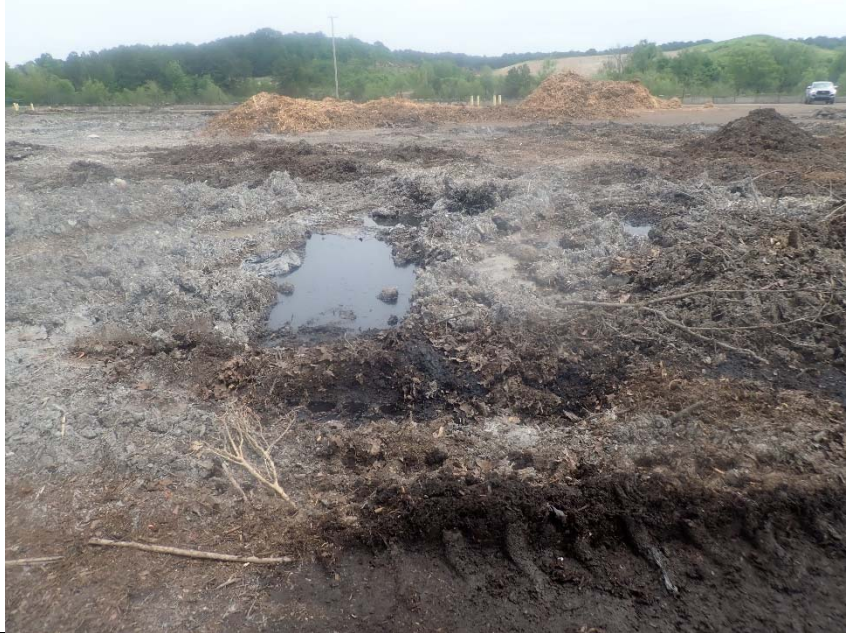
Location	City of Little Rock Compost Yard	Permit	0031-SCYW	AFIN	60-01071
Photographer	Kim Davenport, Inspector	<i>KD</i>	Witness	N/A	
Photo #	2	Of	4	Date	5/10/2023
Description	The eastern compost yard was observed with ponding water.
