ARKANSAS
Department of Environmental Quality

January 13, 2014

RE: Reconnaissance Sanitary Sewer Overflow Inspection (Stone Co)
AFIN: 69-00011 NPDES Permit No.: AR0020117

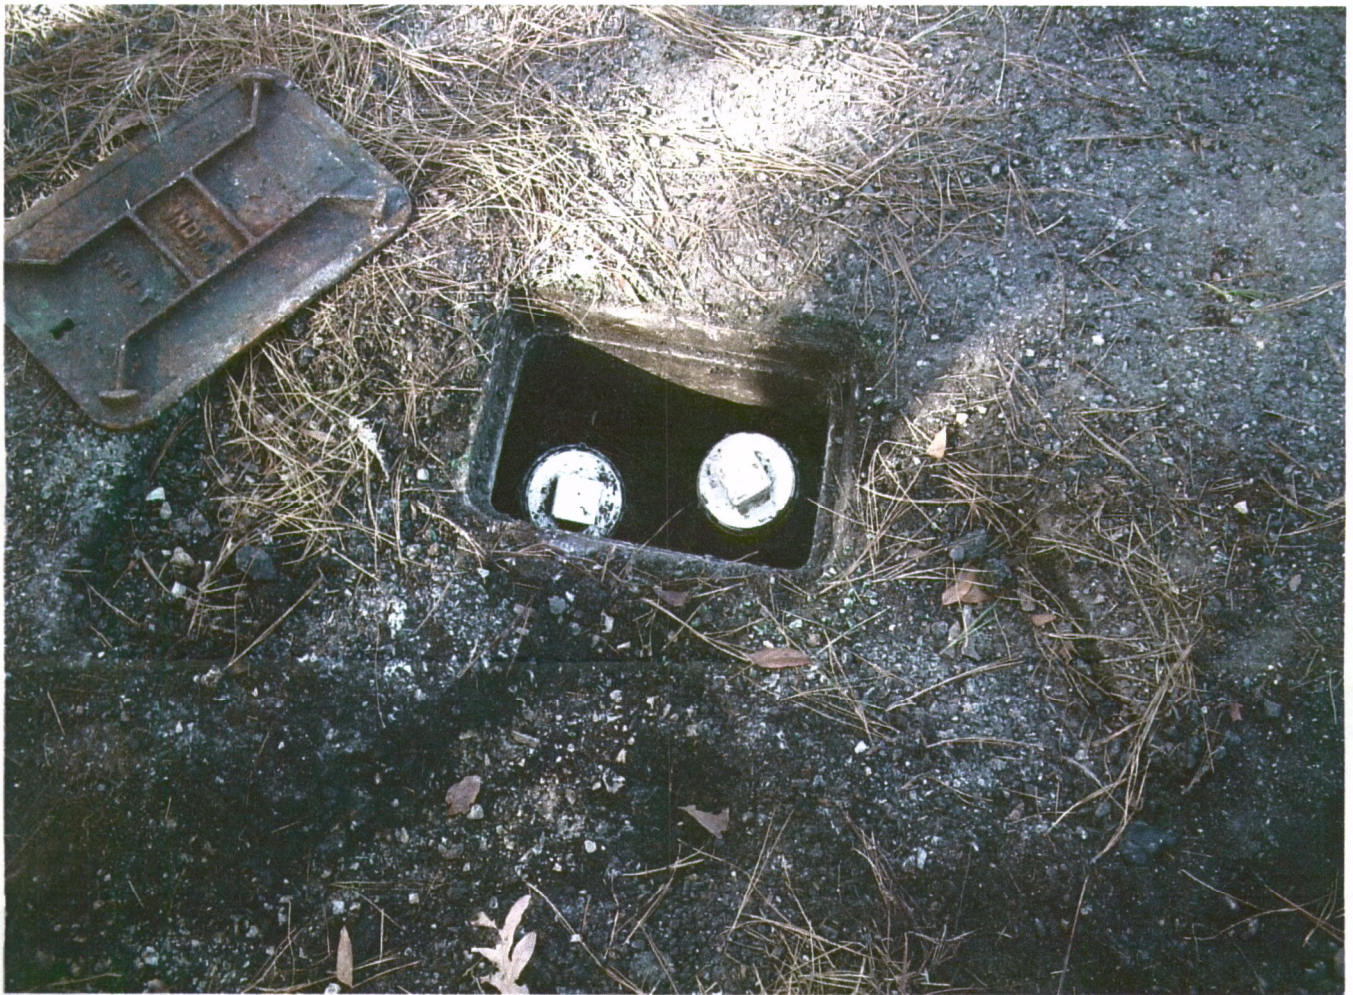
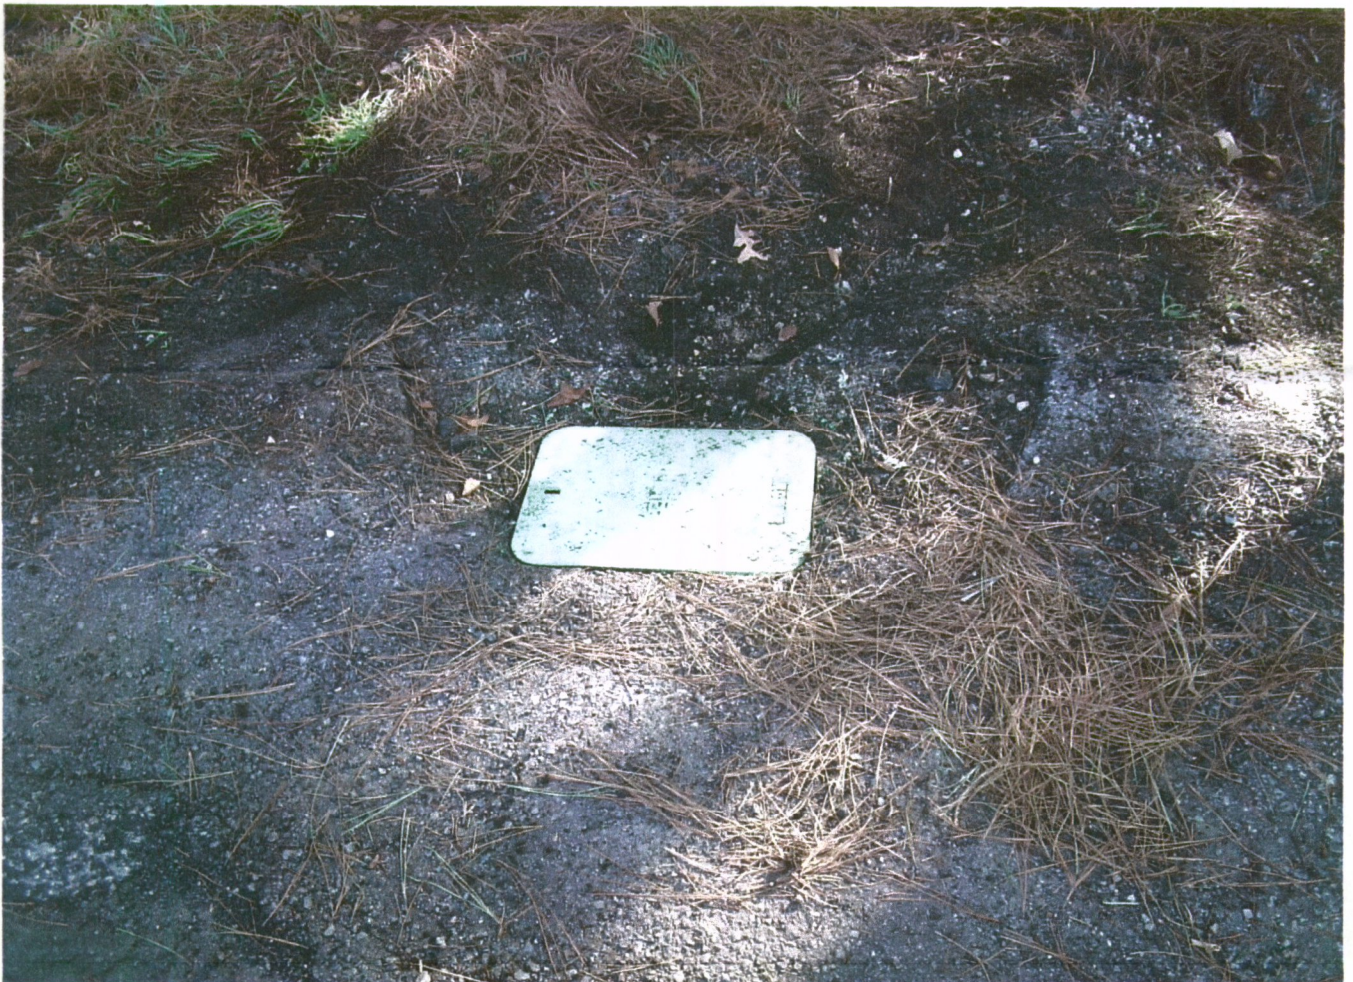
1. You have a work order that shows a SSO had occurred and was repaired at 903 Oak St on January 2, 2014 (the work order is attached to this report). This SSO was not reported to the Enforcement Branch of the Water Division. **This is a violation of Part II. 5 of your permit.**
2. The two (2) sewer line cleanouts at 903 Oak St still had sanitary solids and debris around them, and one line was missing its cap (see Photos 1 and 2). **This is a violation of Part II. 5.6 of your permit.**

corrective Action: Replaced missing cap, cleaned all
Debris from area, Replaced cover.
