City of Bryant Wastewater Department

Pump Station 10 Overflow on August 5, 2015

CLEANUP ACTIVITIES

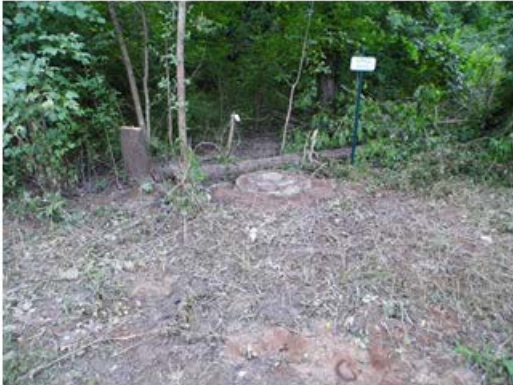
Overflow site before final cleanup

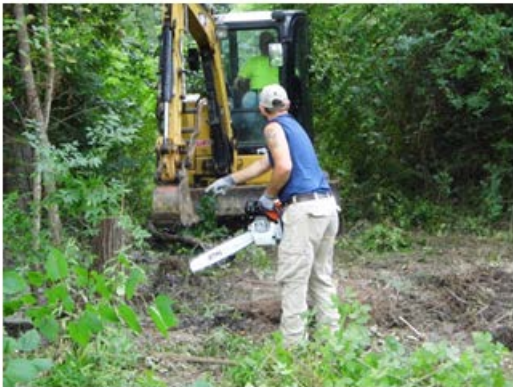
Clearing brush to accommodate cleanup

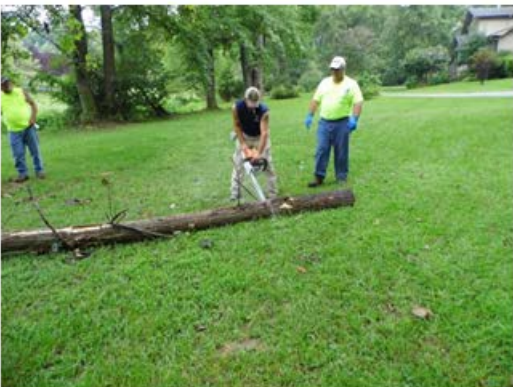
Removal of felled trees left by West Tree Service

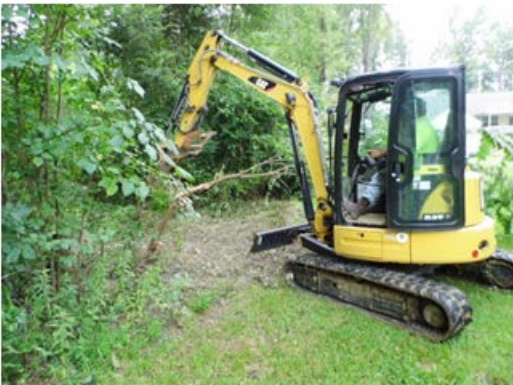
Removal of soil and debris

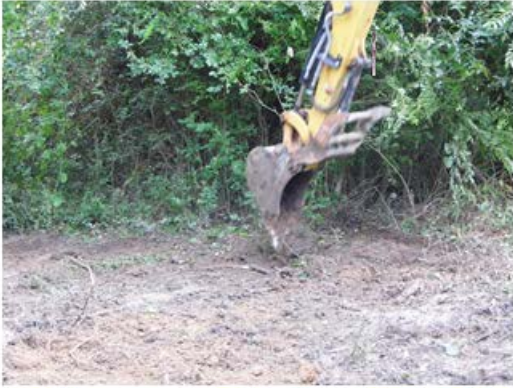
Removal of contaminated debris and soil

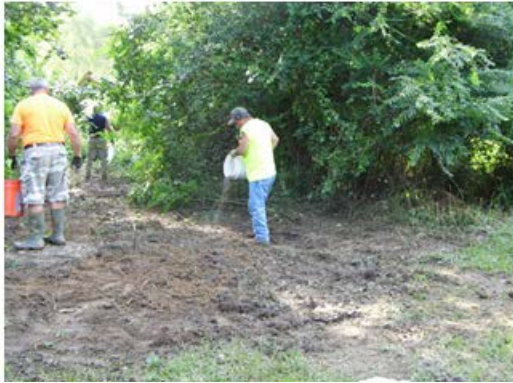
Applying Lime

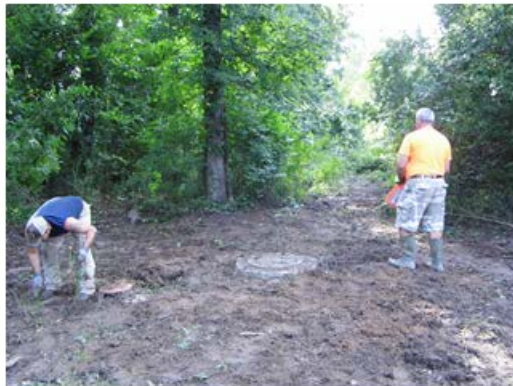
Seeding

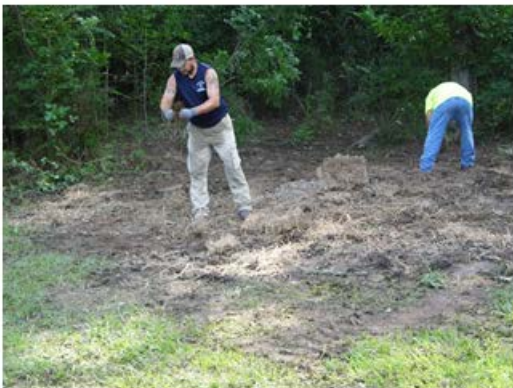
Applying Straw

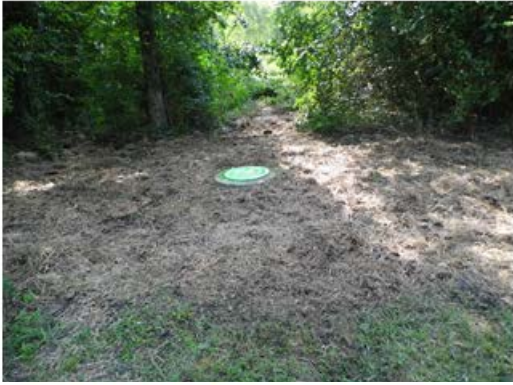
Fresh seeded with straw cover

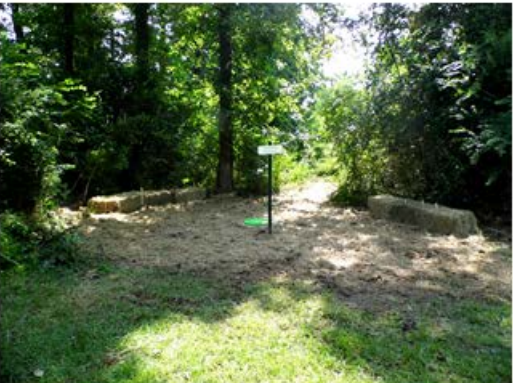
Overflow site after cleanup

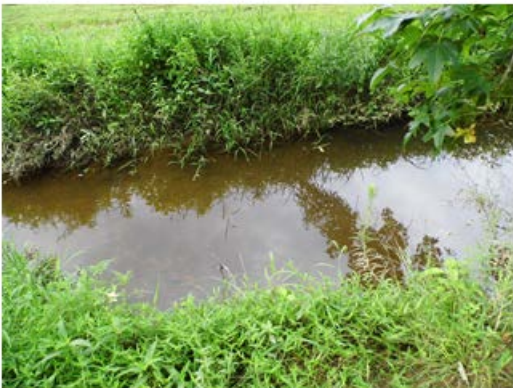
Drainage Channel

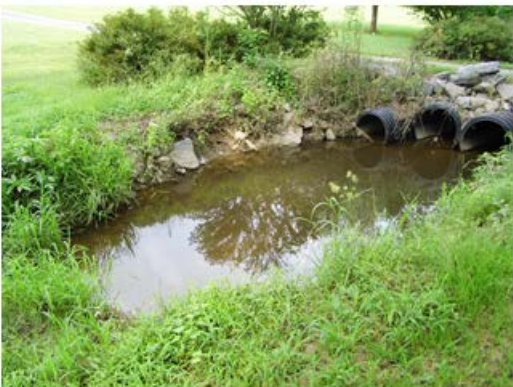
Drainage Channel

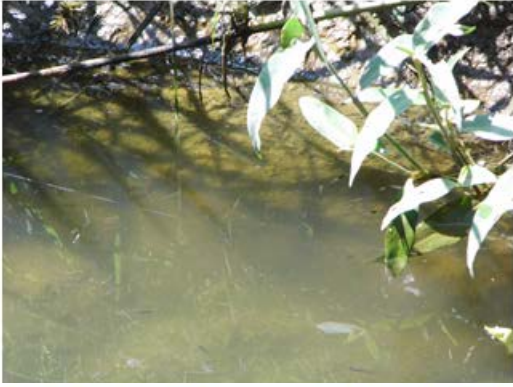
Drainage channel with fish

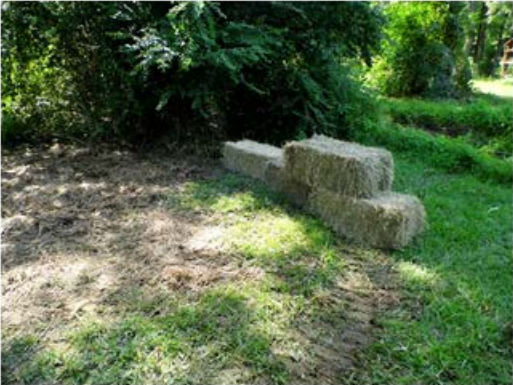
Storm water protection
