Arkansas Department of Environmental Quality Solid Waste Management Division Other Report Form

Activity	Site Visit	PDS #	Doc ID: 066281
Site Name	DAMCO Project / NWRSWMD WTP site	County	Baxter
Location	Baxter CR 831	Date	6-13-14

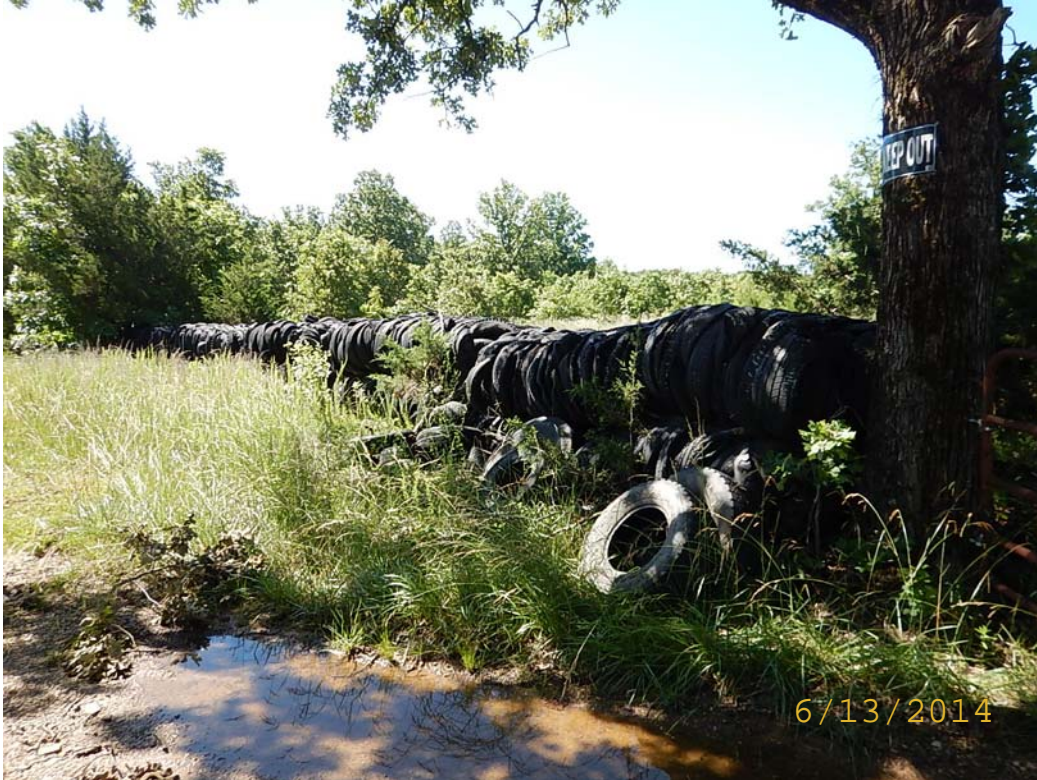
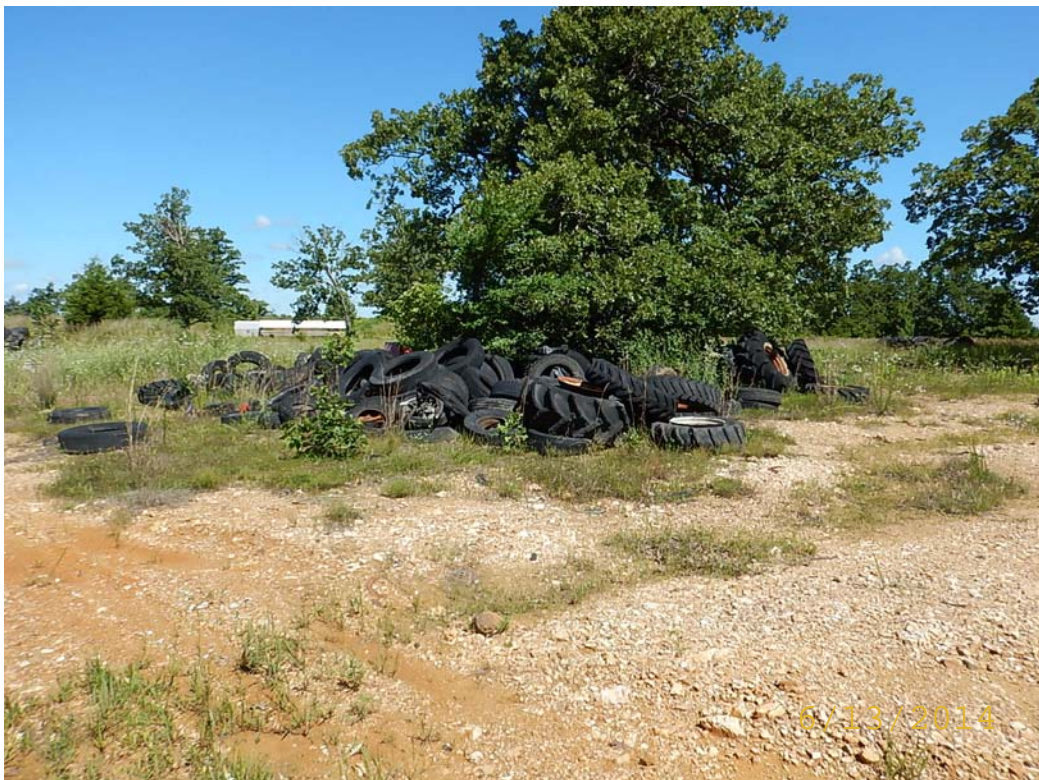
PDS Number 017184
Photos 1 & 2

This report centers on the site visit only. My observation at this time is there has been no activity on this site, including removal of tires, during this growing season. The vegetation on site is overgrown: a visual inspection of the number of tires on site is not possible based on the condition of the vegetation.

1020- I entered the site by climbing over the locked gate at the entrance and walking west toward the lake. The vegetation on the site was overgrown to the extent that I could not see the lake, or the majority of the baled tires. I walked down the entrance road approximately 300ft and found the tire baling equipment and several piles of loose tires. (Approximately 250 loose tires in the vicinity of the baling equipment) It is unclear from the condition of the site to observe where the permitted area is located, and where the boundary of the DAMCO Project begins.

No vector control measures are in place. All loose tires I observed had standing water in them, and the mosquitos in the area are very bad with vegetation growing through the baled tires.
