RE: DeWitt Class I Landfill

AFIN: 01-00117

NPDES Permit No.: ARG160037

NPDES Compliance Inspection Report

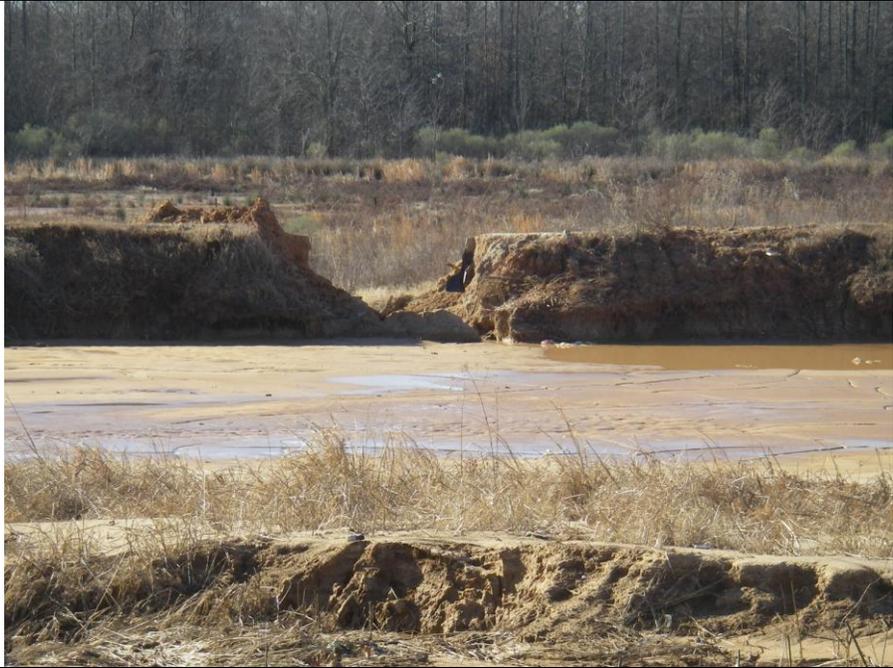
Photo #	1	Of	6	Date:	1/18/2012	Time:	9:55 a.m.
----------------	---	-----------	---	--------------	-----------	--------------	-----------

DETAILS: **Containment on sedimentation pond and active portion of landfill has been breached.**

Description:	Breach in sedimentation pond levee.						
---------------------	-------------------------------------	--	--	--	--	--	--

The levees have been repaired and inspected by the ADEQ Solid Waste Division. However, there are still issues with contamination from leachate leaving the waste mass. The ADEQ Water Division will be contacted for direction on how to properly test and dispose of this liquid.

In the future any upset condition will be promptly reported to the ADEQ. The new operators on site will be properly trained to perform maintenance of the stormwater control features to this from occurring.

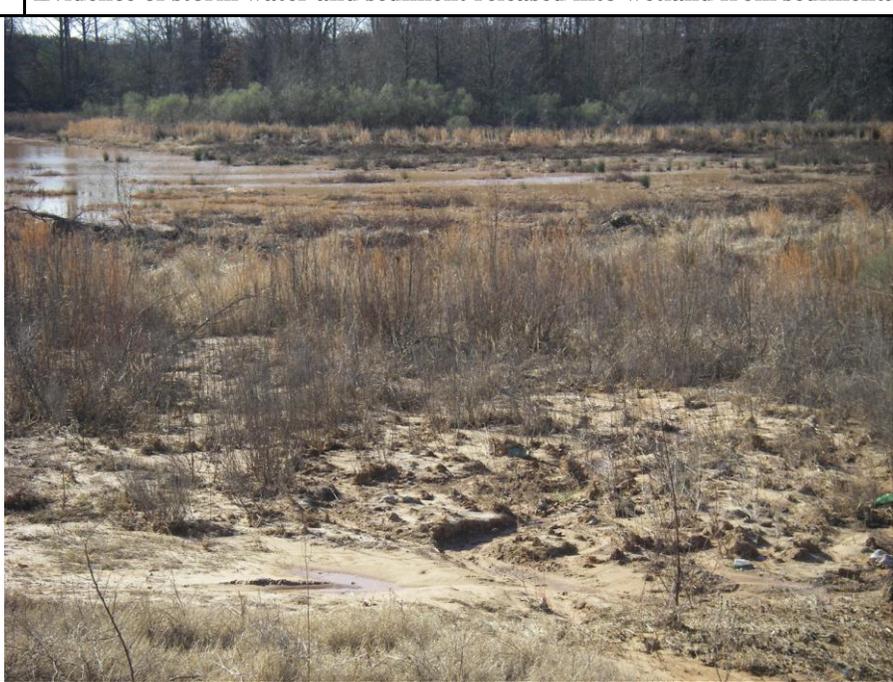
Photo #	2	Of	6	Date:	1/18/2012	Time:	9:57 a.m.
----------------	---	-----------	---	--------------	-----------	--------------	-----------

Description:	Evidence of storm water and sediment released into wetland from sedimentation pond.						
---------------------	---	--	--	--	--	--	--

4. Improper Operation and Maintenance. Specifically, the sedimentation pond levee has been breached. This has allowed storm water and sediment to discharge into an adjacent wetland. This was not reported to ADEQ as required.

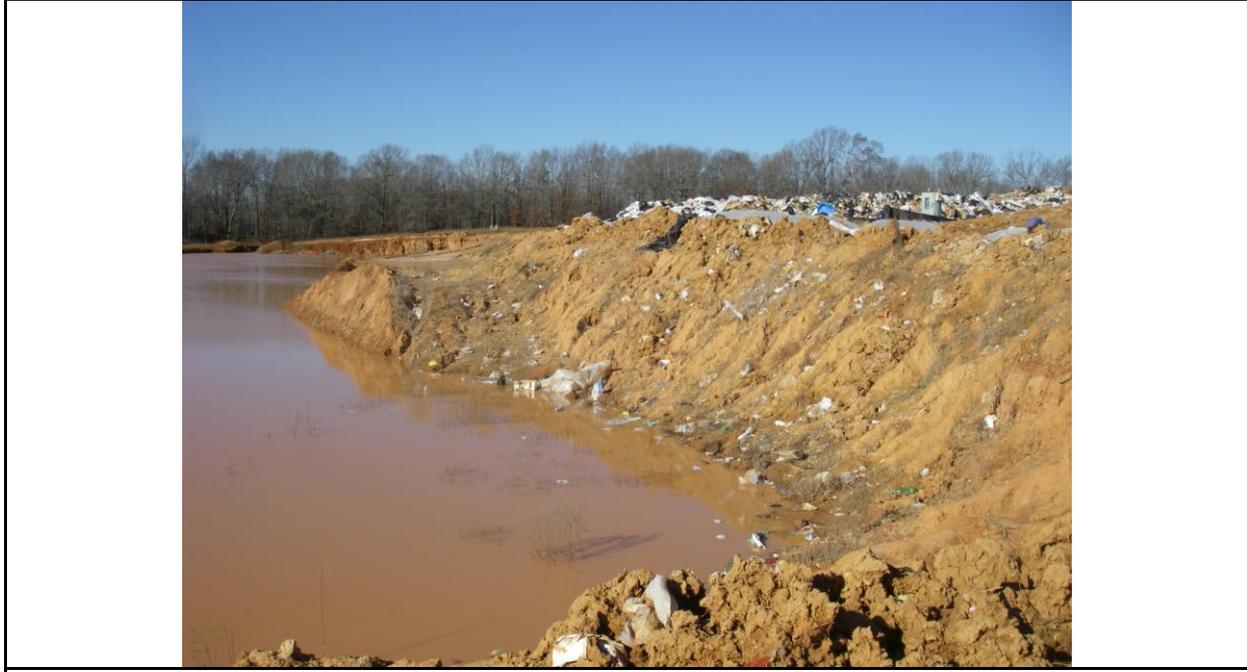
Photo #	3	Of	6	Date:	1/18/2012	Time:	10:00 a.m.
----------------	---	-----------	---	--------------	-----------	--------------	------------

Description:	Active portion of landfill, waste at the edge of borrow pit						
---------------------	---	--	--	--	--	--	--

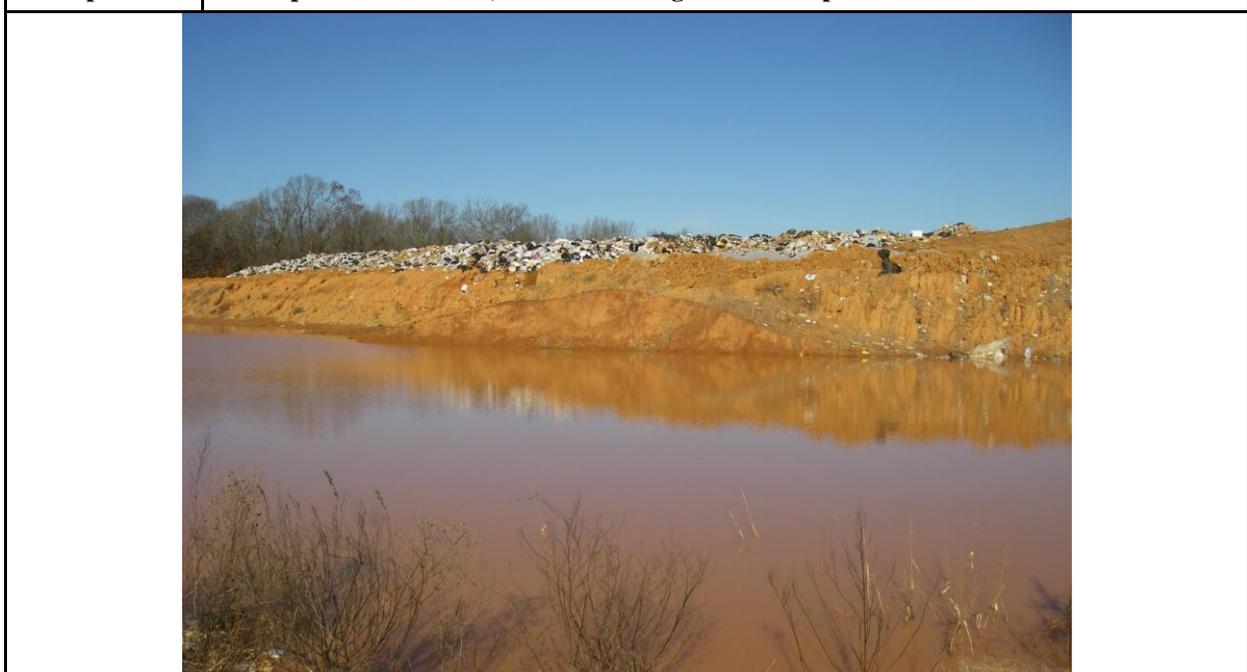
Photo #	4	Of	6	Date:	1/18/2012	Time:	10:01 a.m.
----------------	---	-----------	---	--------------	-----------	--------------	------------

Description:	Active portion of landfill, waste at the edge of borrow pit						
---------------------	---	--	--	--	--	--	--

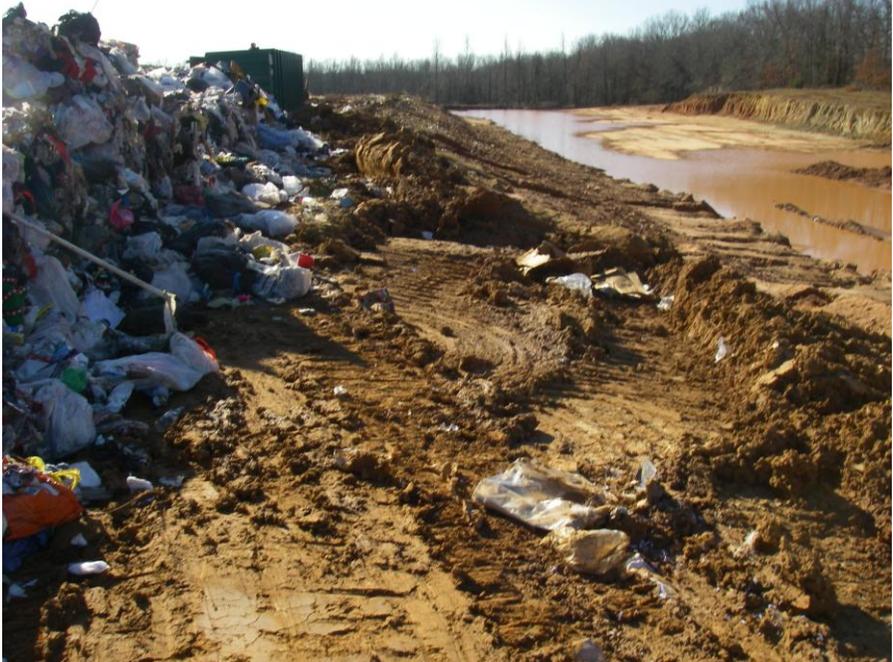
Photo # 5 **Of** 6 **Date:** 1/18/2012 **Time:** 10:10 a.m.

Description: Active portion of landfill, waste at the edge of borrow pit

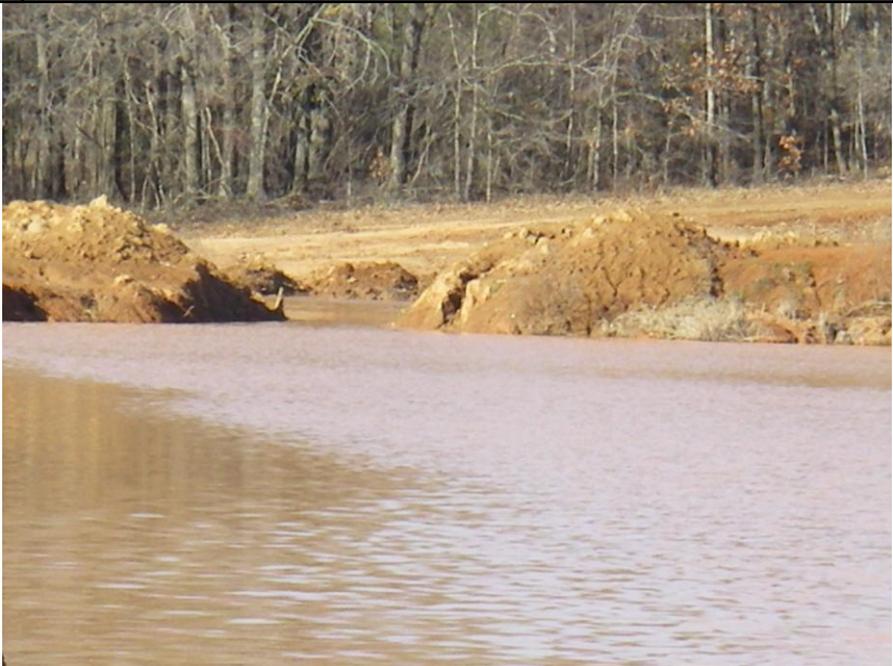
Photo # 6 **Of** 6 **Date:** 1/18/2012 **Time:** 10:02 a.m.

DETAILS: **Containment of sedimentation pond and active portion borrow ditch has been breached.**

Description: Breach in borrow pit containment allowing discharge to the Waters of the State.
