**IN RE: REQUEST BY VULCAN CONSTRUCTION )  
MATERIALS, LLC TO INITIATE ) DOCKET NO. 19-\_\_\_\_-R  
RULEMAKING TO AMEND REGULATION )  
NO. 2 )**

3. Vulcan owns and operates the Black Rock Quarry, a limestone quarry facility in Lawrence County, Arkansas.

The principal purpose of this rulemaking is to establish the site specific criteria contemplated by this language in Reg. 2.511(B).

**EXHIBIT B**  
**FINAL UAA REPORT**

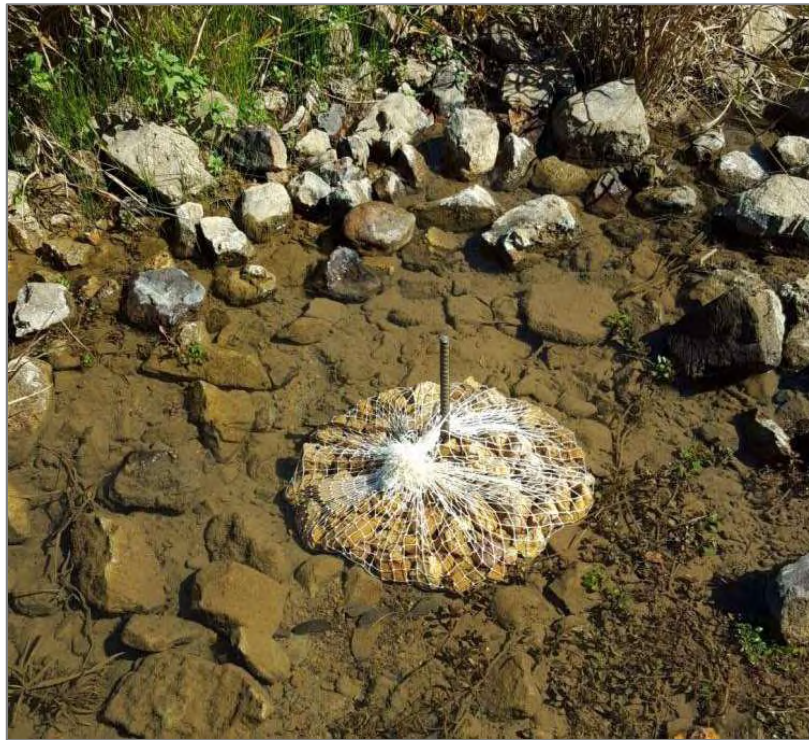
Figure 2.6. Photograph of newly deployed rock bag sampler.

Upon retrieval (41 days after deployment), the substrate material was removed from the RB sampler and washed and agitated to remove attached organisms. The organisms and fine substrate material/detritus was preserved with 70% ethanol in high-density polyethylene (HDPE) jars in preparation for taxonomic identification. Each RB sampler was analyzed independently which resulted in a total of 18 RB data sets (3 RBs in each of three riffles in both the BC-0A and BC-1A reaches).

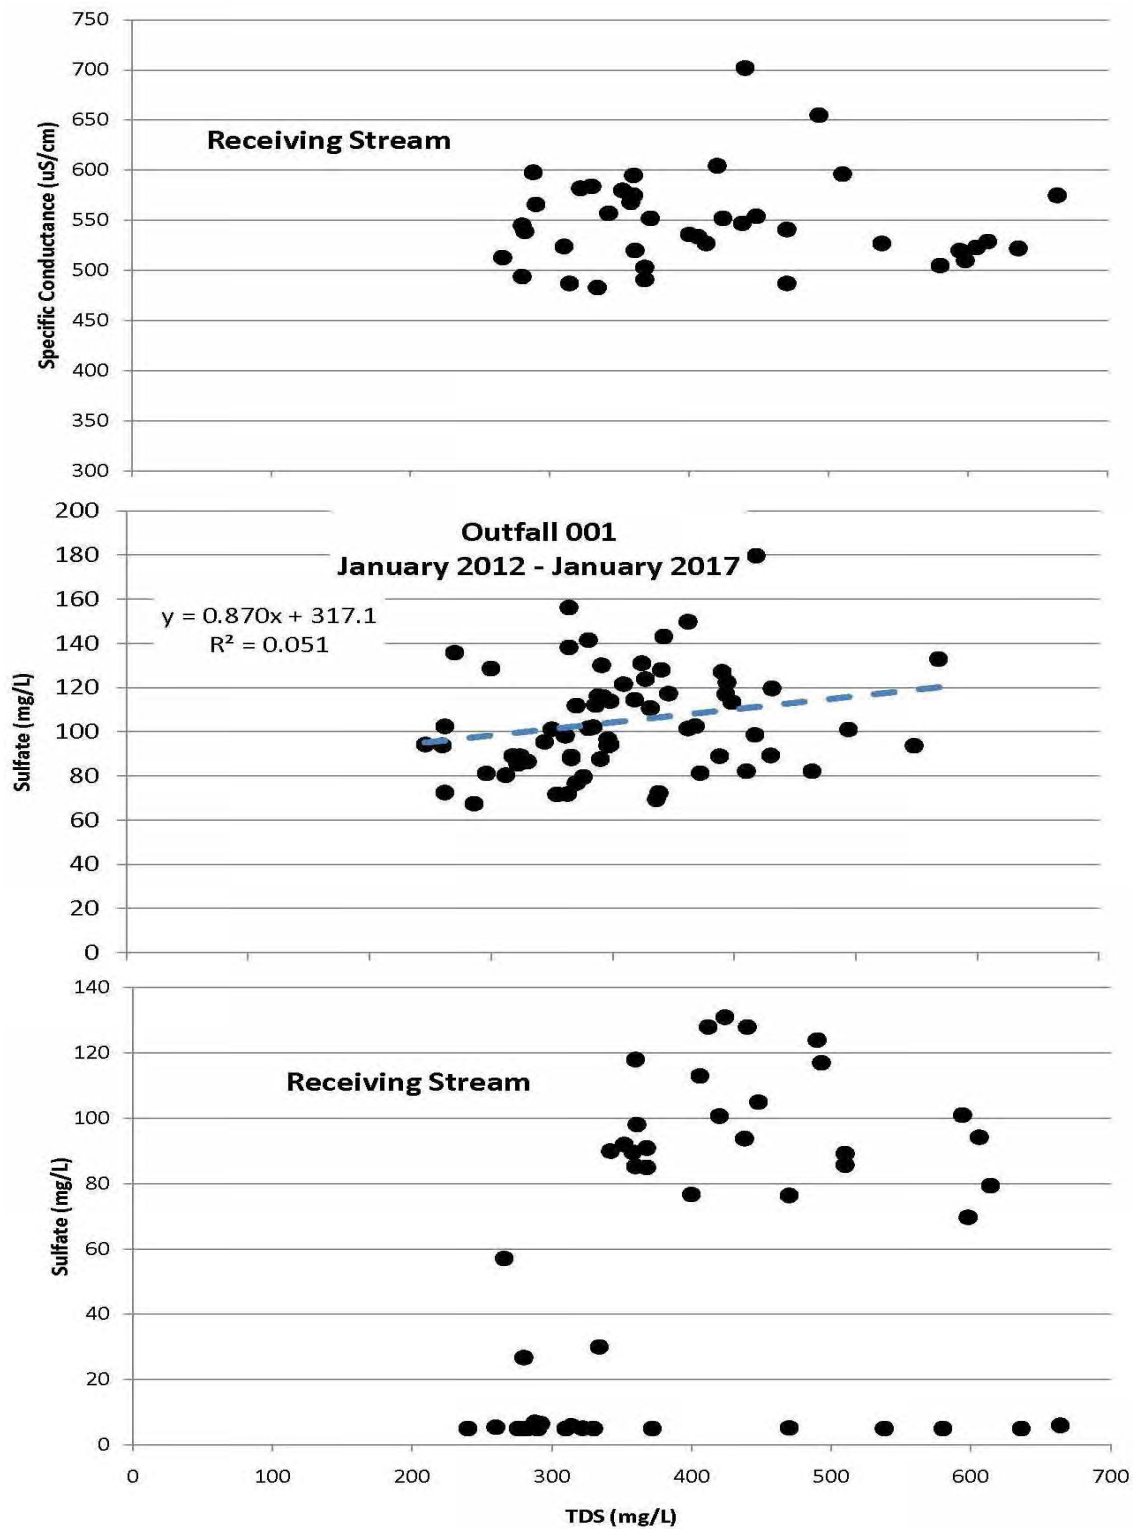
Figure 3.6. Scatter plots of the relationships between TDS versus sulfate and TDS versus conductivity.

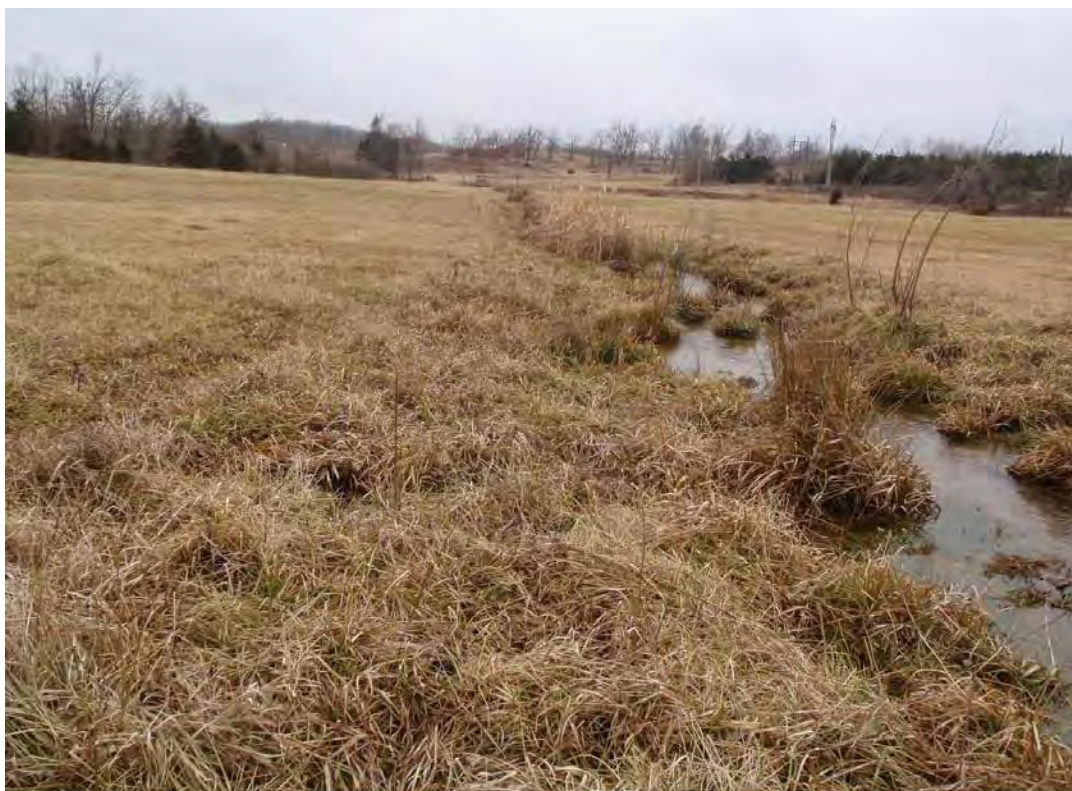
Figure 1.6 Unnamed tributary drainage across pasture.

overflows via pipe (Figure 1.5) through the pond dam and travels through a natural drainage feature across the farm property, referred to herein as the unnamed tributary (Figure 1.6), thence to Brushy Creek (Figure 1.7). The drainage route from the outfall to Brushy Creek is shown on Figure 1.8, as is the permitted facility's property boundary.

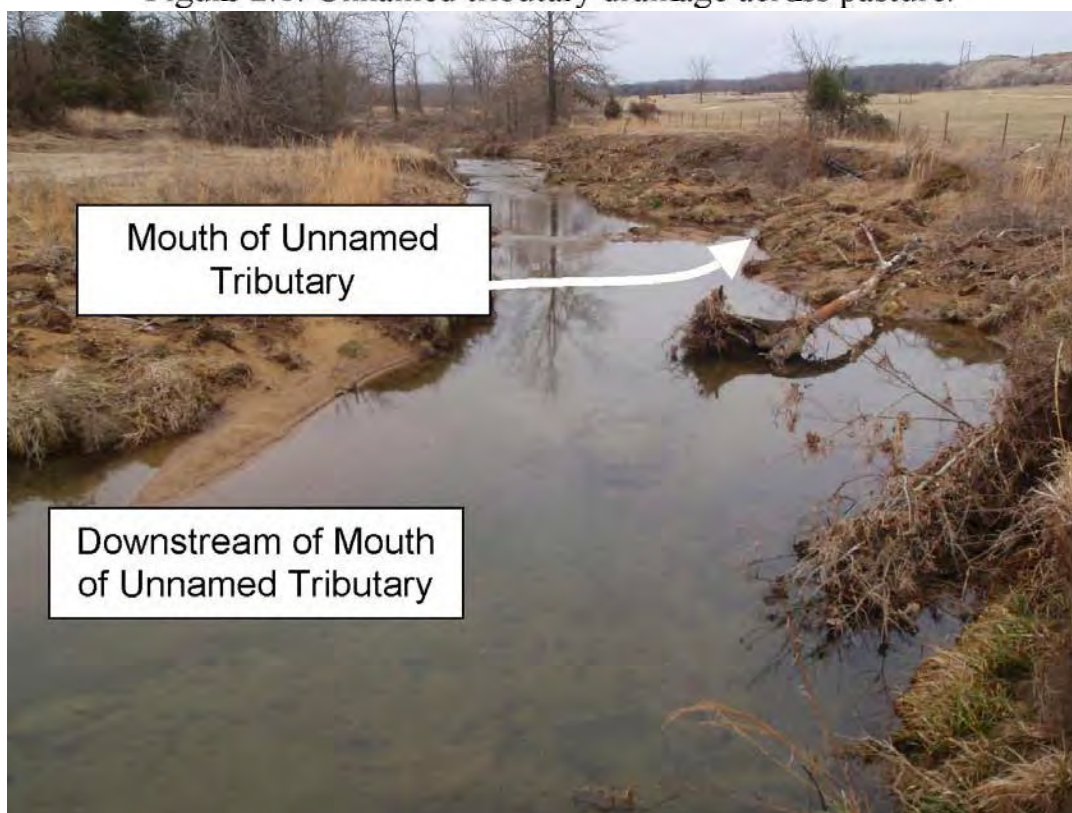
Figure 1.7. Brushy Creek looking upstream towards mouth of unnamed tributary.

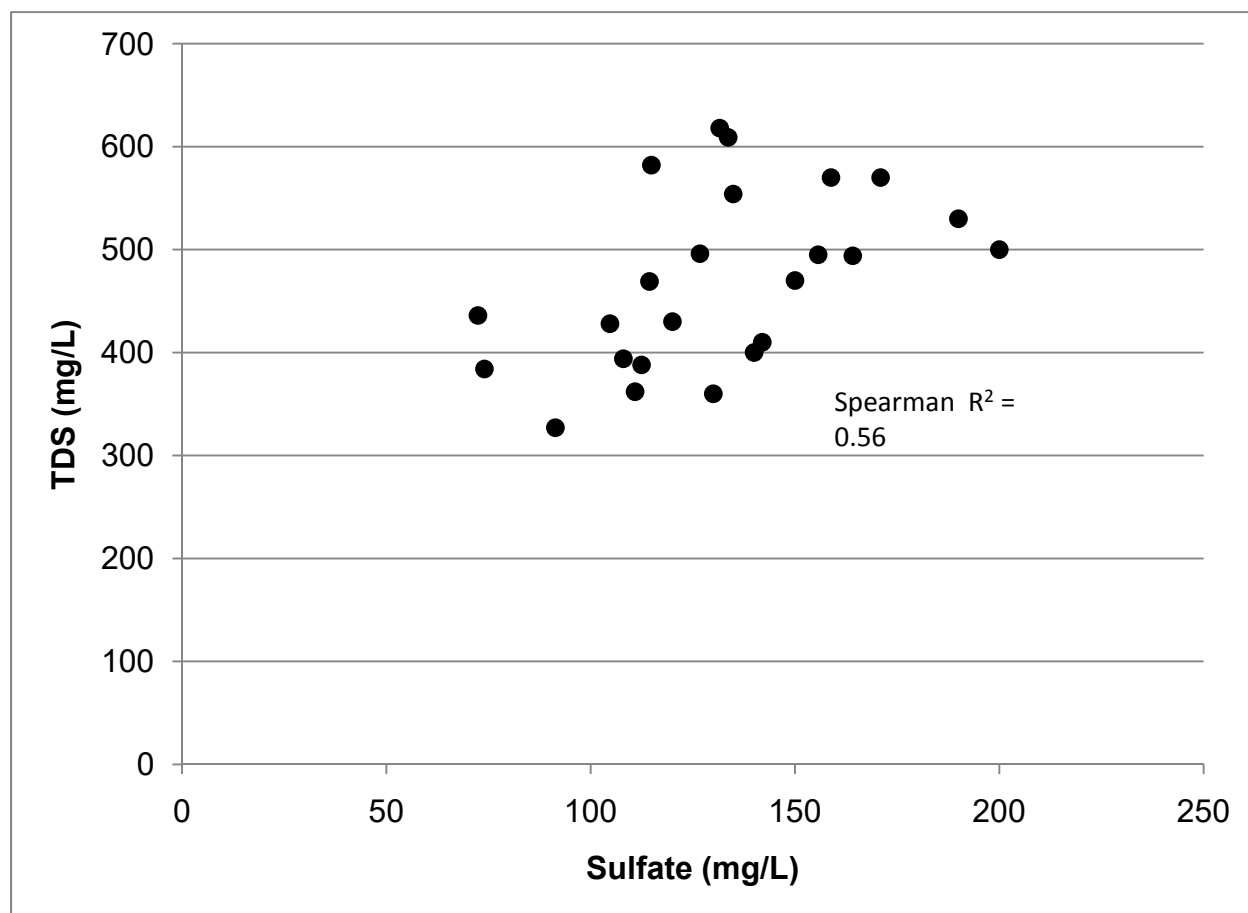
Figure 4.1. Plot of TDS versus  $\text{SO}_4^{2-}$  from Outfall 001. (Data collected February 24, 2009, to June 22, 2011.)

These monitoring data from Outfall 001 encompass two complete years and include periods of unusually wet (spring of 2009) and dry (summer and fall of 2010) weather and are therefore representative of the range of TDS and  $\text{SO}_4^{2-}$  concentrations likely to occur at Outfall 001. A striking feature of the groundwater data summarized in Table 4.1 is that *all of the TDS data exceed the ecoregion TDS criterion of 250 mg/L*. Therefore, background TDS concentrations in the study area can be expected to exceed ecoregion criteria depending on local surface and groundwater hydrology. A plot of  $\text{SO}_4^{2-}$  versus TDS from the outfall (Figure 4.1) shows a significant correlation (Spearman  $R^2 = 0.56$ ,  $p = 0.004$ ) between TDS and  $\text{SO}_4^{2-}$ , which indicates that  $\text{SO}_4^{2-}$  from the outfall contributes to the relatively high background TDS.

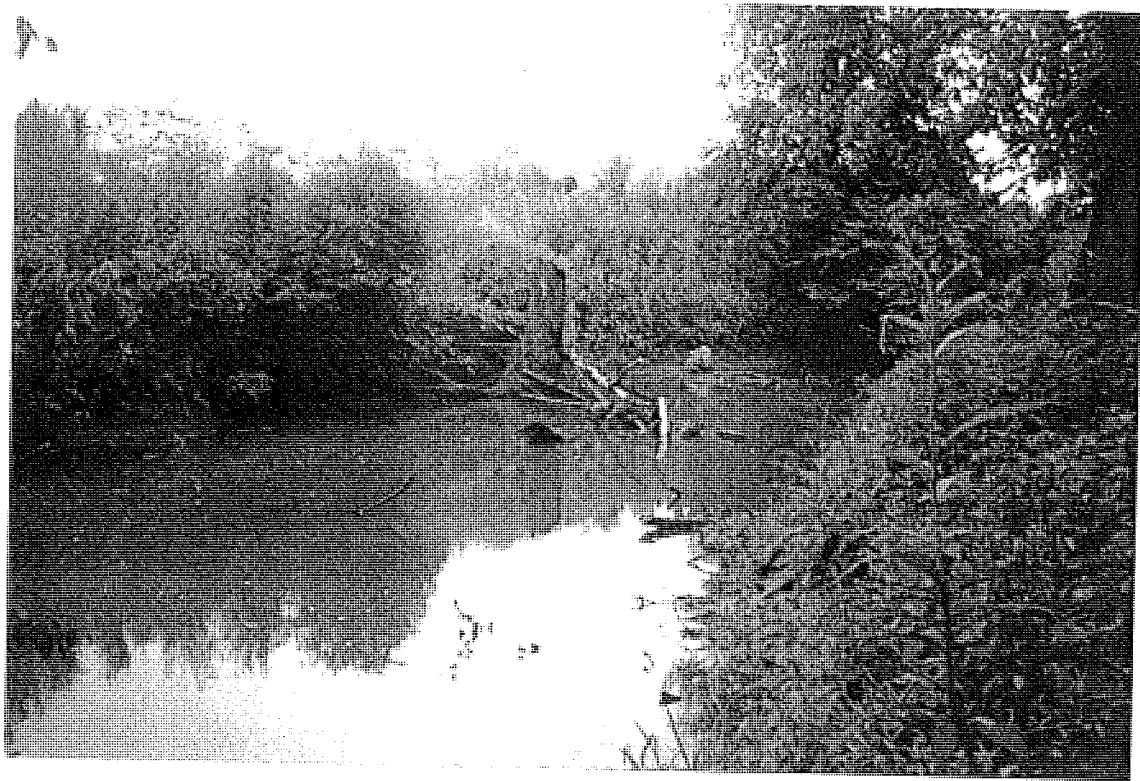
Figure 4. Typical section of Stennitt Creek at Site SC-1, upstream of the Meridian discharge location, July 1998.

The upstream station, SC-1, was composed mostly of pools with riffle/run areas accounting for only 20% of the reach. The average stream width was 20.0 ft and the average stream depth was 1.0 ft. The average velocity and flow recorded at this station during the low flow period were 0.2 fps and 0.7 cfs, respectively. An average channel width as measured bank to bank was 41.0 ft. (Figure 4).

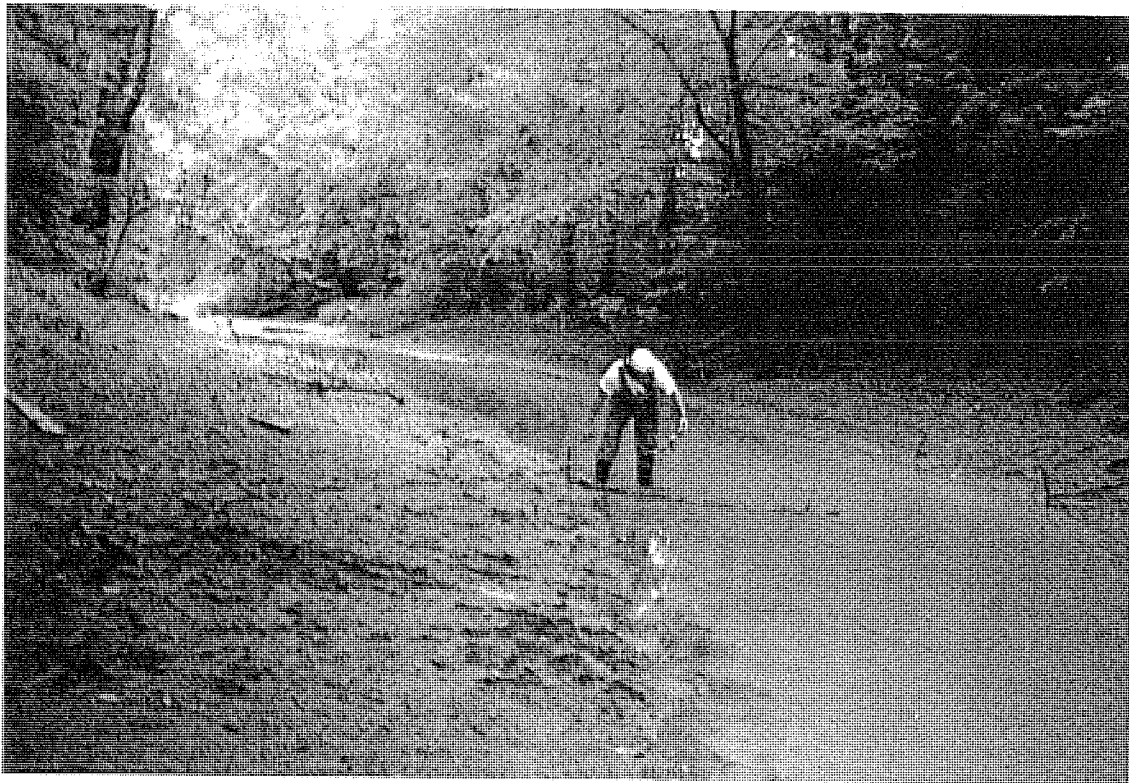
Figure 7. Typical section of Stennitt Creek at the downstream station, SC-2, July 1998.

The downstream station, SC-2, was composed mostly of pooled areas with runs and riffles comprising approximately 30% of the reach. Although the average stream width was 14.3 ft which was 30% less than the upstream station, the average depth was 0.8 ft. An average flow of 0.5 cfs was measured with an average velocity of 0.9 fps. The average channel width as measured bank to bank was 41.0 ft which was similar to the upstream reach indicating bank full flows varied little from the two reaches (Figure 7).

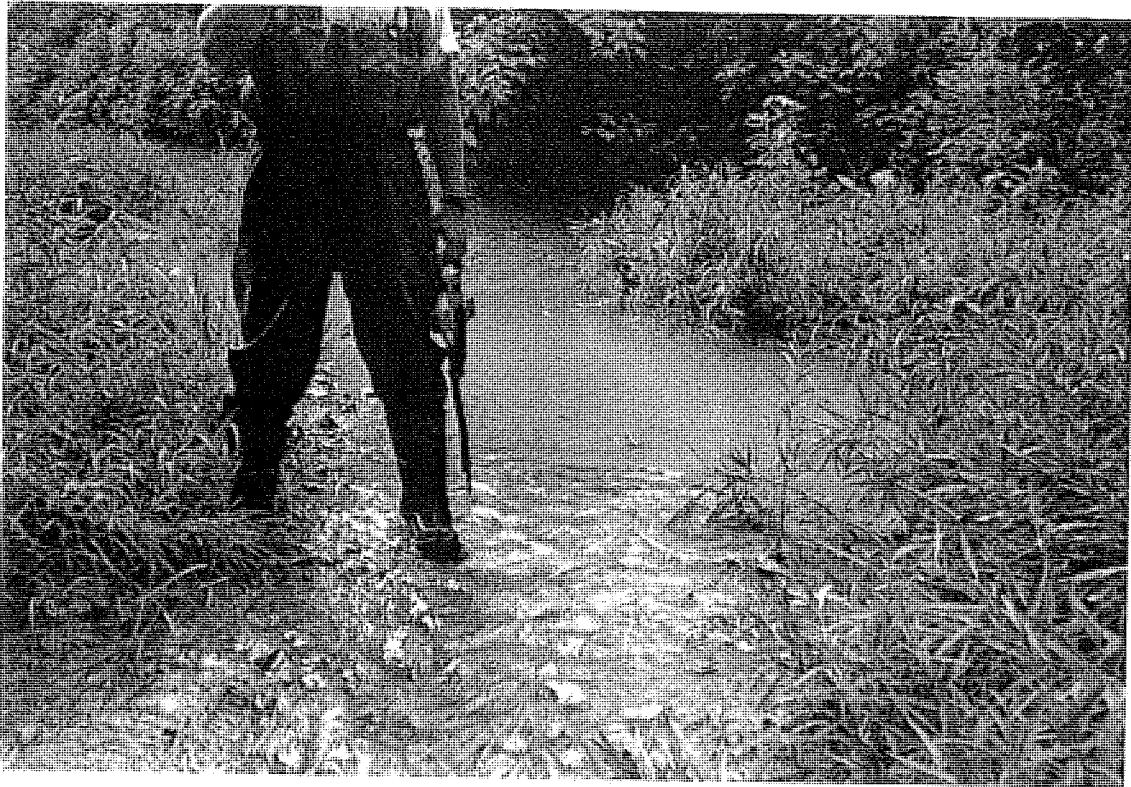
Figure 8. Cobble riffle area at SC-2 in Stennitt Creek, July 1998.

The existing instream habitat was composed entirely of vegetation with much of the reach being devoid. A cobble and gravel substrate dominated the stream bed in this reach (Figure 8). A unique feature of this reach is the bedrock outcropping which comprised a portion of the reach but was not included as substrate since most of it was exposed due to low flow conditions. The bank habitat was composed of vegetation, roots, and undercut banks. The bank slope was generally steep to moderately steep. The soils on the bank varied greatly from stable to unstable.

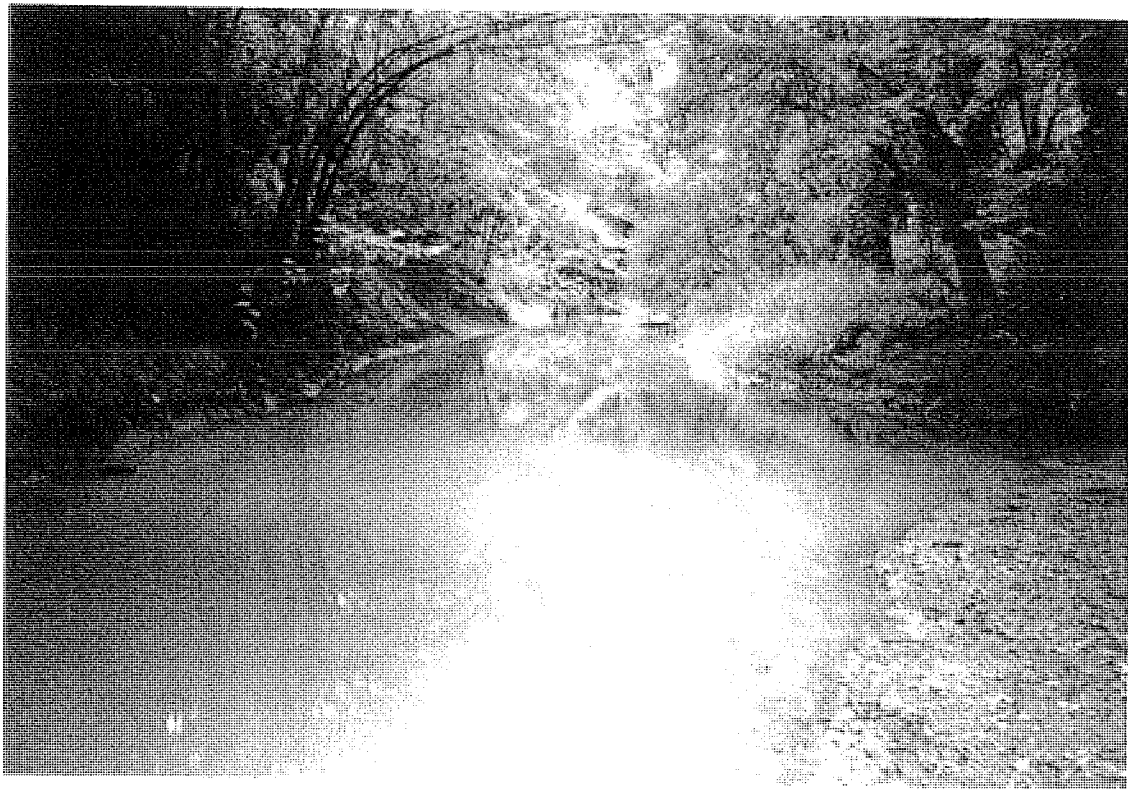
Differences between SC-1 and SC-2 included the vegetation and the amount of instream structure (logs and woody debris) that was present at SC-1 when compared to SC-2, where logs and debris were sparse (Figure 9). Additionally, there were some differences in substrate at SC-2 relative to SC-1. The downstream station was dominated by cobble and gravel substrate, while the upstream station was sand and mud bottomed with very little gravel and cobble. These differences are reflected in habitat potential.

Figure 9. Stennitt Creek at Station SC-2, showing typical reach of stream with limited in-stream structure, July 1998.

The results of the qualitative habitat assessment indicate the presence of more available habitat for fish at SC-1 (upstream) than at SC-2 (downstream).
