# BUFFALO RIVER WATERSHED ALLIANCE

## **Comments on Regulation 5 Revisions**

The following are comments from the Buffalo River Watershed Alliance on proposed revisions to APC&EC Rule 5 Liquid Animal Waste Management Systems, Markup Draft July, 2019.

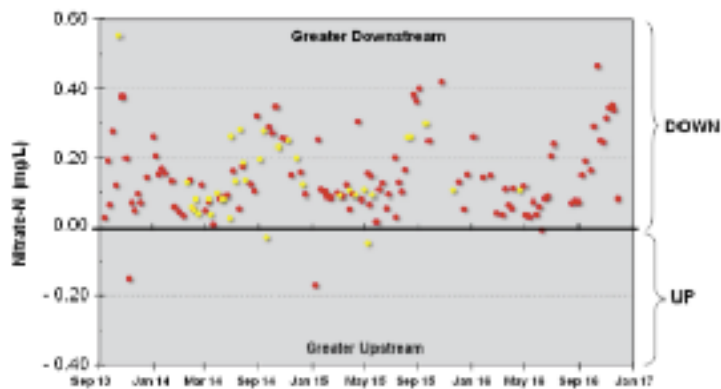
Figure 1. Difference in  $NO_3-N$  concentration in Big Creek up- and downstream from the C&H CAFO. Following the “upstream vs. downstream” comparative criterion that is the basis of the BCRET study, the data clearly indicate that the C&H CAFO is contaminating Big Creek with nitrates. From BCRET (2017a; note that explanation was not given for the yellow versus red color-coding).

Nitrates are being measured by the *Big Creek Research and Extension Team (BCRET)* of the *University of Arkansas Division of*

Agriculture both upstream and downstream of the facility and nearby spreading fields Figure 1.

Regarding this data illustration, Burkholder in a report to Buffalo River Watershed Alliance (2017) states:

***“The data clearly indicate that the C&H CAFO is contributing swine waste pollution to adjacent public trust waters. The nitrate levels downstream from this CAFO commonly are levels that have been shown in other research to be toxic to sensitive aquatic life (Camargo et al. 2005, Guillette et al. 2005). The nitrate signal is stronger than the E. coli signal because nitrate does not adsorb to sediment particles and settle out (Stumm and Morgan 1996); instead, nitrate is highly soluble and is transported rapidly from swine CAFOs to receiving surface and groundwaters (Evans et al. 1984, Stone et al. 1998, Ham and DeSutter 2000, Mallin 2000, Krapac et al. 2002), the latter problem being exacerbated in underlying karst geology (Mellander et al. 2012, Knierim et al. 2015) which is characteristic of the region that includes the C&H CAFO (Hudson et al. 2001, 2011).”***
