**City of Helena-West Helena (AR0043389 & AR0022021)
Quarterly Progress Reports
July 2023 – September 2023**

Report Date : Oct 06, 2023
Current CAO Completion Date : TBD (Applied for extension on May 22, 2023)

**System Assessment Report
Existing Operational Condition
Helena-West Helena
(2017)**

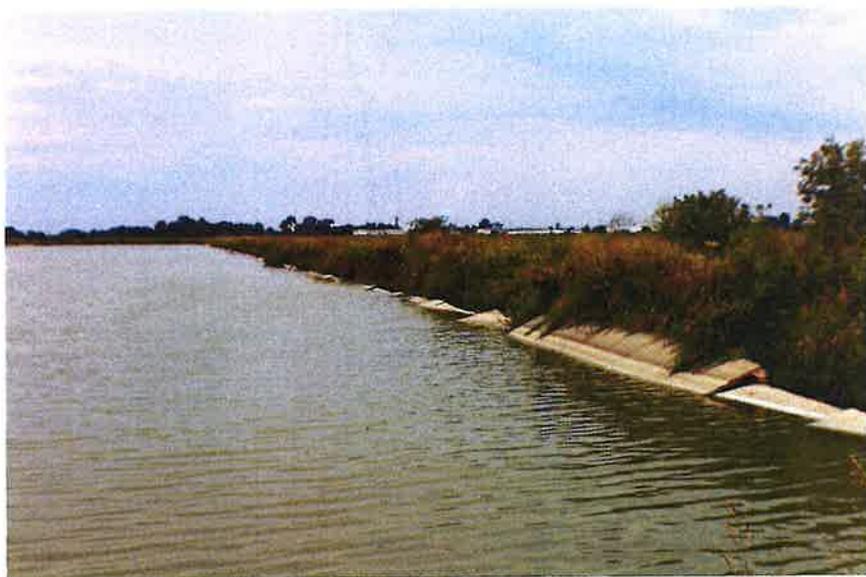
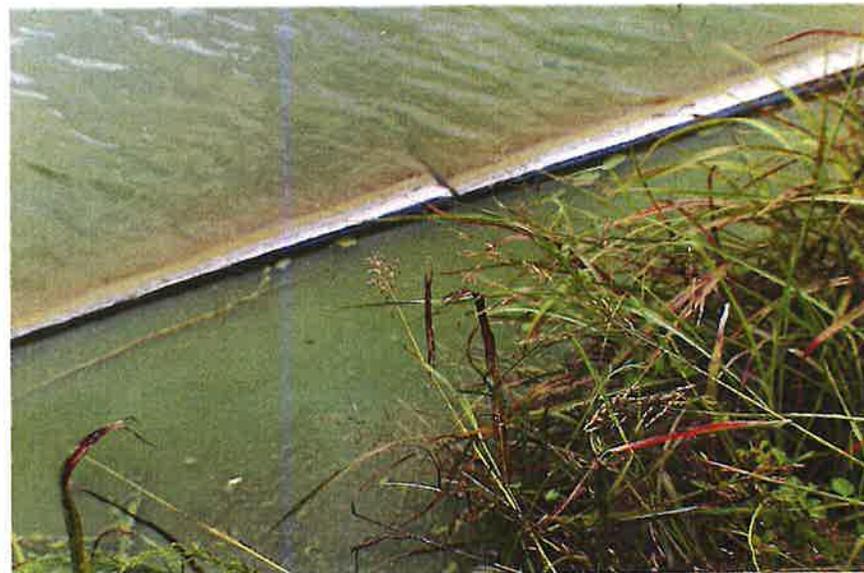
- A. Northeast levee wall on the #1 Oxidation Pond has eroded approximately 70%. If wall breaches we will be in violation of our NPDES permit issued by ADEQ.

Helena WWTP Cell 1, North East Side Wall

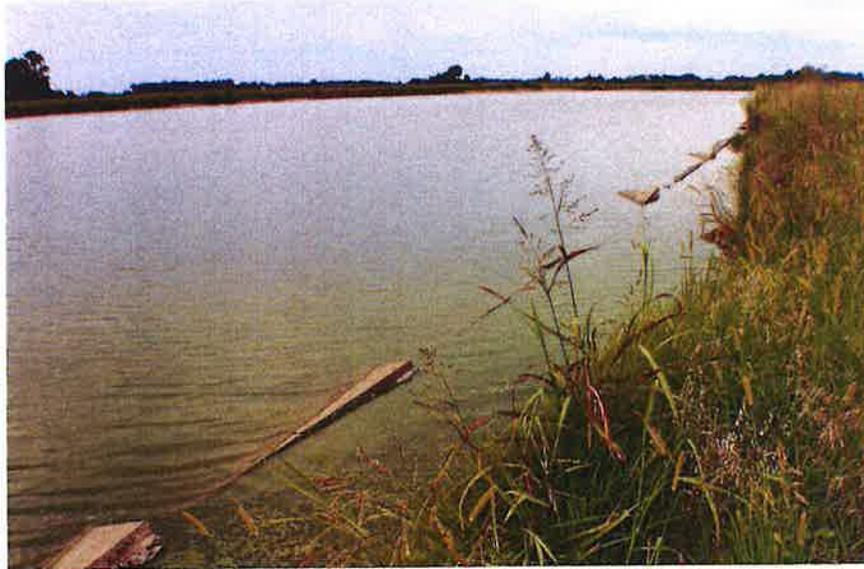
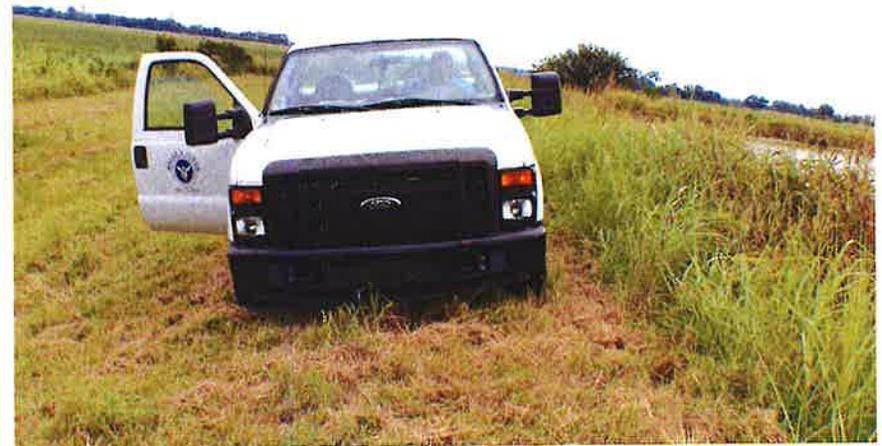
Helena WWTP Cell 1, North East Side Wall

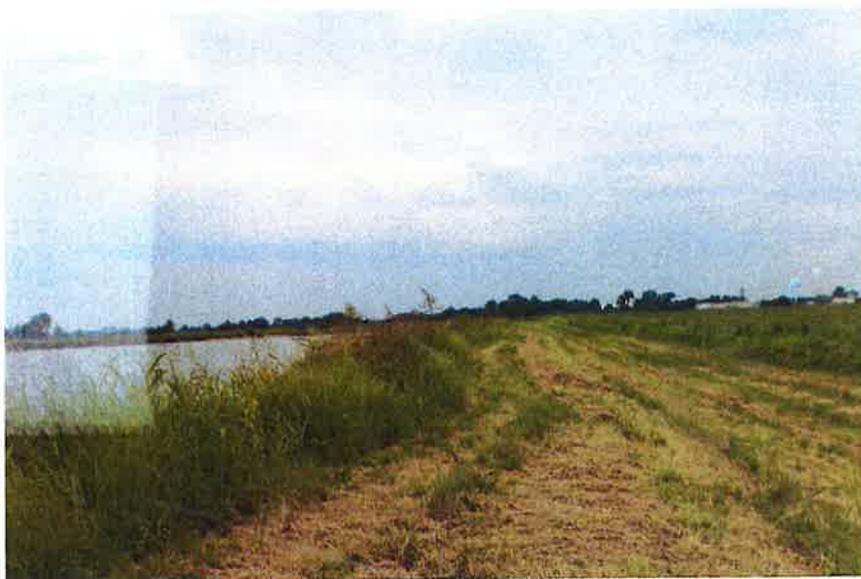
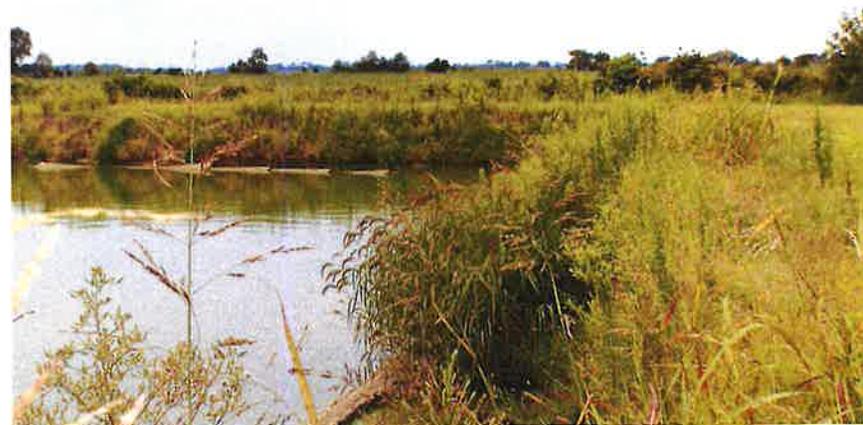
Helena WWTP Cell 1, North East Side Wall

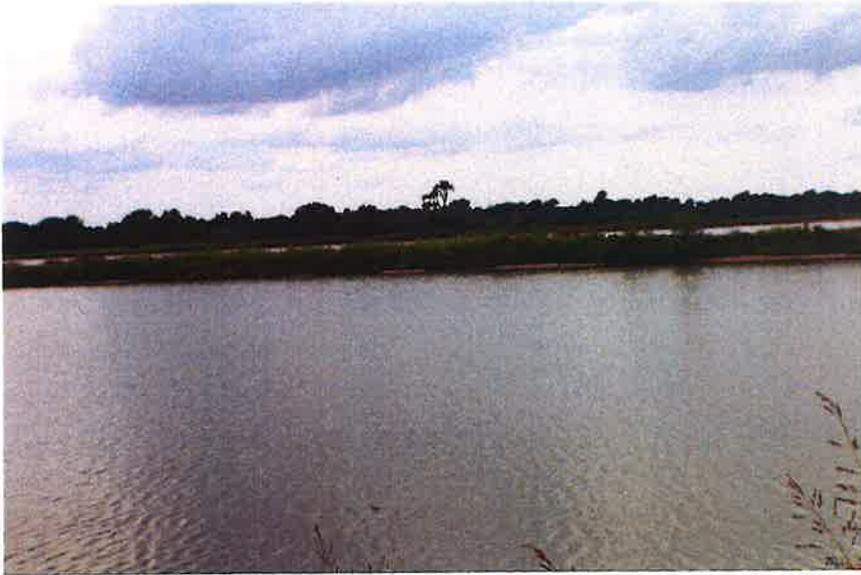
Helena WWTP Cell 1, South Side Wall

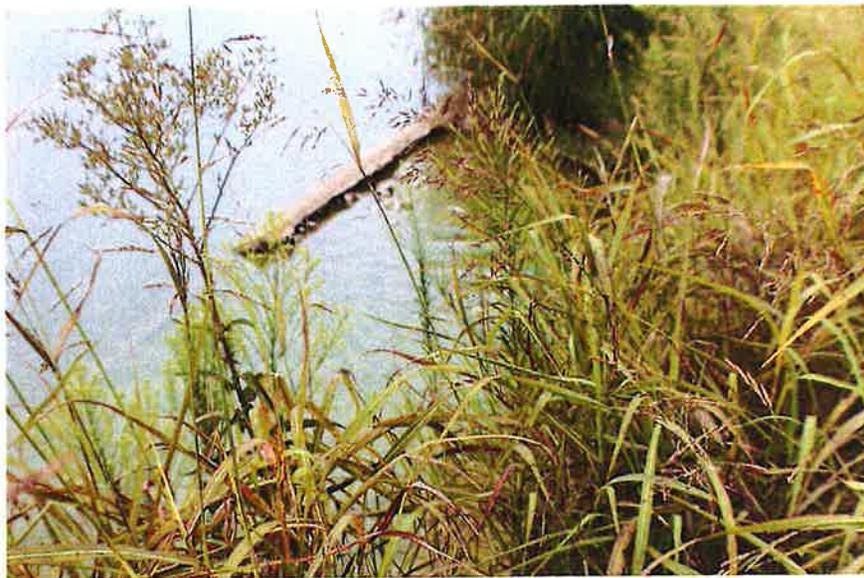
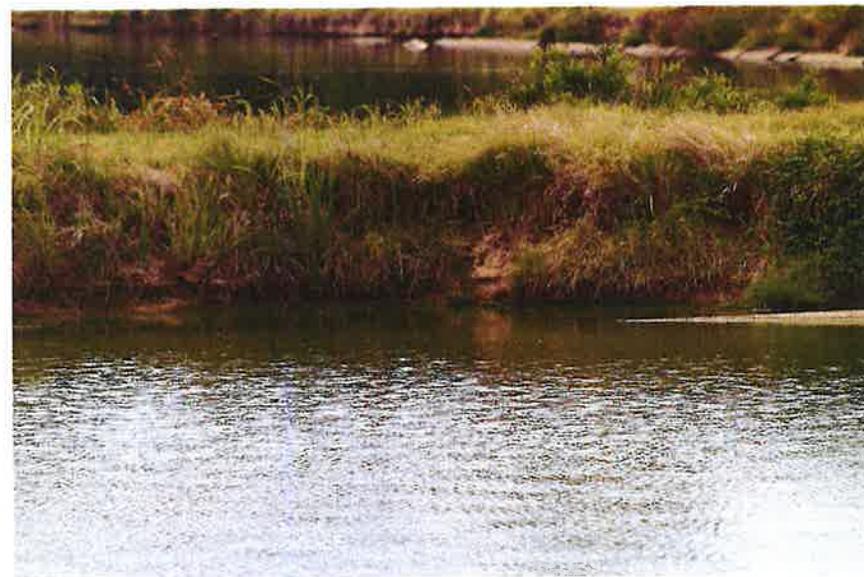
Helena WWTP Cell 1, South Side Wall

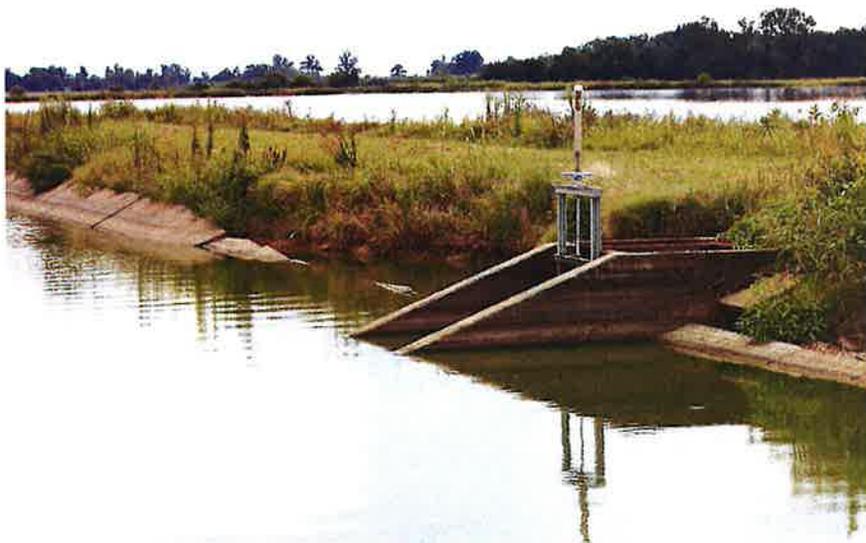
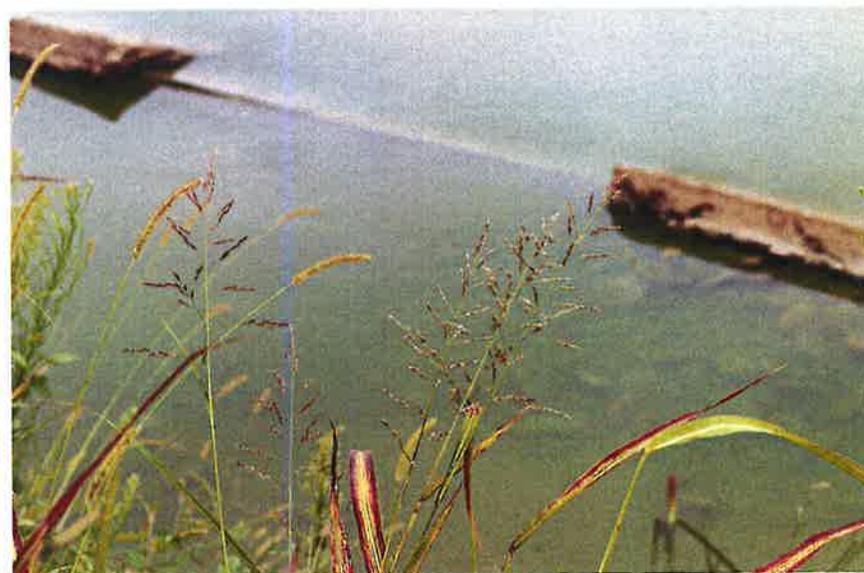
Helena WWTP Cell 1, West Side Wall

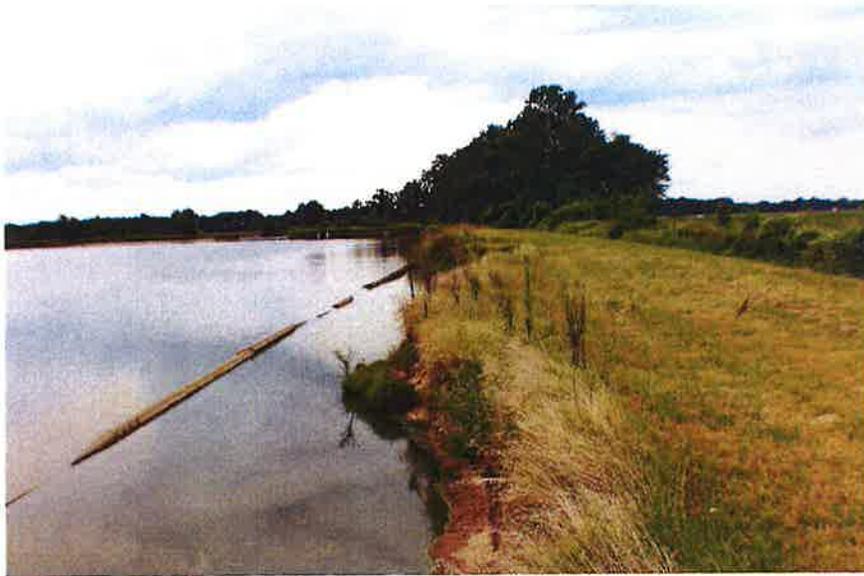
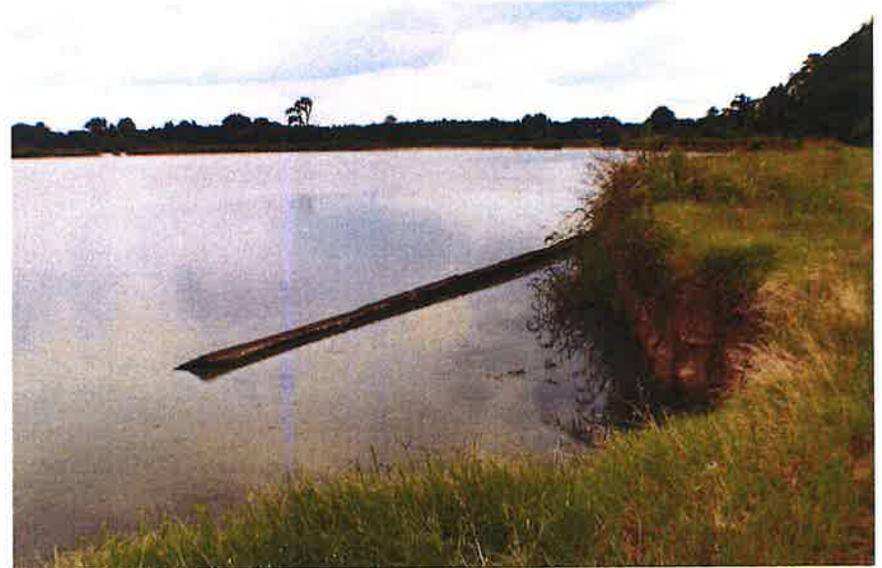
HWWTP Cell 2 NW Side Levee

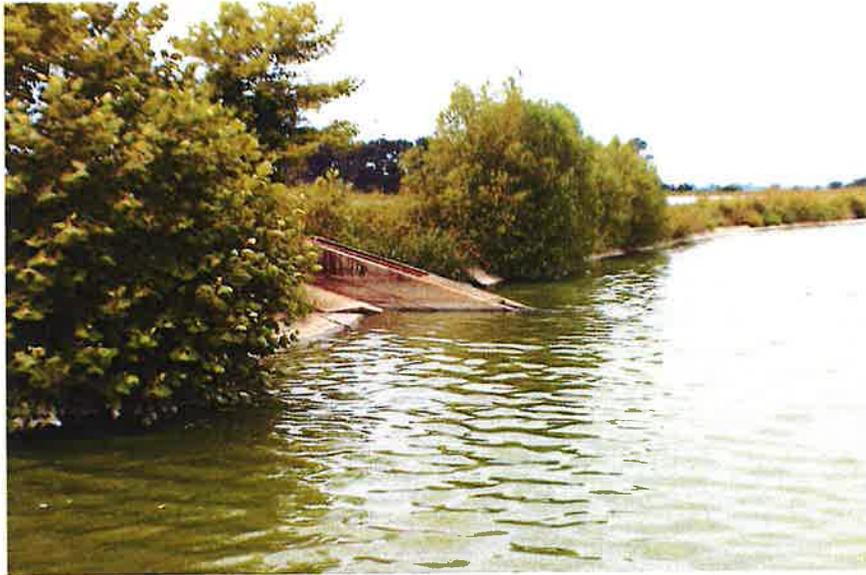
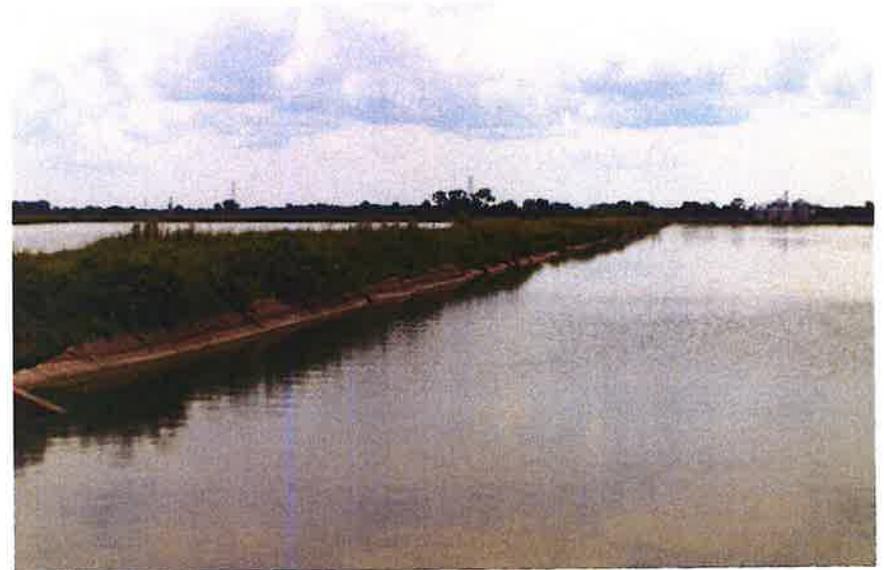
Helena WWTP Cell 2, West Side Wall

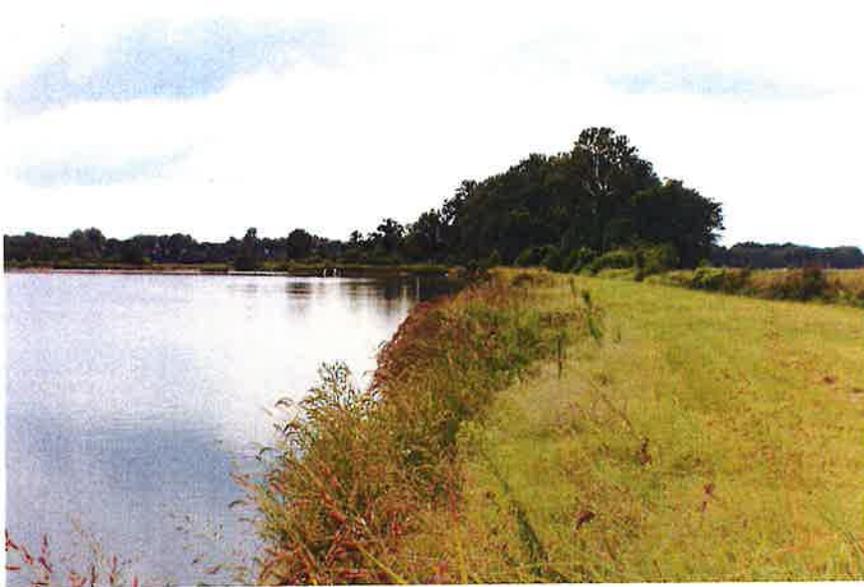
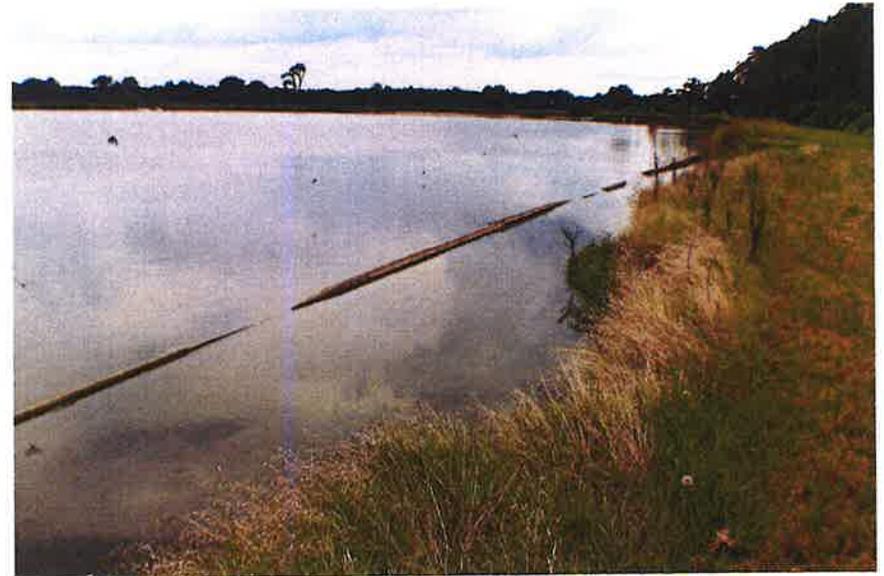
Helena WWTP Cell 2, West Wall

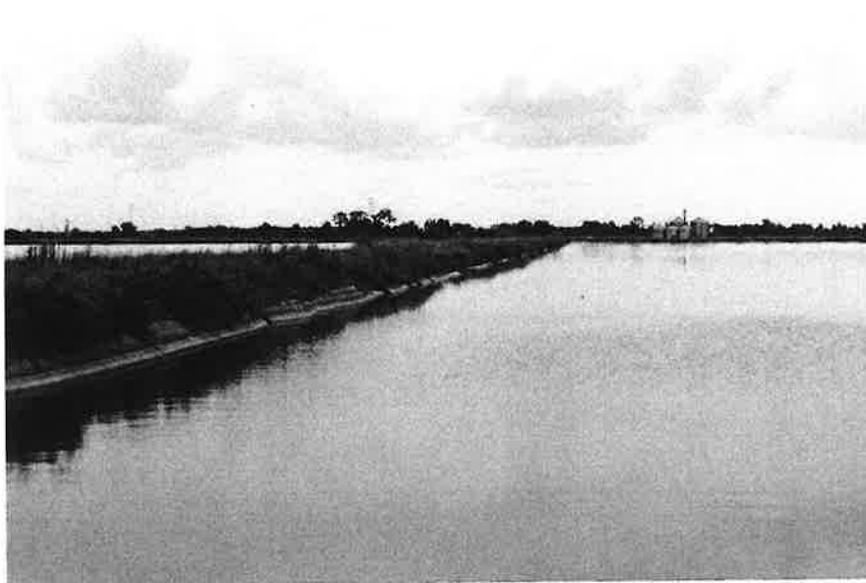
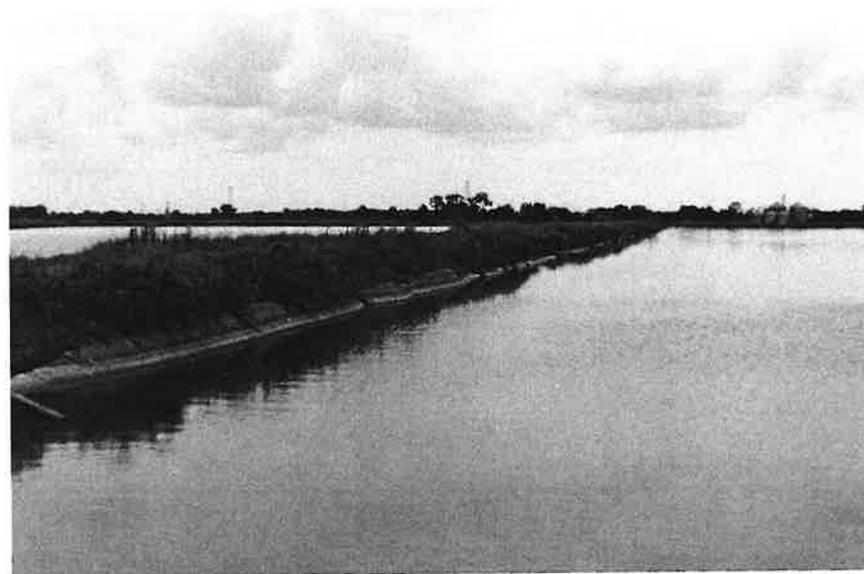
Helena WWTP Cell 2, West Wall

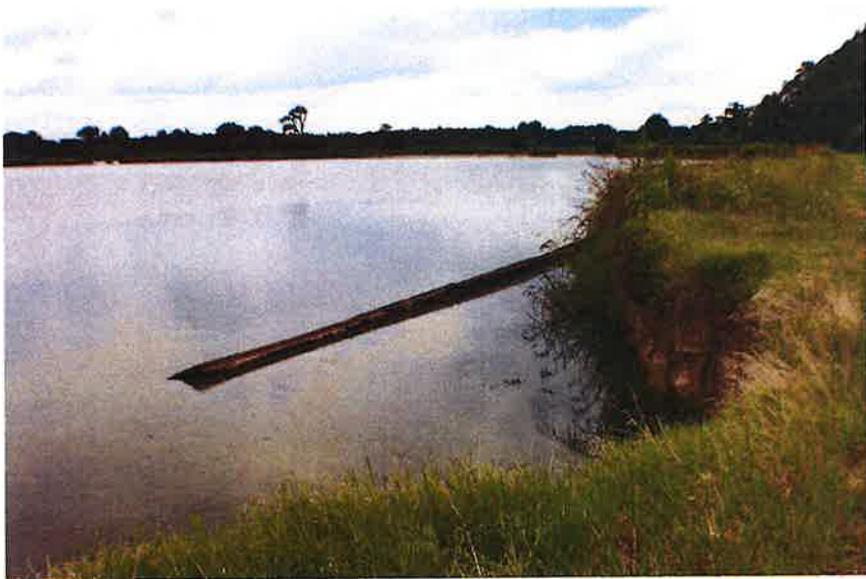
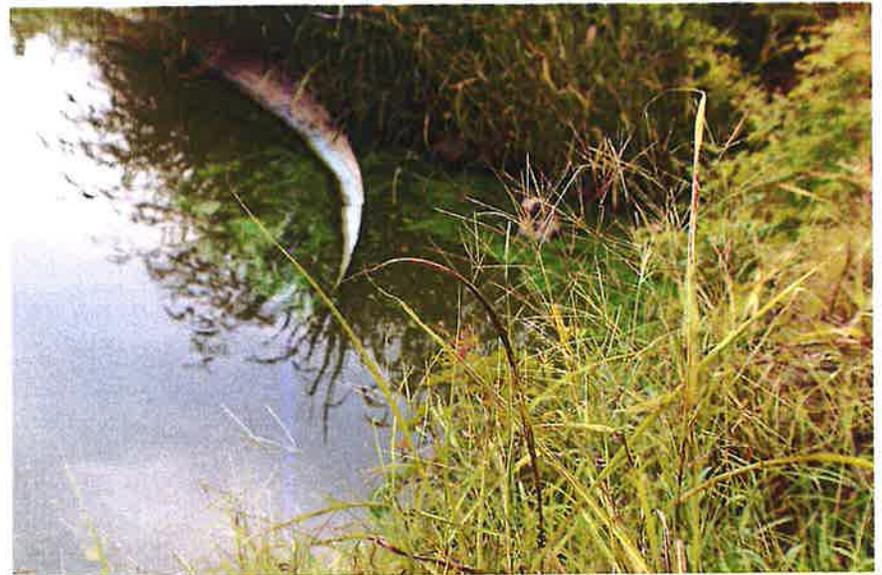
Helena WWTP Cell 2, West Wall

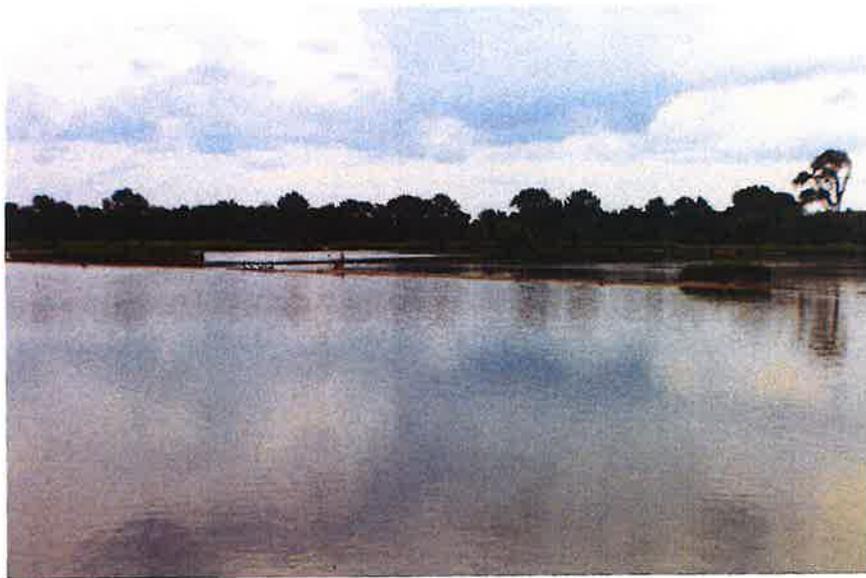
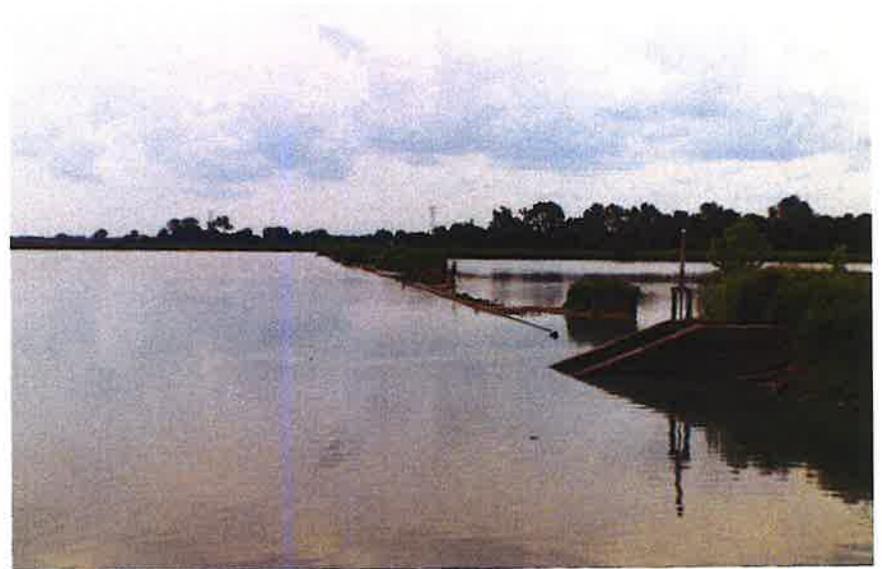
HWWTP Levee Wall Between 2 & 3

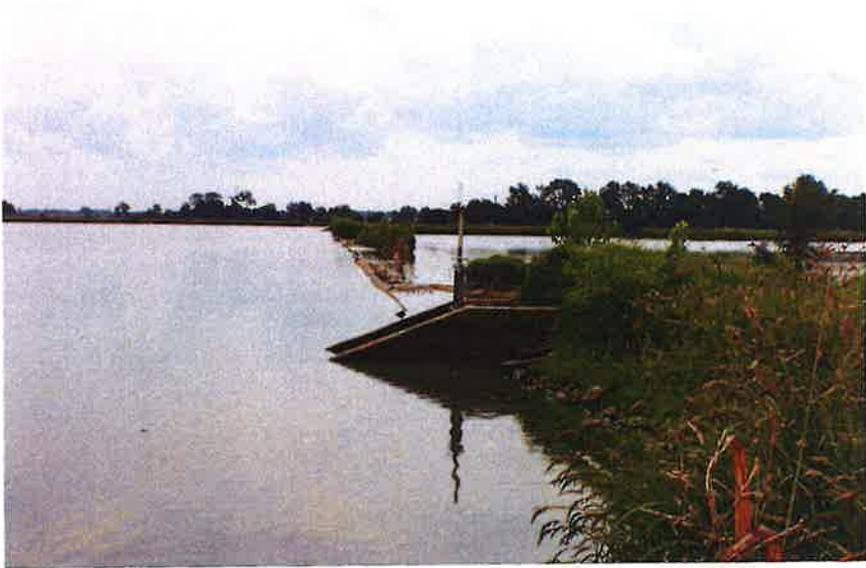
HWWTP Cell 2 & 3 Levee Wall Collapse

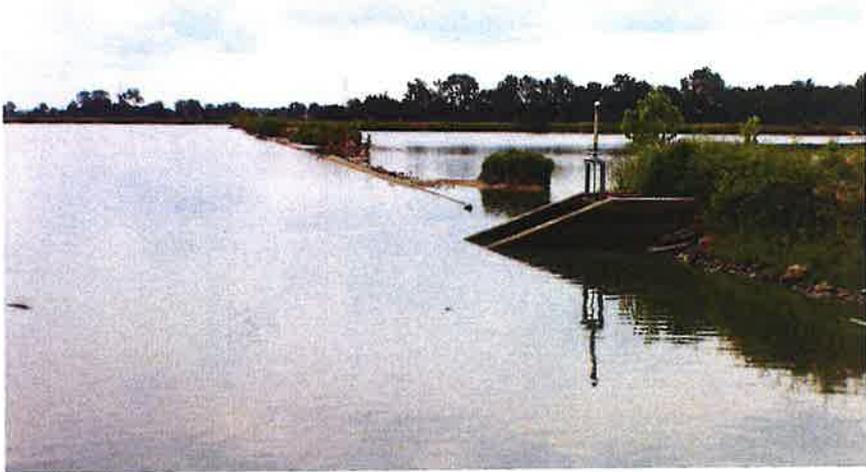
Helena WWTP Cell 2 & 3 Complete Levee Wall Collapse between Cells

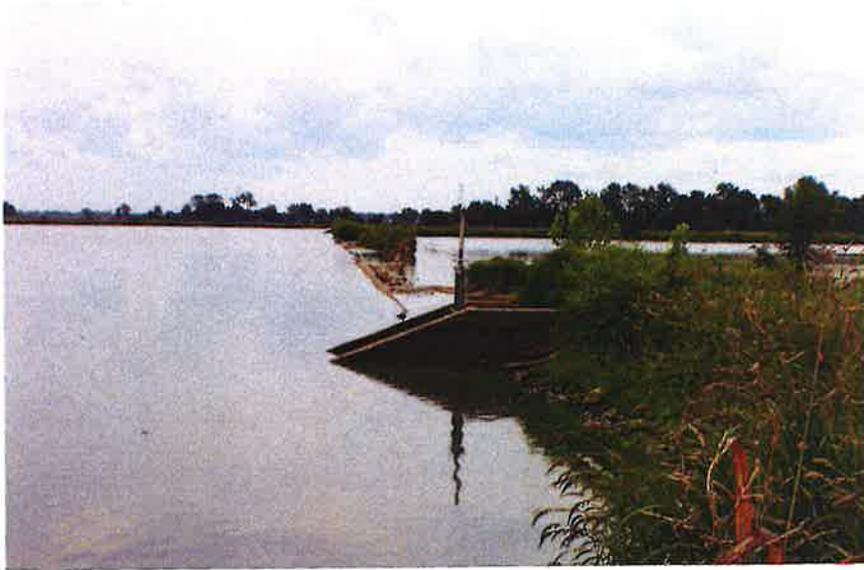
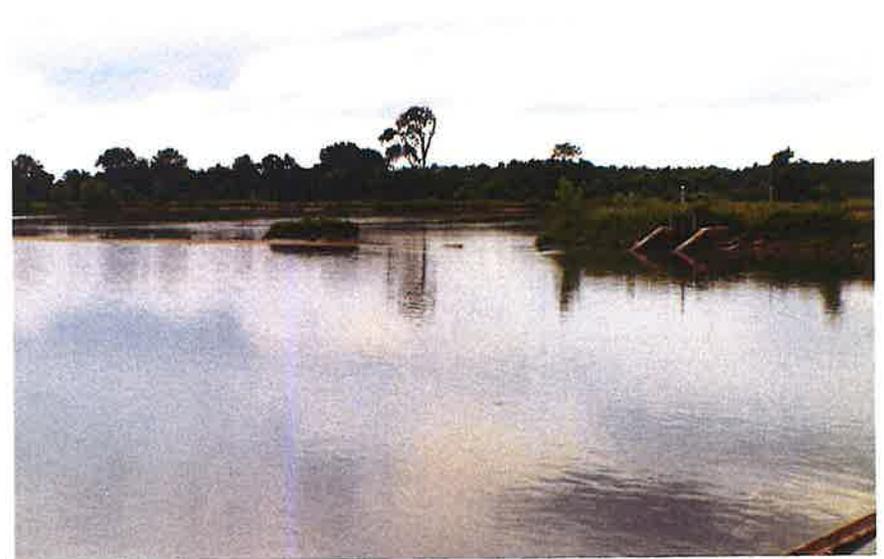
Helena WWTP Cell 2 & 3 Complete Levee Wall Collapse between Cells

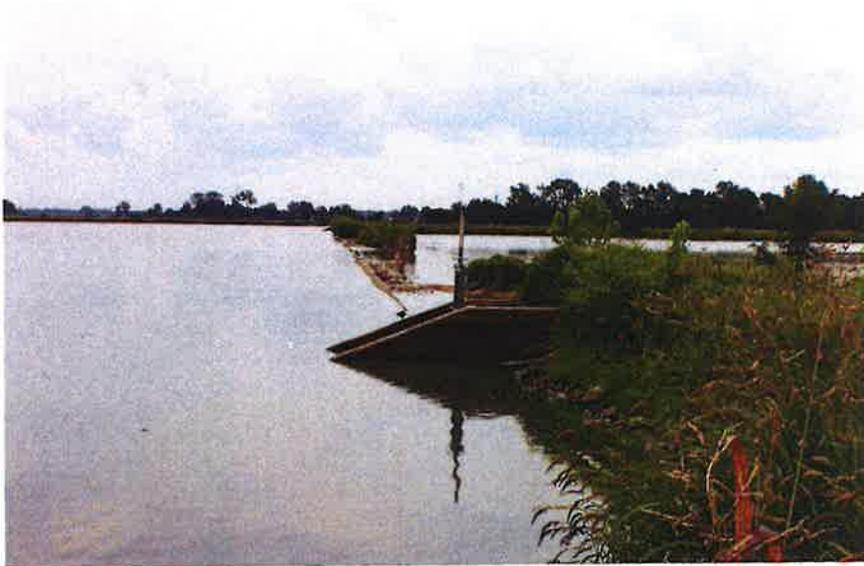
Helena WWTP Cell 2 & 3 Complete Levee Wall Collapse between Cells

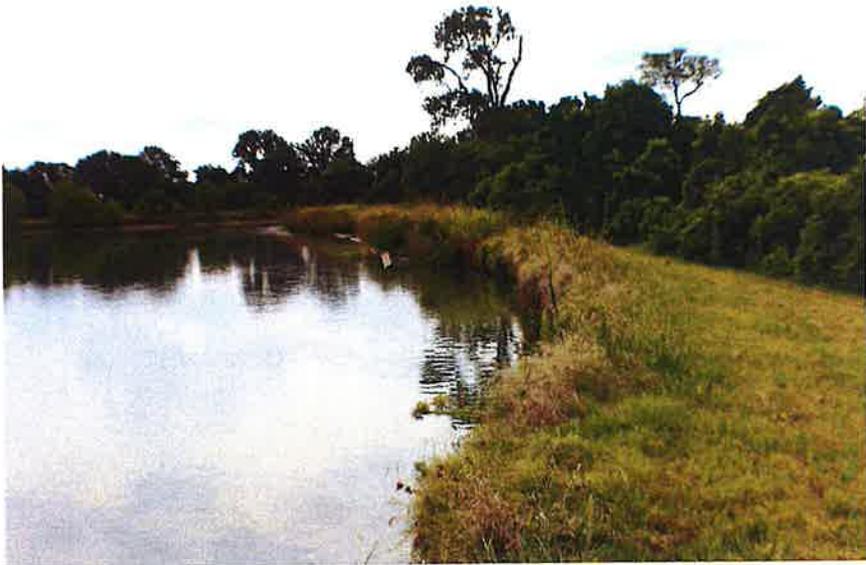
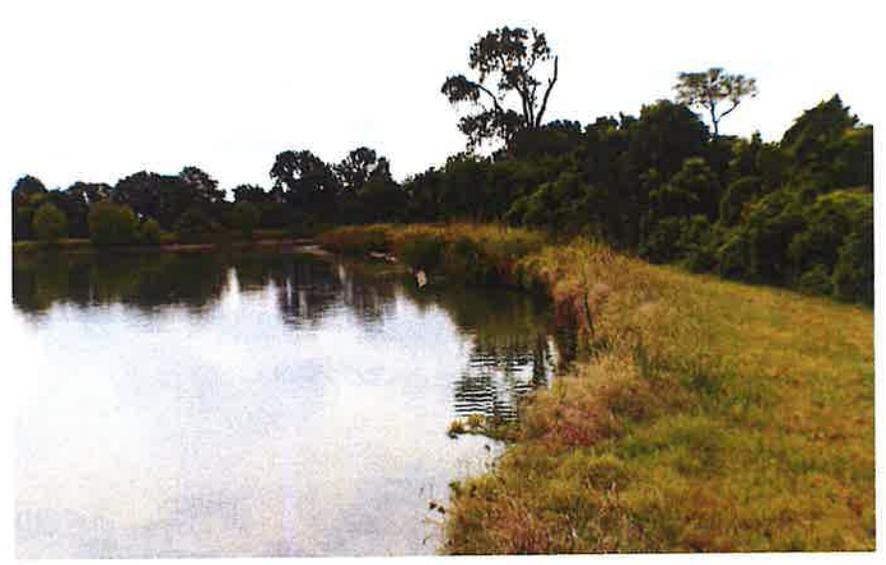
HWWTP Cell 3 SW Levee Wall

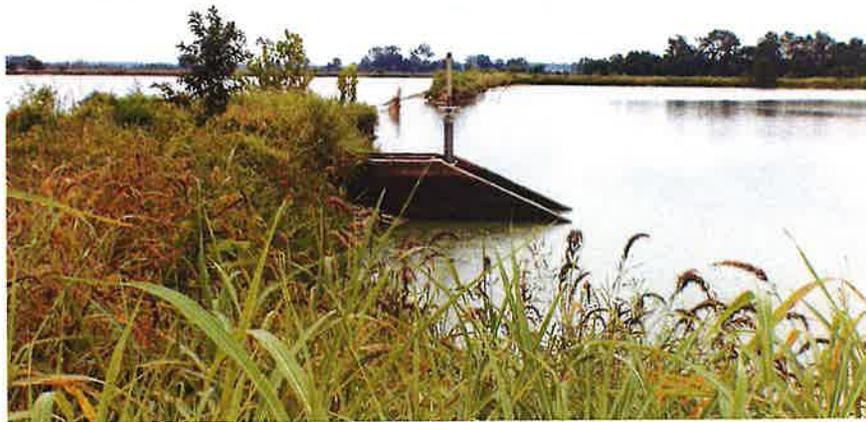
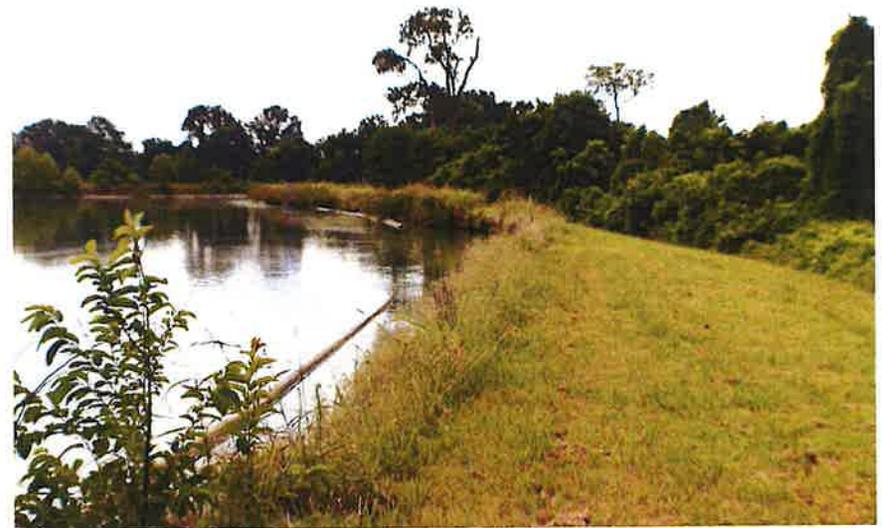
Helena WWTP Cell 3 West Levee Wall

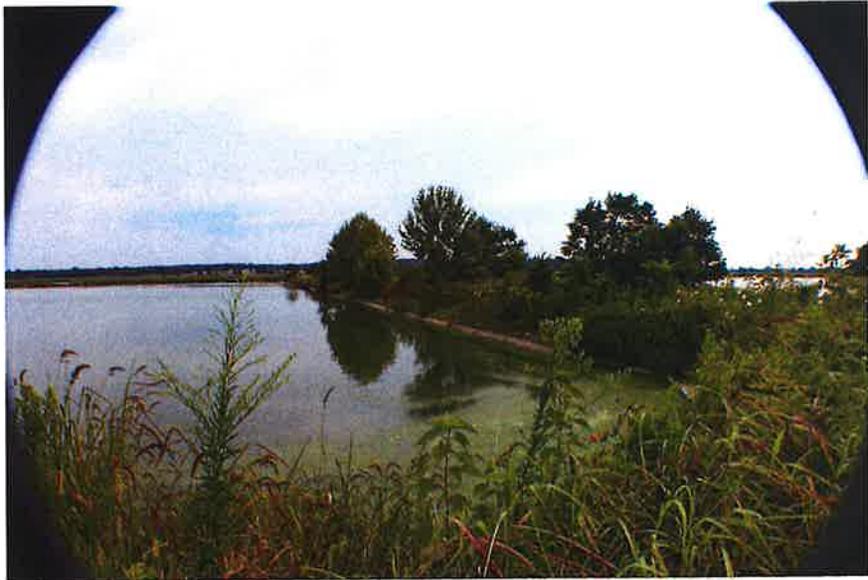
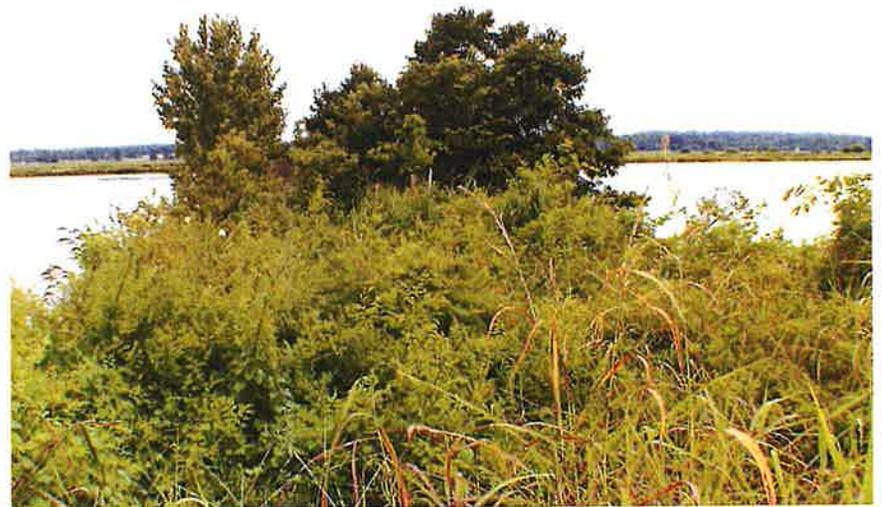
Helena WWTP Cell 3 & 4 Levee Wall

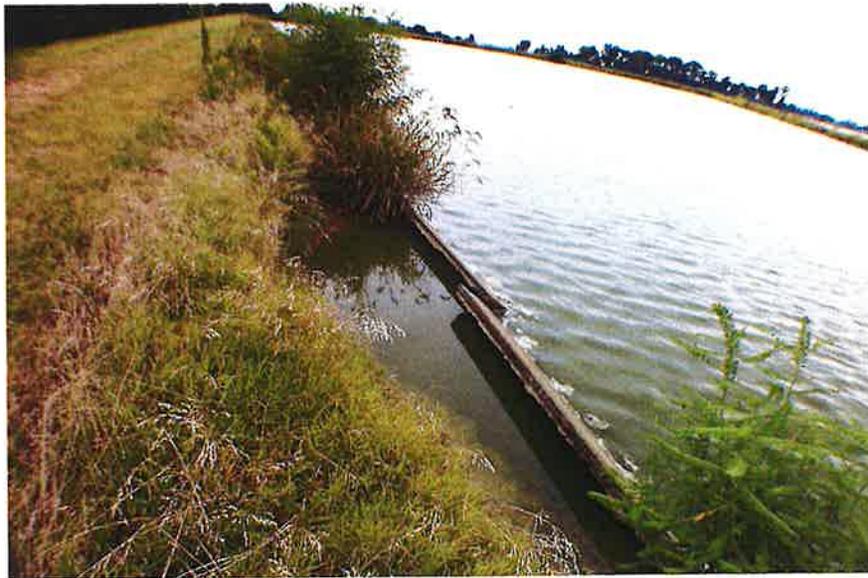
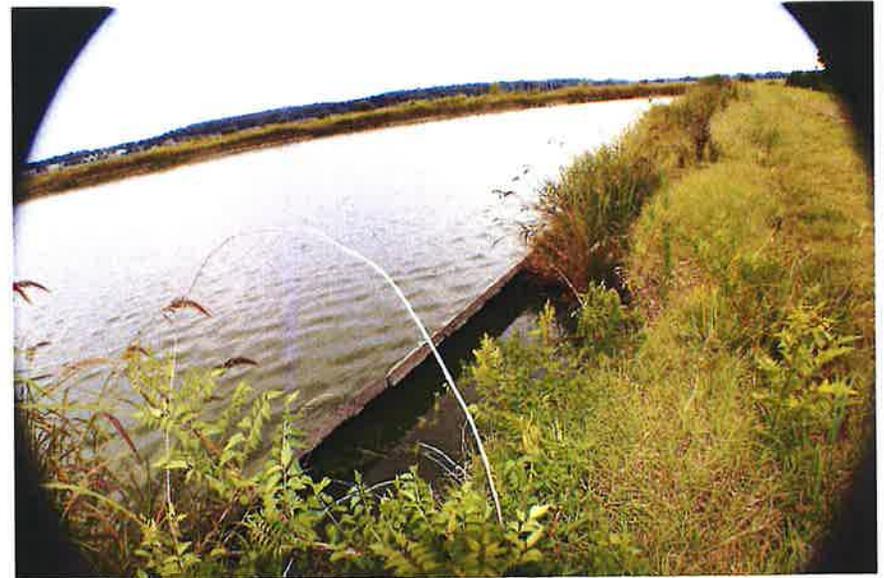
Helena WWTP Cell 4 South East Levee Wall

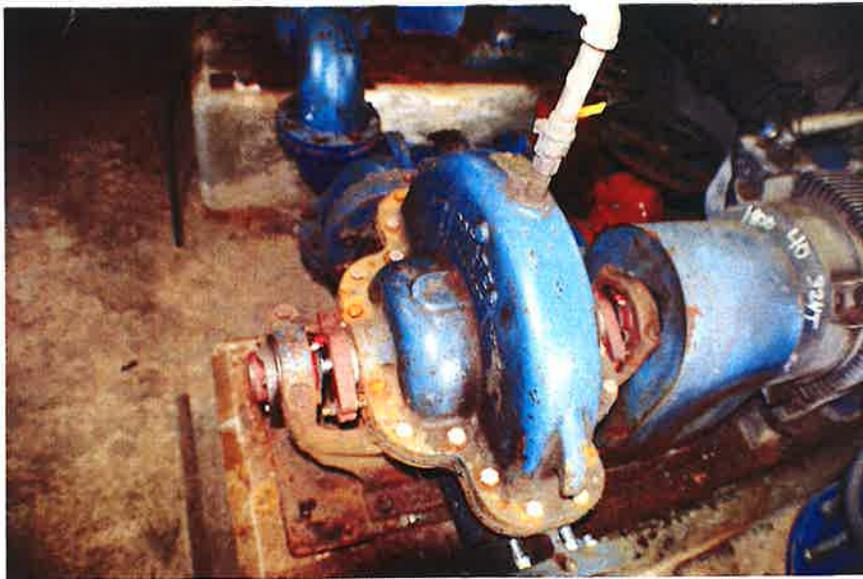
Helendale Booster Station Pumps Complete Rebuilds with new Seals, Bearings, Impellers

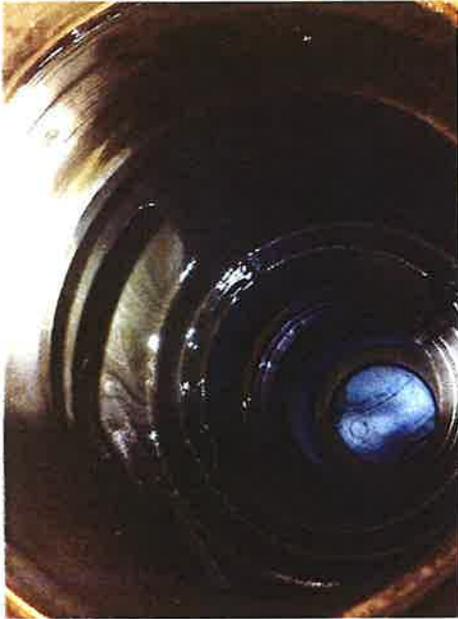
Holes in the impeller.

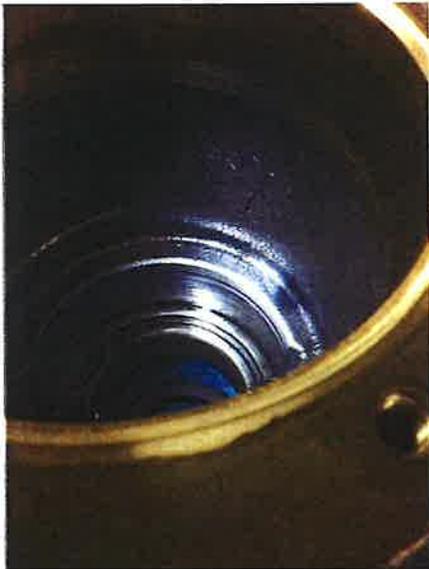
Metal particles, and sludge in the bearing oil.

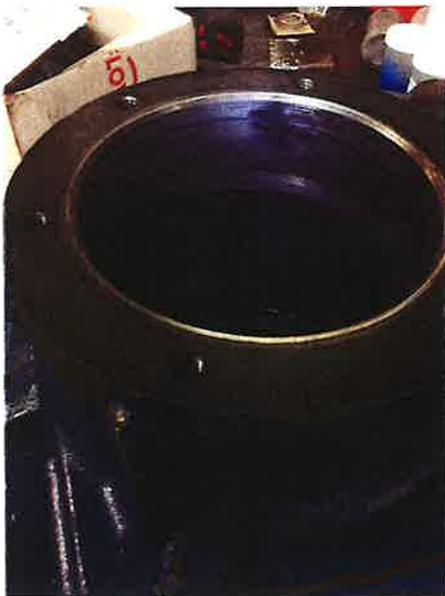
Inboard bearing had spun in the bearing housing.

The specifications for the housing fit is 4.9225"

Option #1 is to have the housing bored out and a sleeve inserted, and rebored to match the bearing fit. Cost \$500-\$650

Option #2 is to buy a new bearing housing. Cost \$1150.

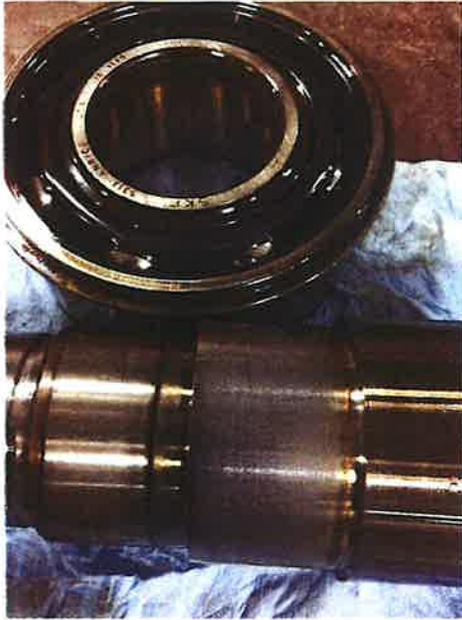
Outboard bearing had spun in the bearing housing.

The specifications for the outboard bearing housing fit is 5.5125".

The present housing measurement is 5.5129"

The outboard bearing fit is ok.

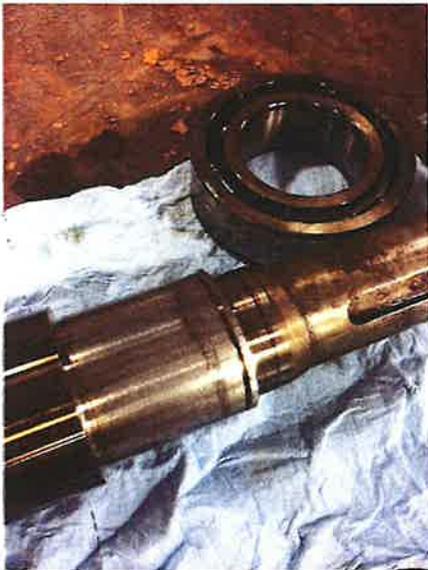
Shaft is ok at the bearing fits on outboard bearing.

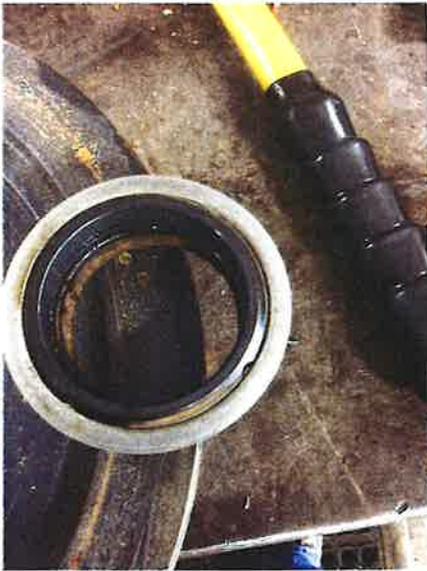
Seal plate is ok. The mechanical seal is bad.

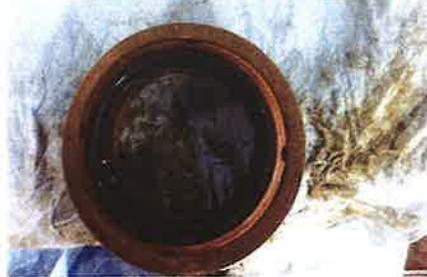
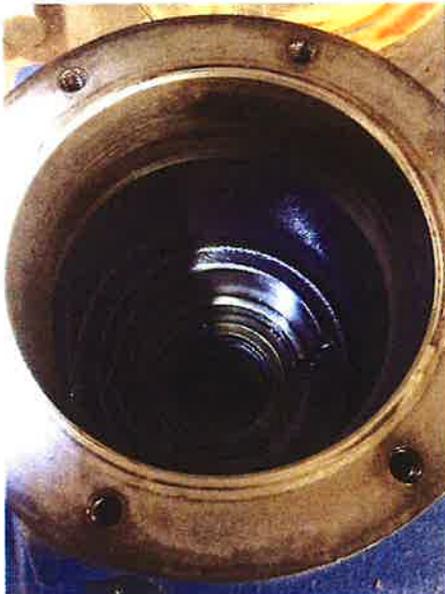
Mechanical seal plate is ok, the mechanical seal is bad.

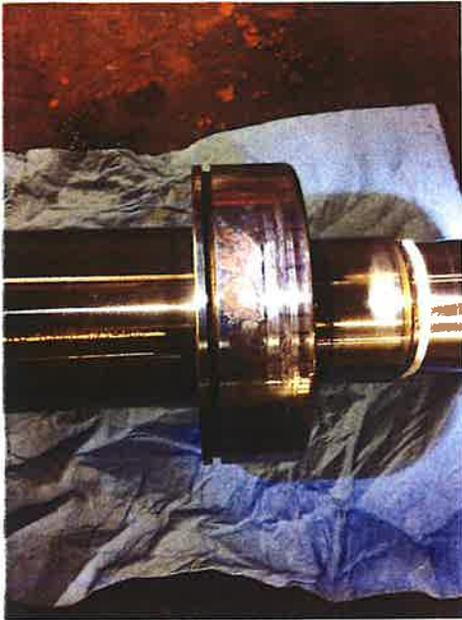
Inboard bearing had spun in the bearing housing.

The specifications for the housing fit is 4.9225"

The present housing measurement is 5.5134".

The outboard bearing fit is ok by 0.0006"; and inboard bearing fit is ok by 0.0007".

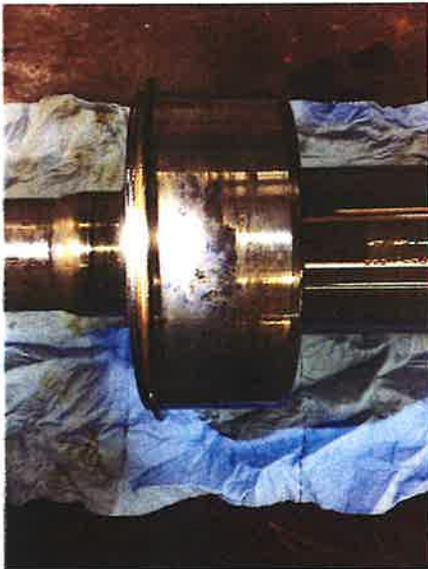
Inboard bearing had spun in the bearing housing

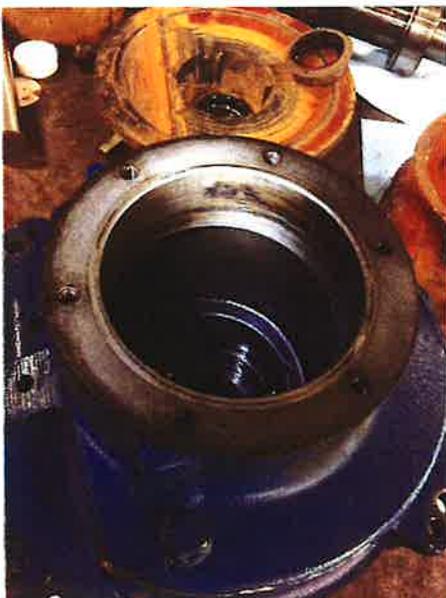
Outboard bearing had spun in the bearing housing.

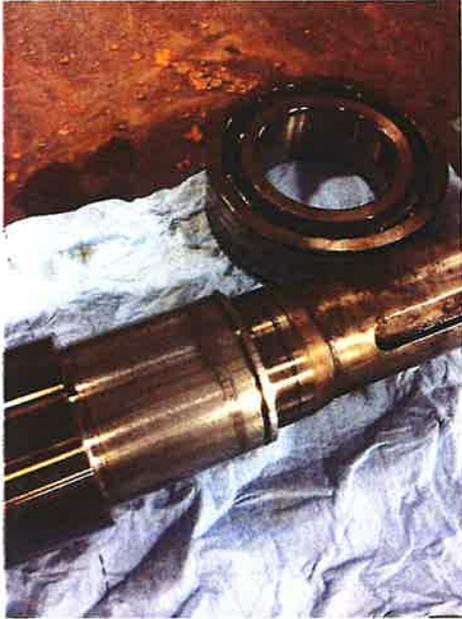
Bearings had spun in the bearing housing.

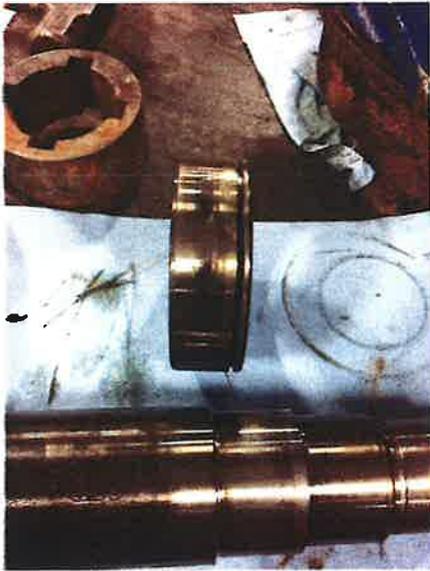
Outboard bearing shaft fit is ok.

Inboard bearing fit is ok, the outer bearing race had started to spin in the housing.
