Pre-Design Study Results

**Pre-Design Study – Revision 1
Mayflower Pipeline Incident Response, Mayflower, Arkansas**

Downstream Areas Pre-Design Study Photolog

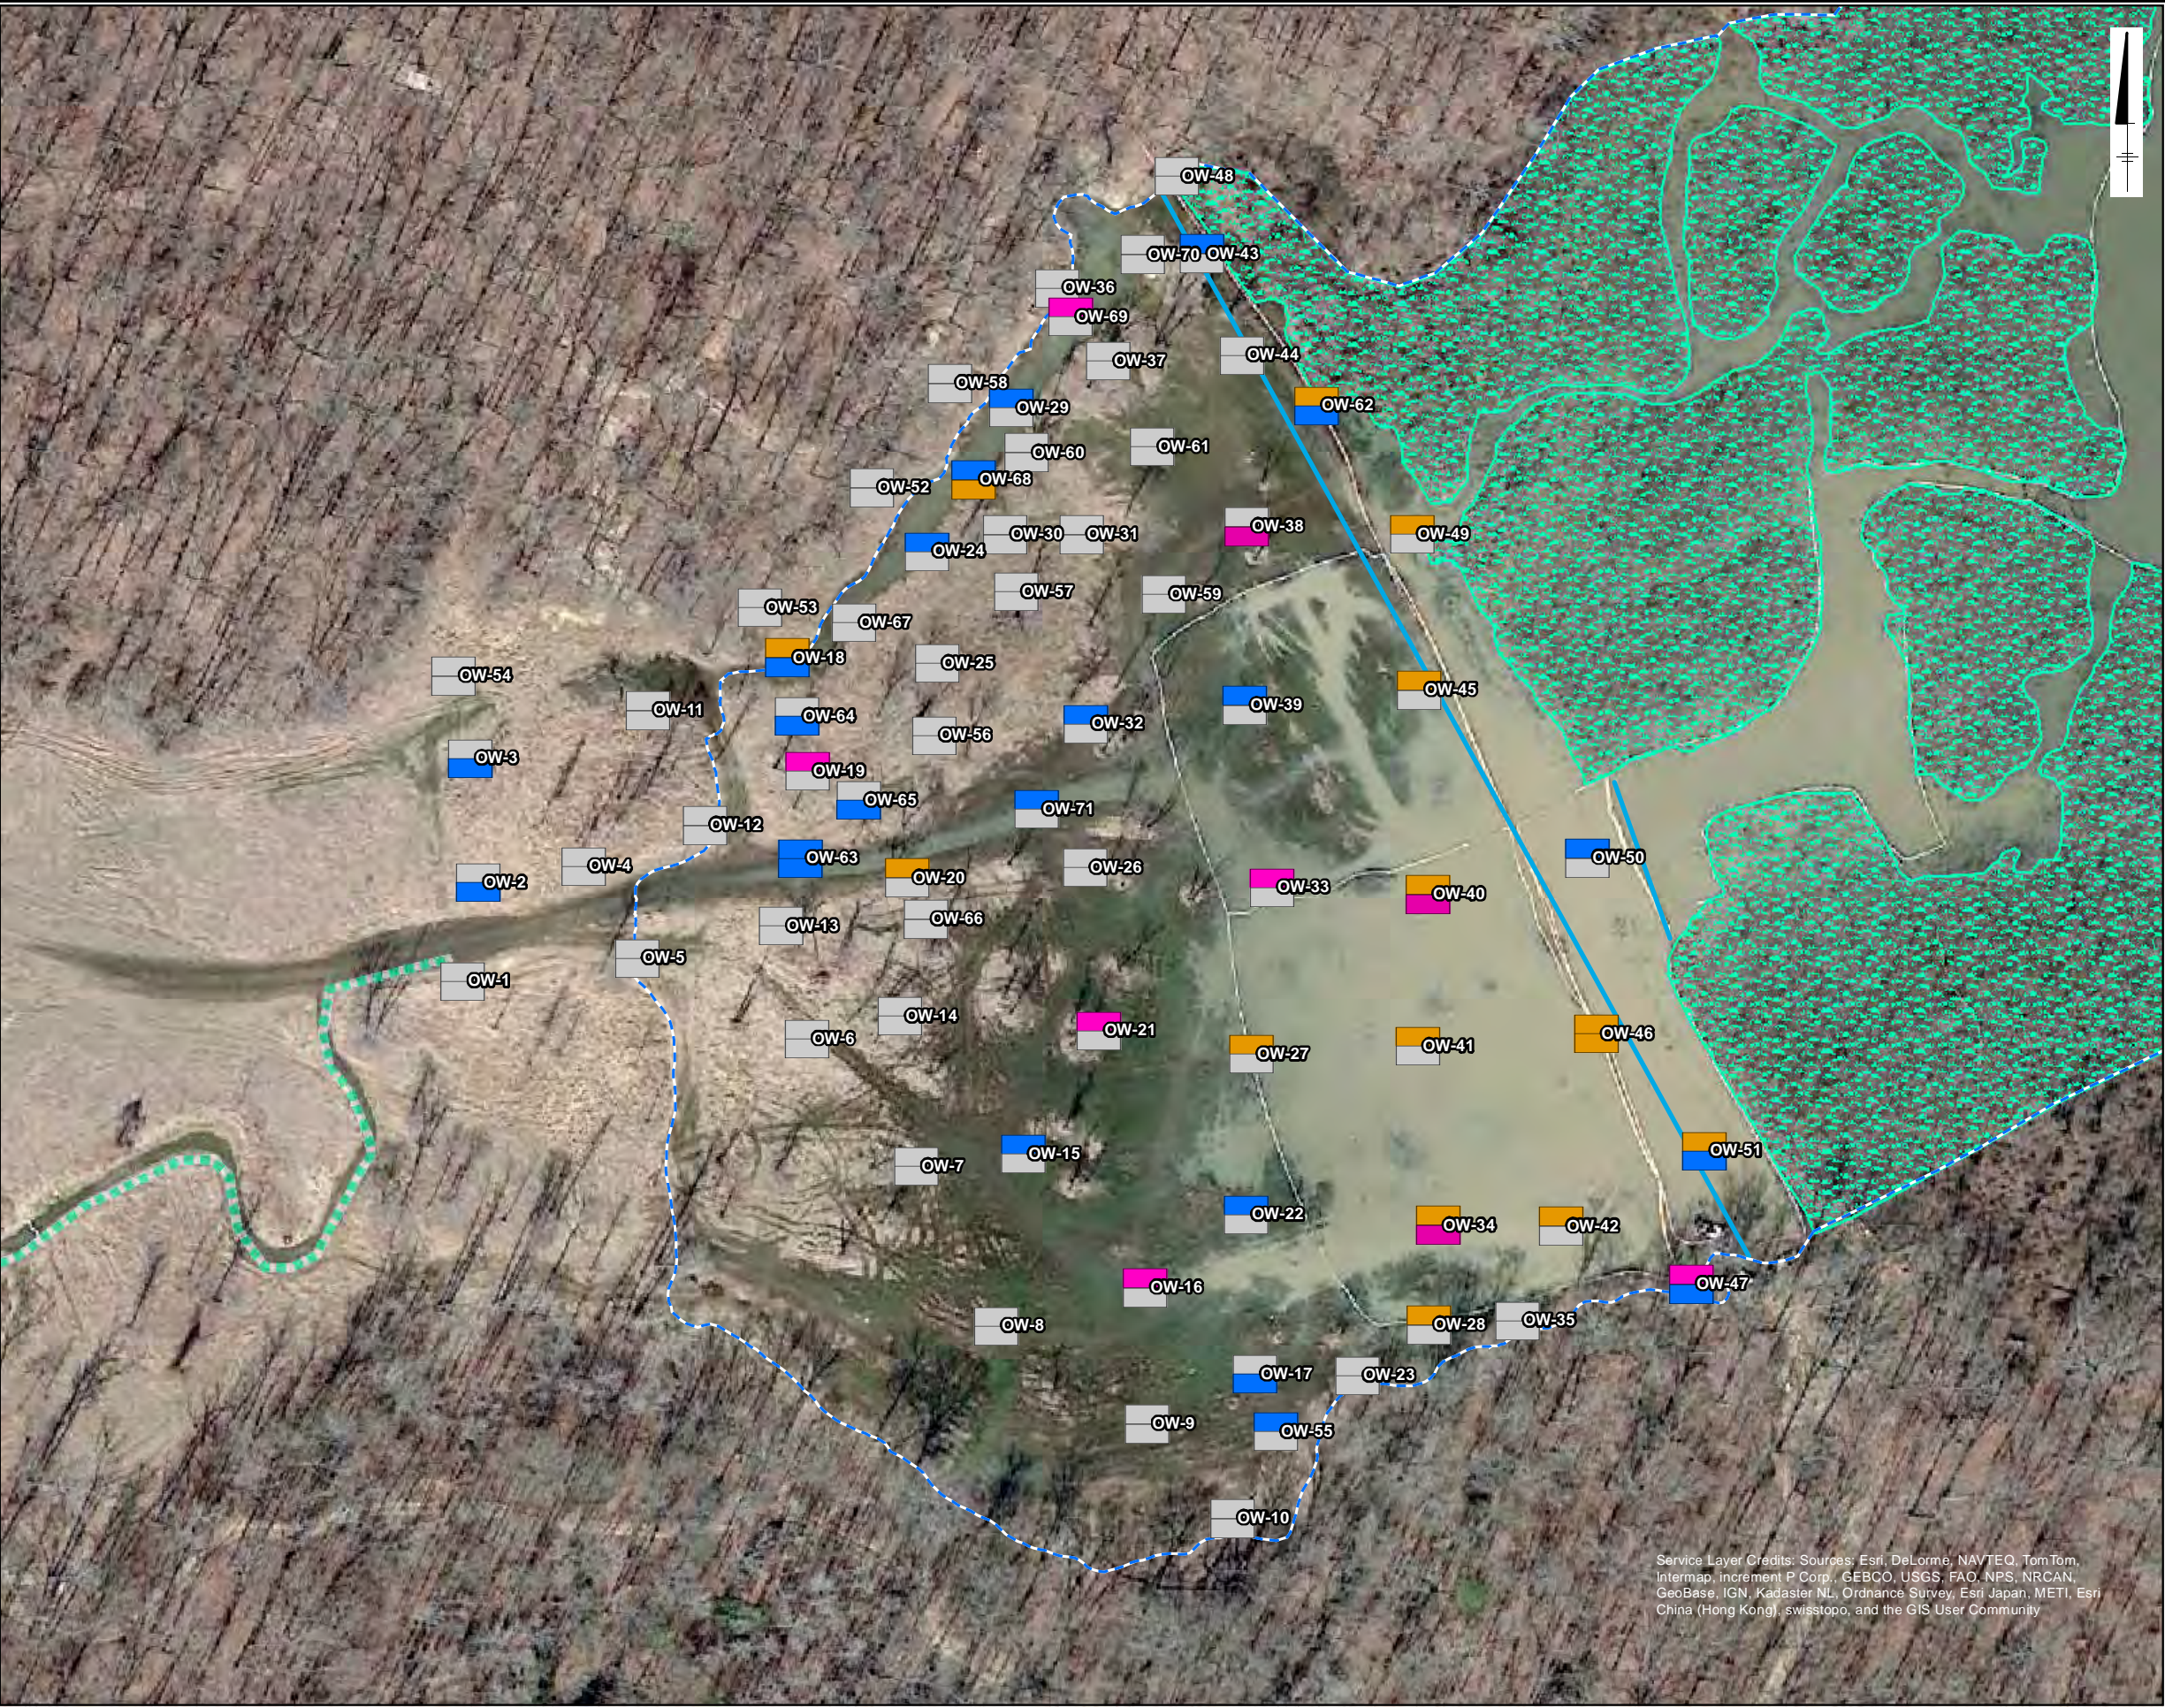
**FIGURE
A-2**

Relative Sheening Observed During Pre-Design Study

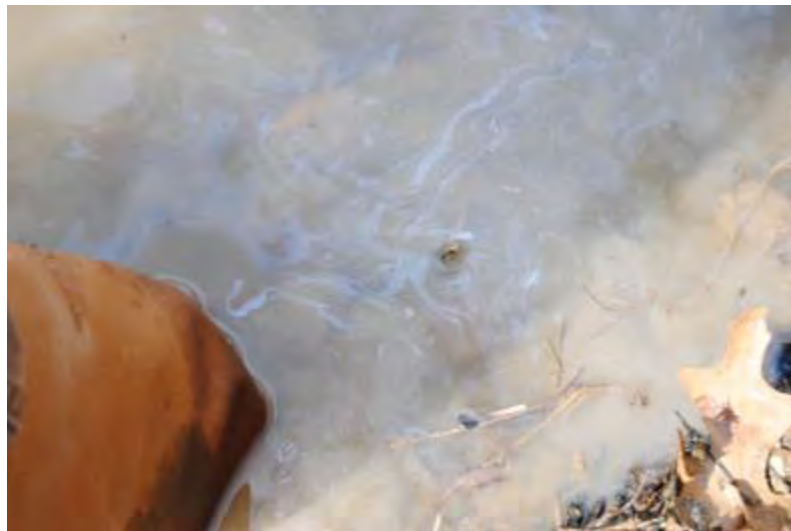
Probing Observation:

Surface : Patches/streamers of non-brittle silver gray sheen
0-6 inches : Patches/streamers of non-brittle silver gray sheen

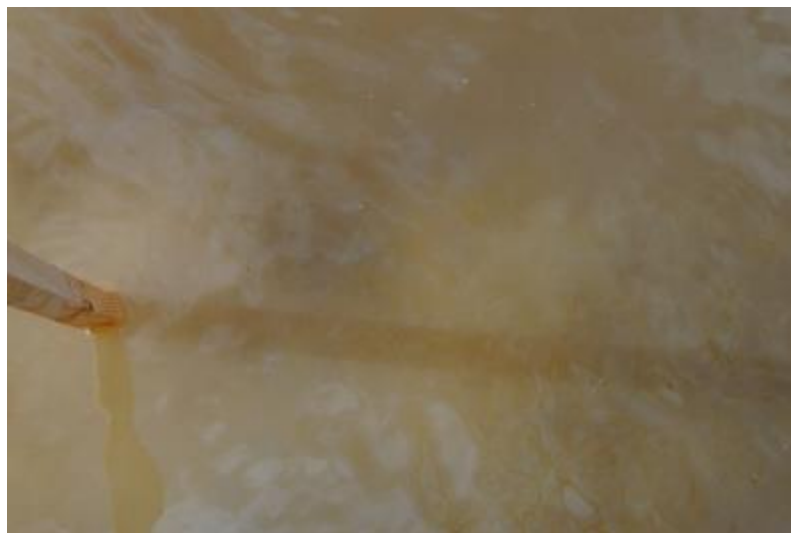
Probing Observation:

6-12 inches : Patches/streamers of non-brittle silver gray sheen with oil spots (<0.25-inch wide)

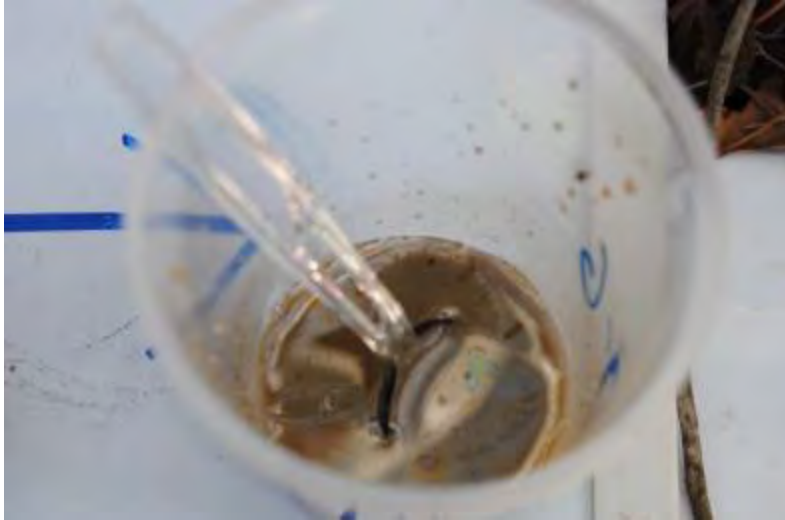
Sheen Stir-Test:

0-6 inches : Cover of rainbow sheen
(Heavier)

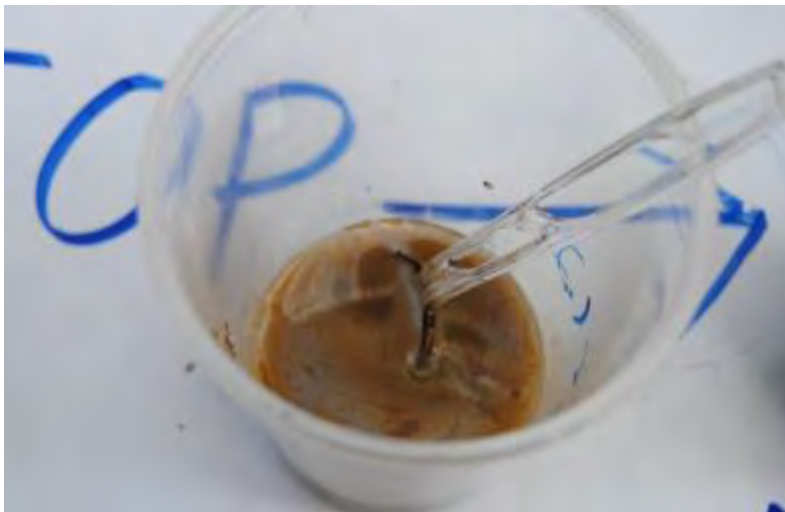
Sheen Stir-Test:

6-12 inches : Cover of rainbow sheen
(Heavier)

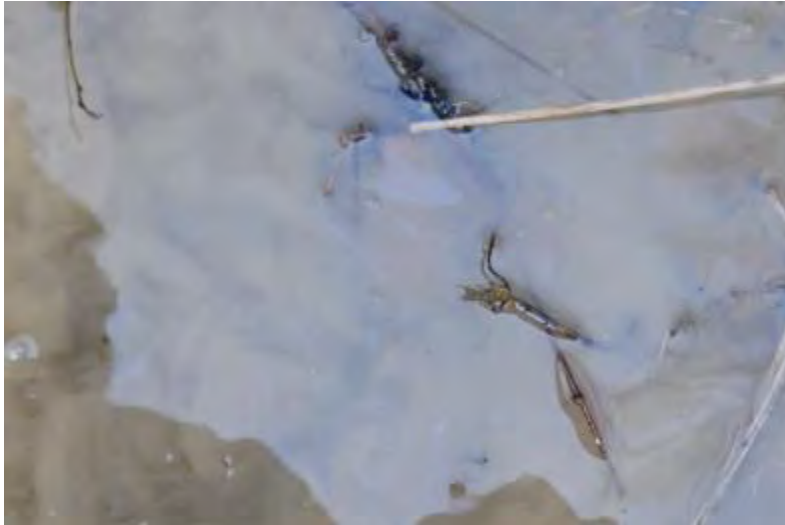
Probing Observation:

0-6 inches : Patches/streamers of non-brittle silver gray sheen

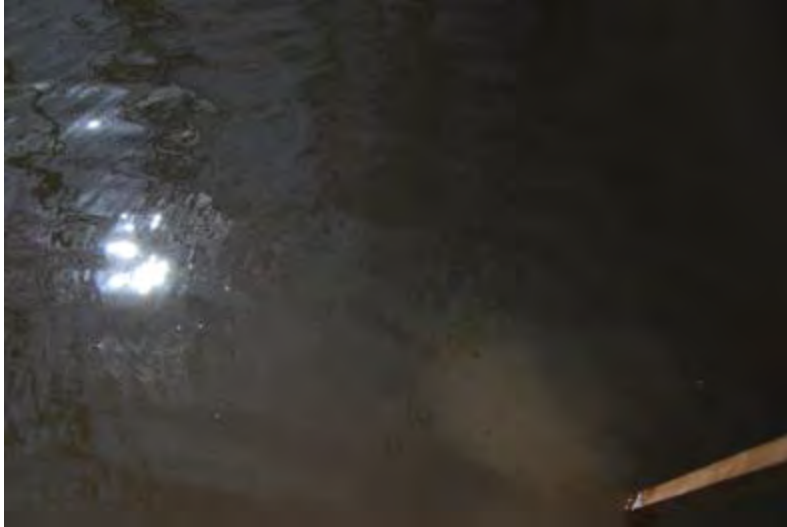
Probing Observation:

0-6 inches : Patches of non-brittle silver gray sheen
6-12 inches : Patches of non-brittle silver gray sheen

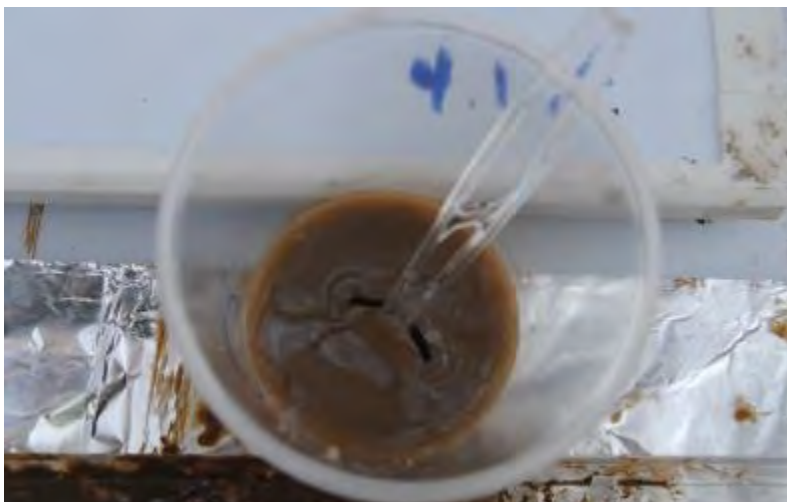
Sheen Stir-Test:

0-6 inches : Streamers of silver gray sheen (Medium)

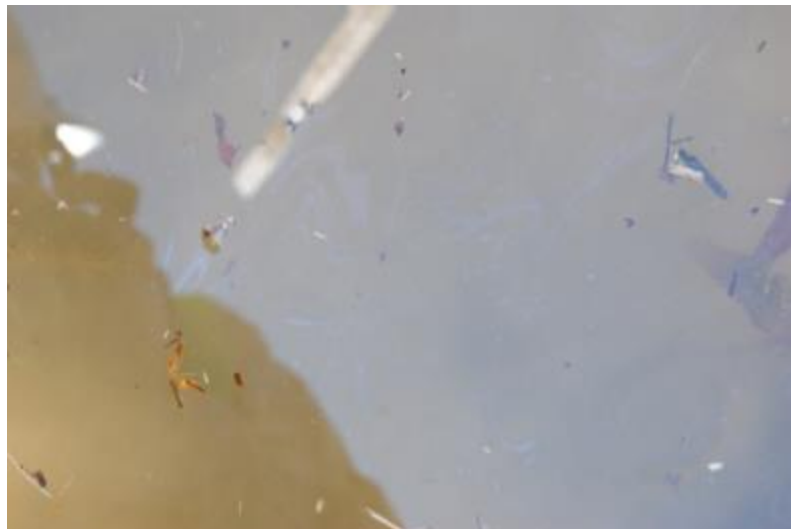
Probing Observation:

0-6 inches : Patches/streamers of non-brittle silver gray sheen with oil spots (<0.25-inch wide)
6-12 inches : Patches/streamers of non-brittle silver gray sheen with oil spots (<0.25-inch wide)

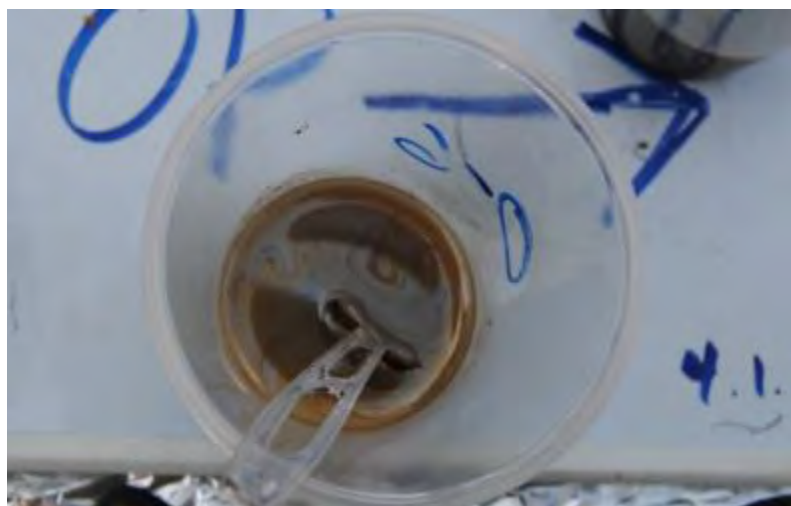
Sheen Stir-Test:

0-6 inches : Cover of rainbow sheen (Heavier)

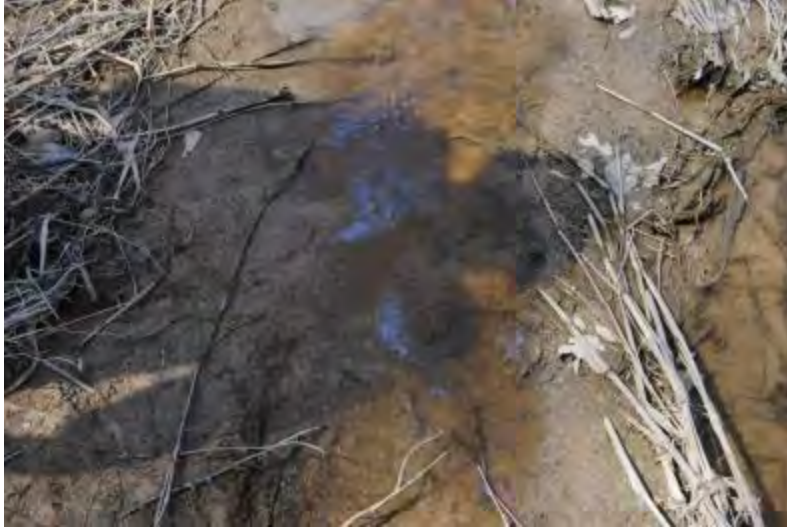
Initial Observation:

Patches of brittle silver gray sheen

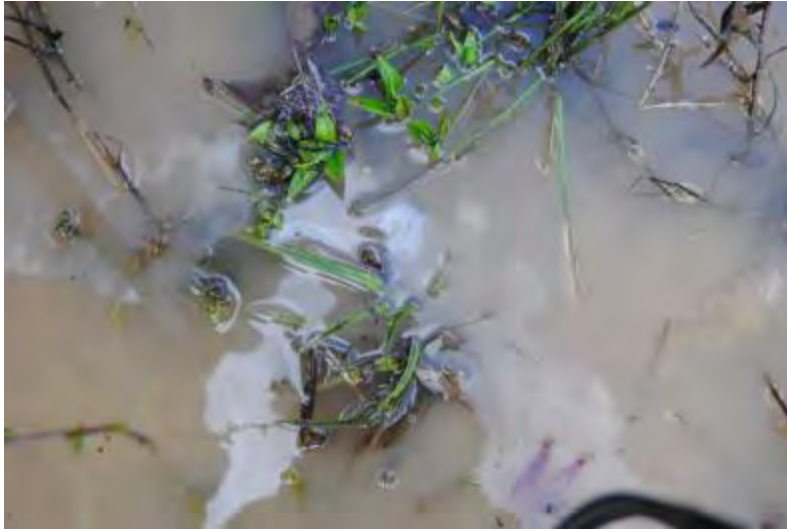
Probing Observation:

0-6 inches : Patches/streamers of non-brittle silver gray sheen (quickly dissipated)
6-12 inches : Patches/streamers of non-brittle silver gray sheen (quickly dissipated)

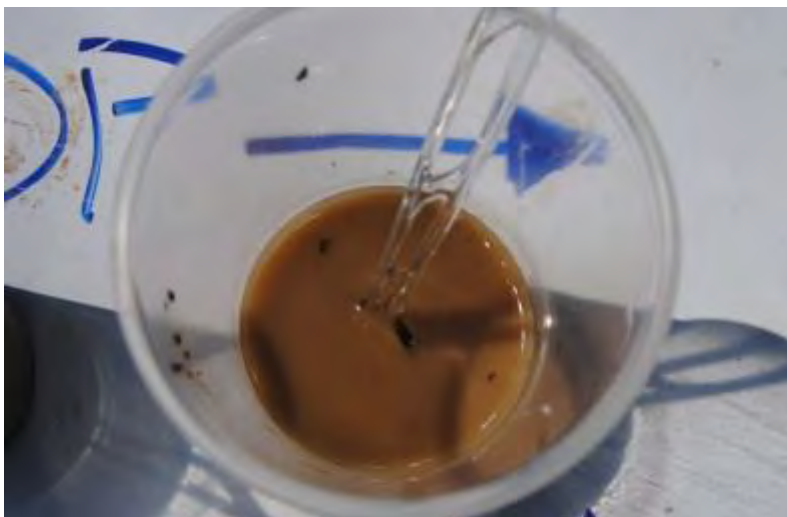
Sheen Stir-Test:

0-6 inches : Streamer of silver gray sheen (Lighter)

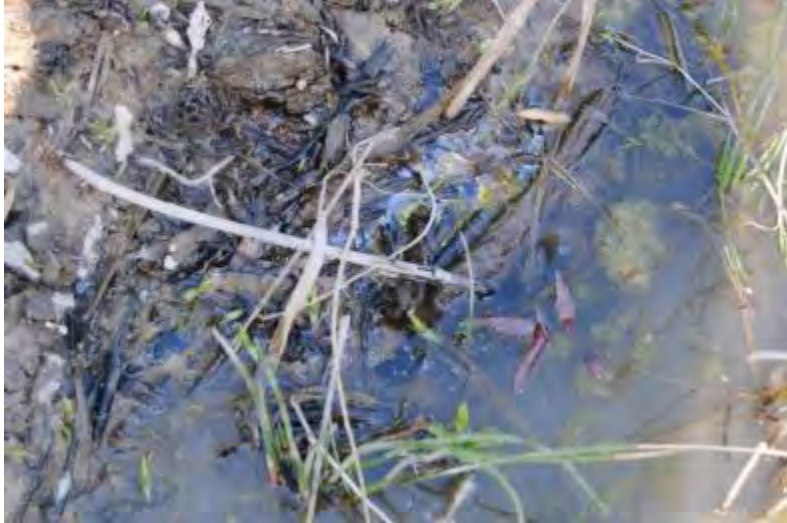
Initial Observation:

Cover of brittle silver gray sheen

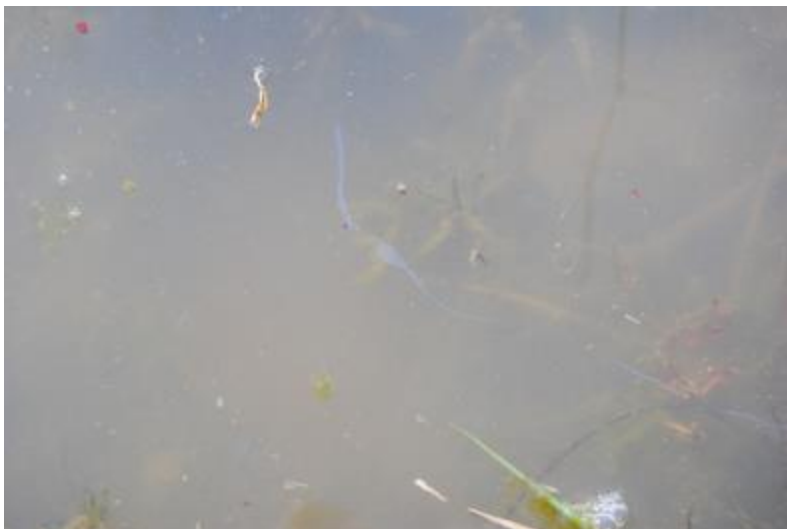
Probing Observation:

0-6 inches : Streamers (< 2 inches) of non-brittle silver gray sheen
6-12 inches : Streamers (< 2 inches) of non-brittle silver gray sheen

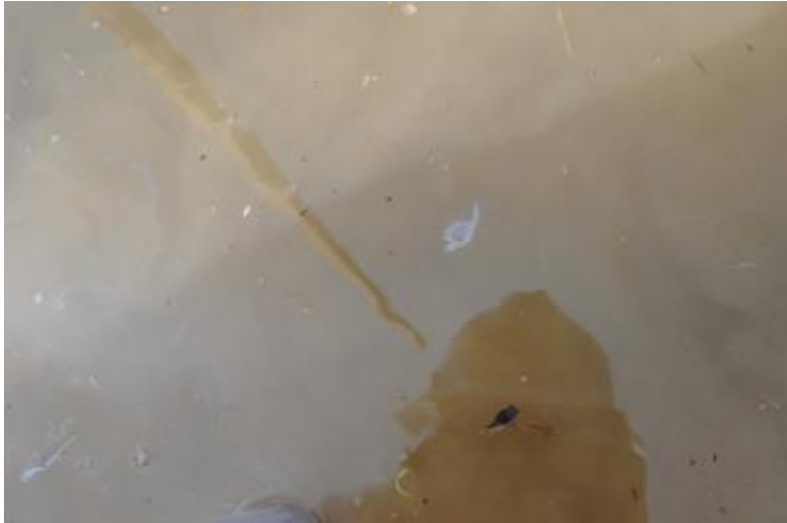
Overall Qualitative Sheening Amount:

0-6 inches : Lighter
6-12 inches : No Sheen
12-17 inches : No Sheen

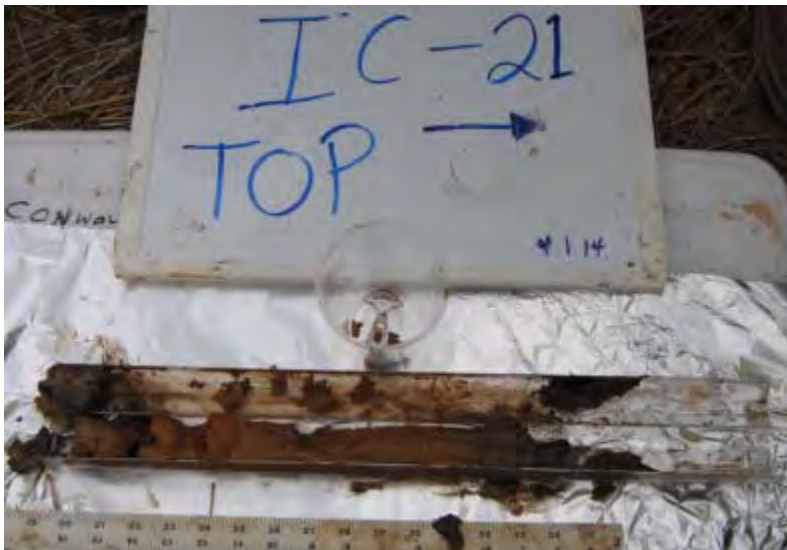
Probing Observation:

0-6 inches : Patches/streamers of non-brittle silver gray sheen (quickly dissipated)
6-12 inches : Patches/streamers of non-brittle silver gray sheen (quickly dissipated)

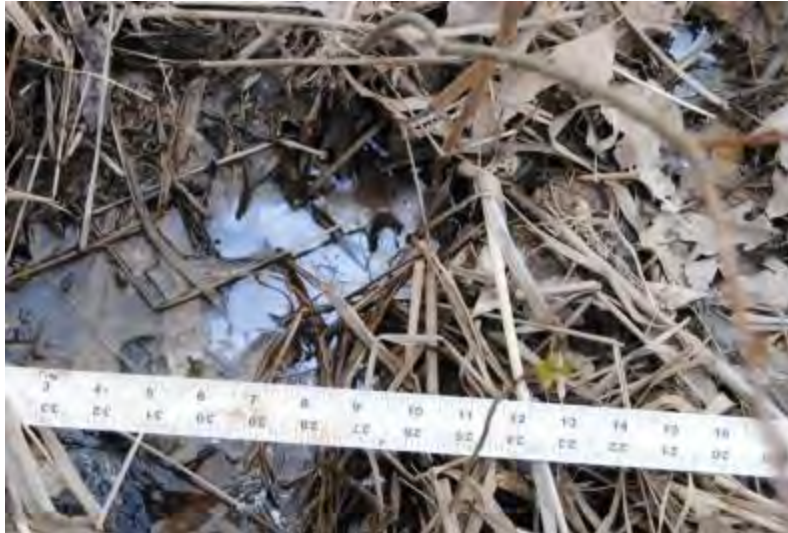
Initial Observation:

Cover of brittle rainbow sheen

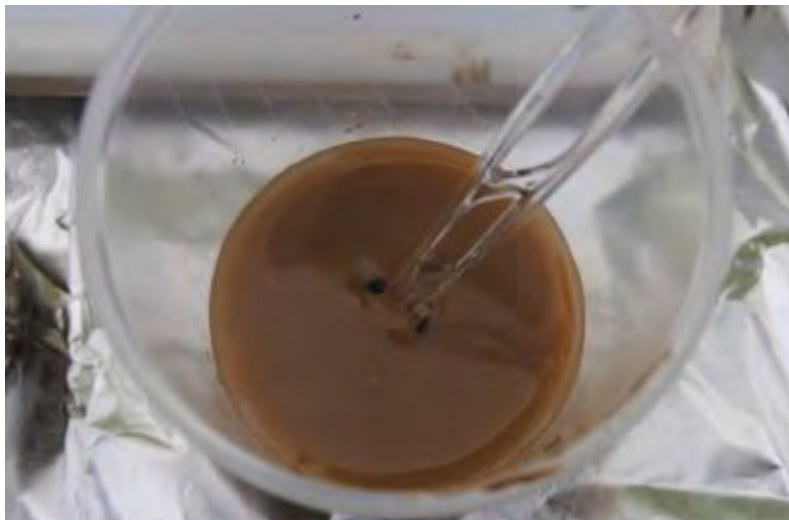
Sheen Stir-Test:

0-6 inches : Streamer of silver gray sheen (Lighter)

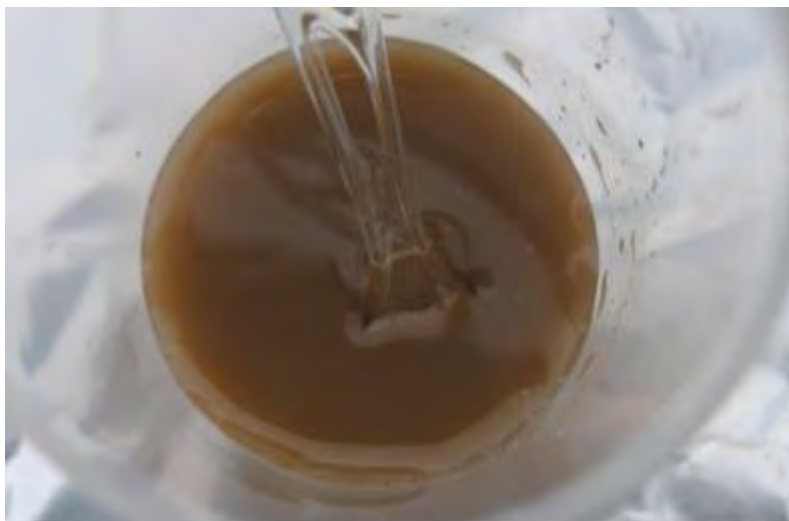
Sheen Stir-Test:

12-15 inches : Streamer of silver gray sheen (Lighter)

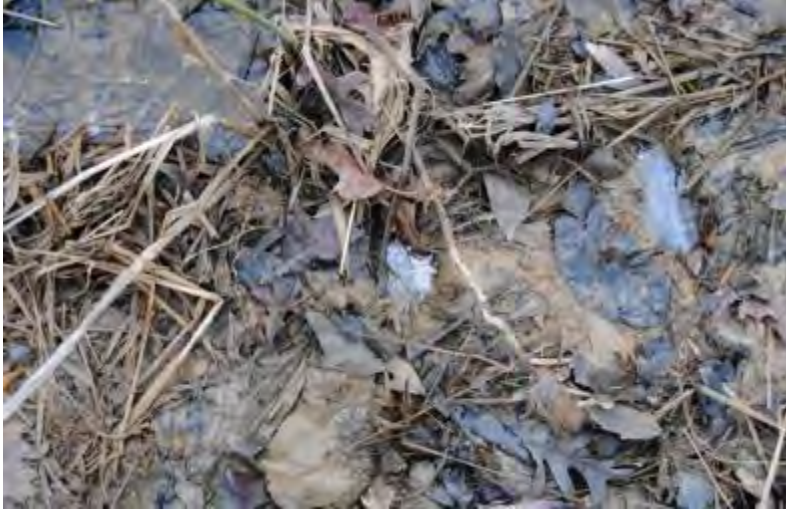
Initial Observation:

Cover of non-brittle rainbow sheen

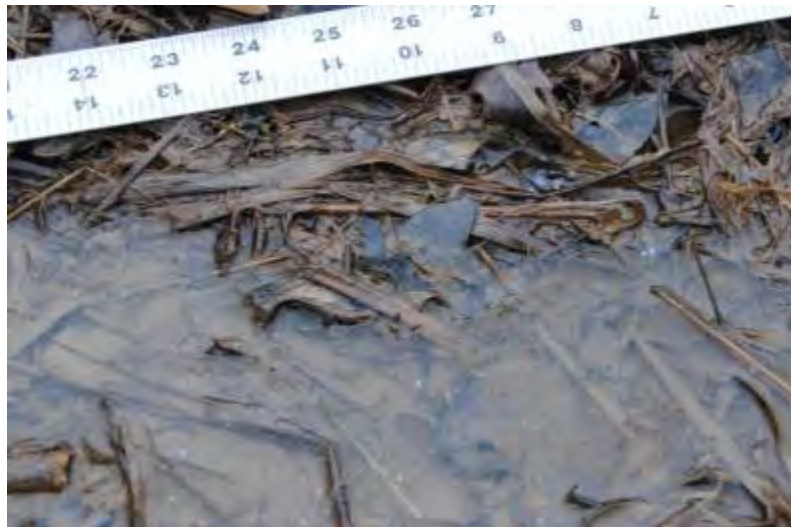
Initial Observation:

Patches of brittle silver gray sheen

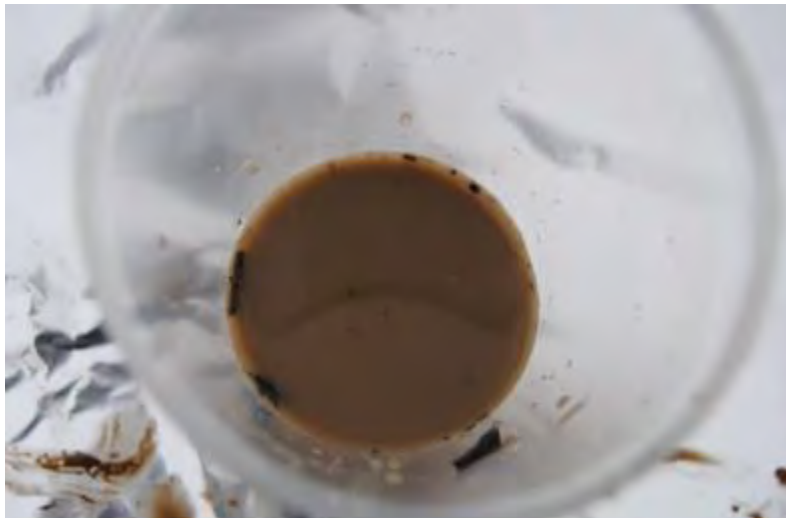
Sheen Stir-Test:

6-12 inches : Patch of silver gray sheen (Lighter)

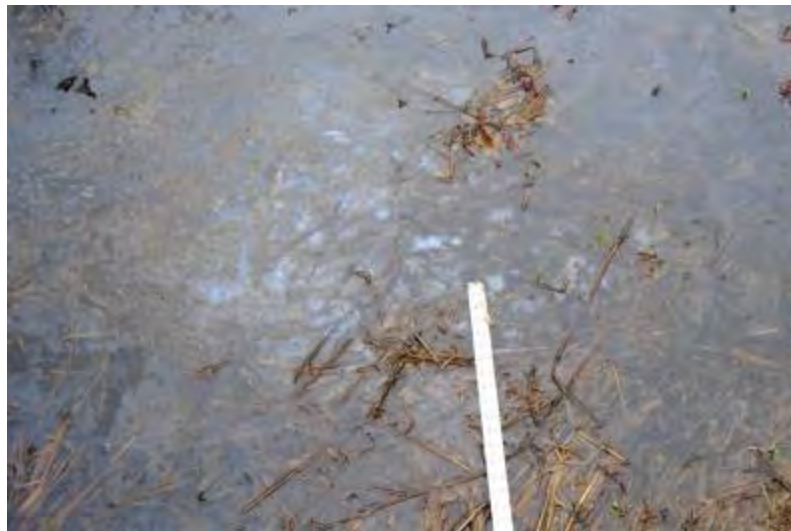
Initial Observation:

Cover of brittle and non-brittle silver gray sheen

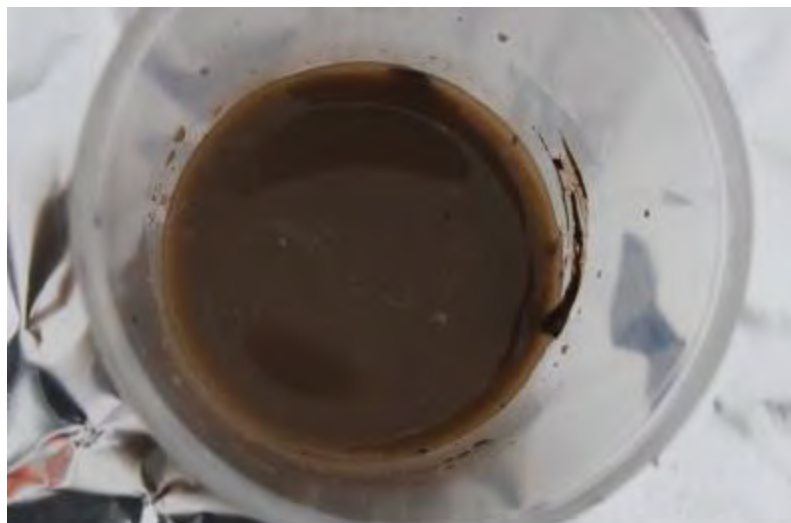
Sheen Stir-Test:

6-12 inches : Patches/streamers of silver gray sheen (Lighter)

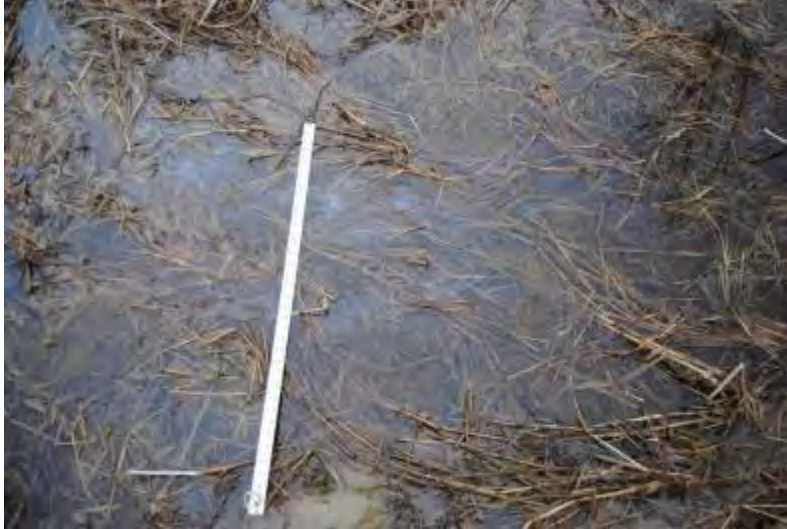
Initial Observation:

Cover of brittle silver gray sheen

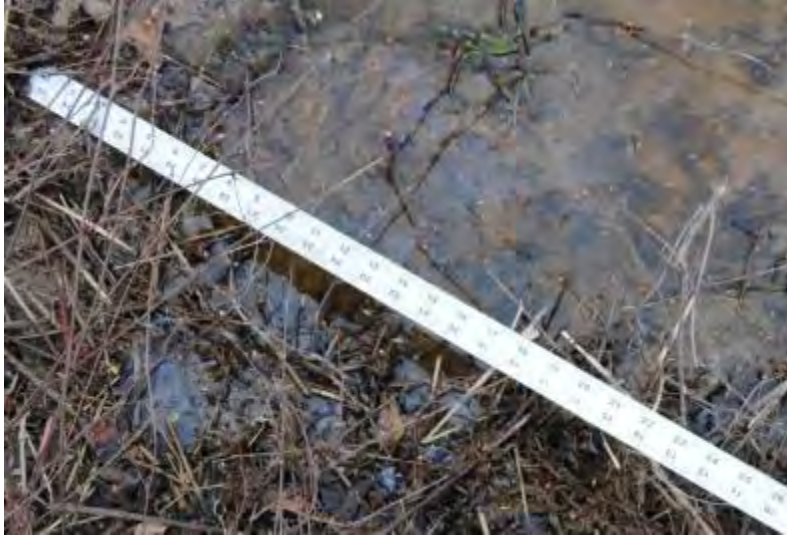
Initial Observation:

Cover of brittle silver gray sheen

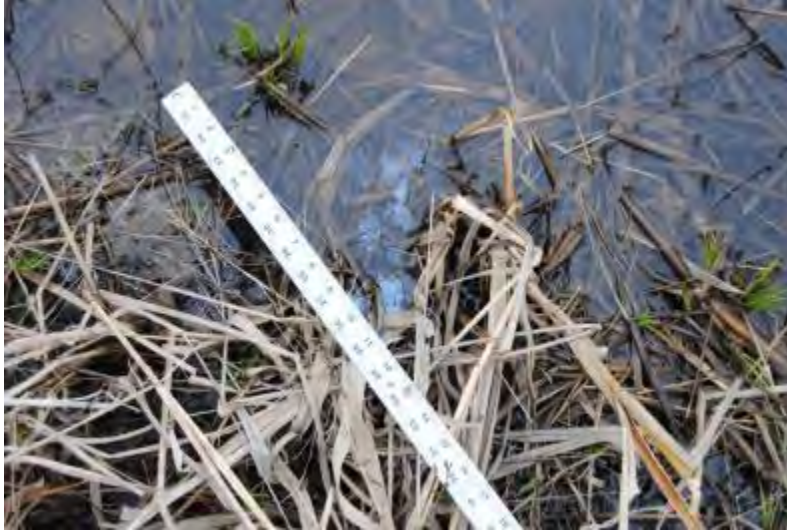
Initial Observation:

Cover of brittle silver gray sheen

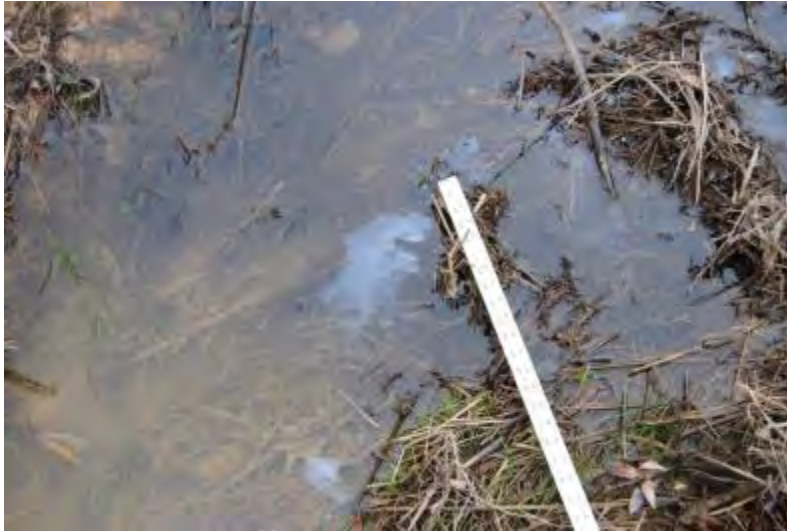
Initial Observation:

Patches of brittle silver gray sheen

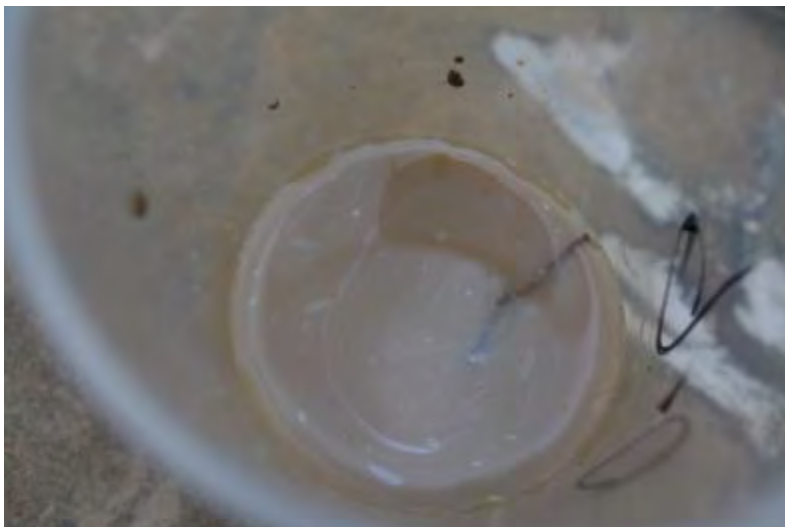
Sheen Stir-Test:

0-6 inches : Patches/streamers of silver gray sheen (Lighter)

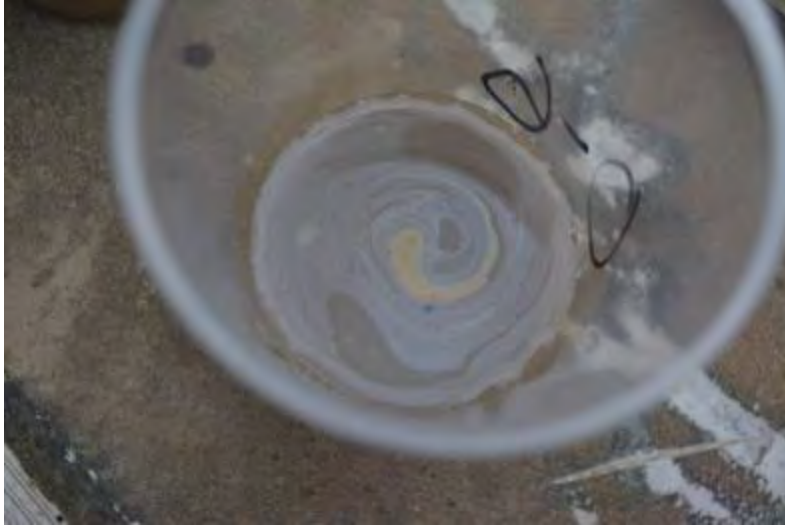
Sheen Stir-Test:

0-6 inches : Patches/streamers of rainbow sheen with 10 oil spots (0.1- to 0.25-inch wide) (Medium)

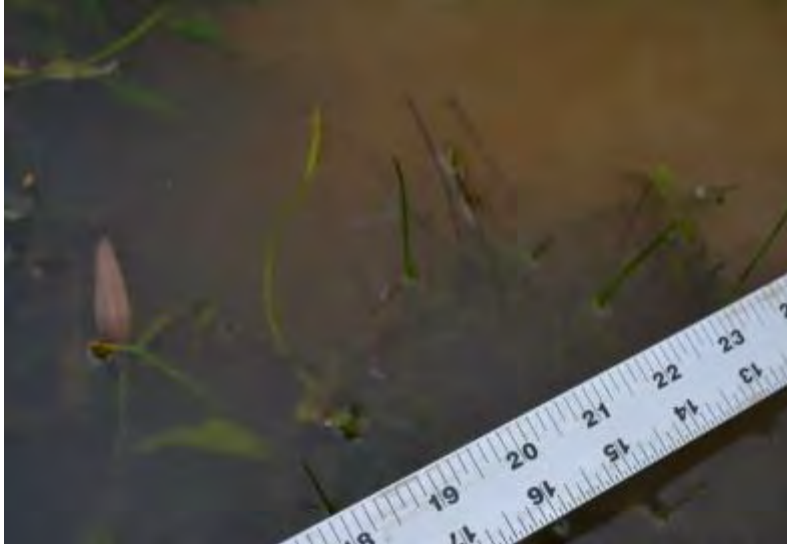
Probing Observation:

6-12 inches : Streamers of non-brittle silver gray sheen

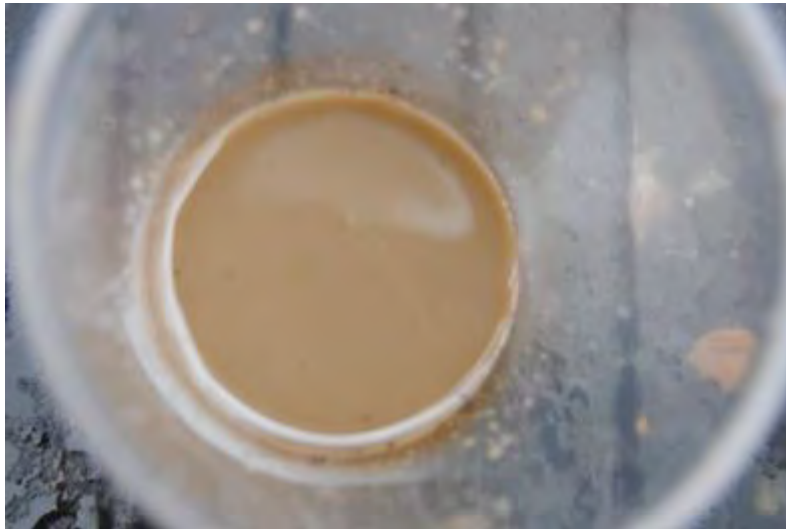
Core Description:

0-3 inches : Gray silty clay (CL), soft
3-10 inches : Gray and reddish brown clayey silt (MH)
10-12 inches : Gray silty clay (CL)

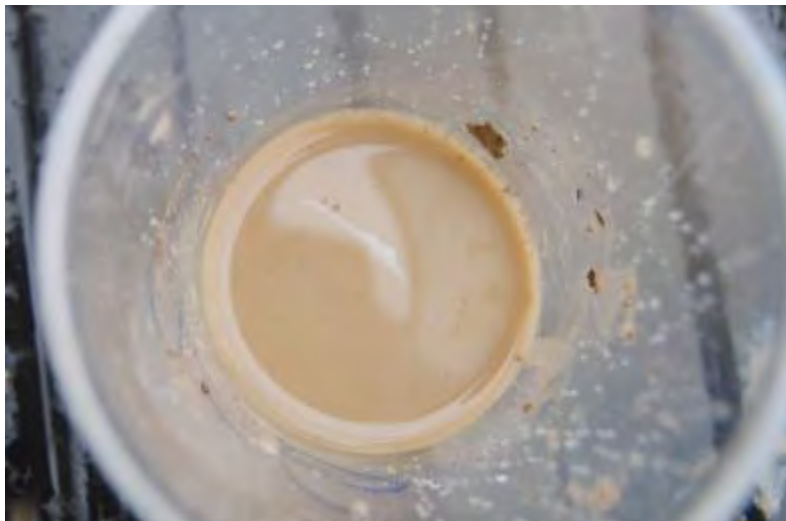
Sheen Stir-Test:

0-6 inches : Streamer of rainbow sheen (Heavier)

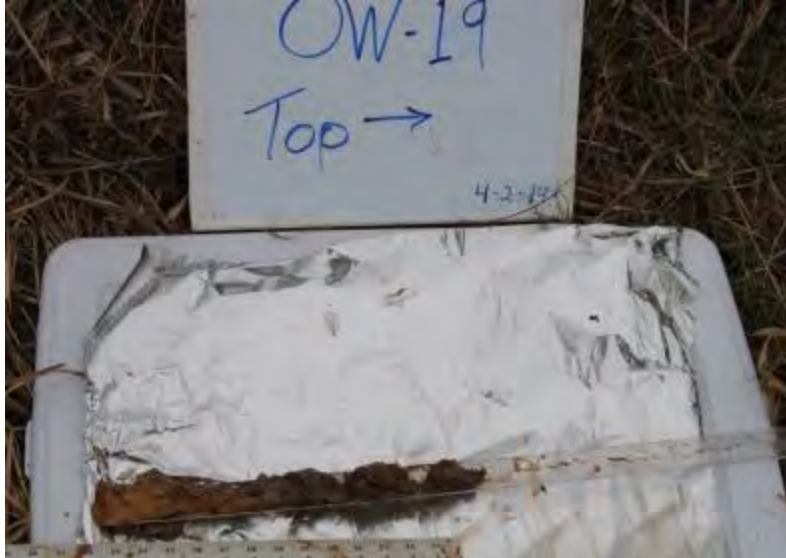
Core Description:

0-12 inches : Gray and reddish brown silt with clay (MH), roots and plant material at 0-2"

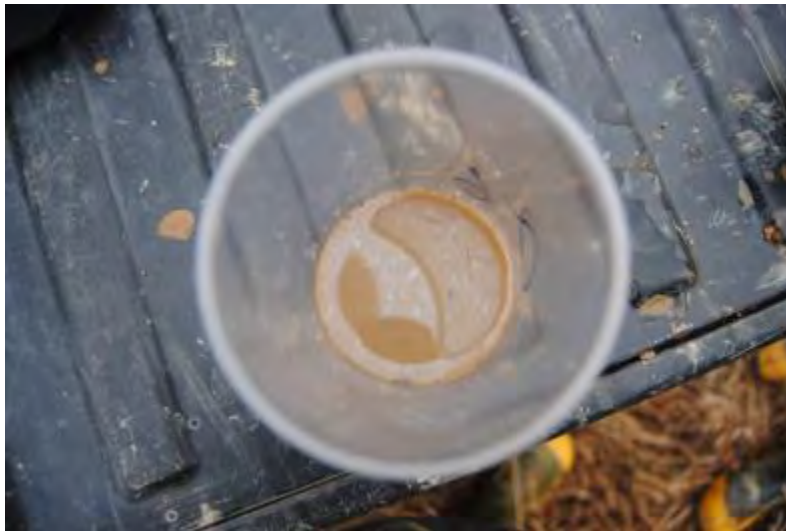
Sheen Stir-Test:

0-6 inches : Patches of silver gray sheen (Medium)

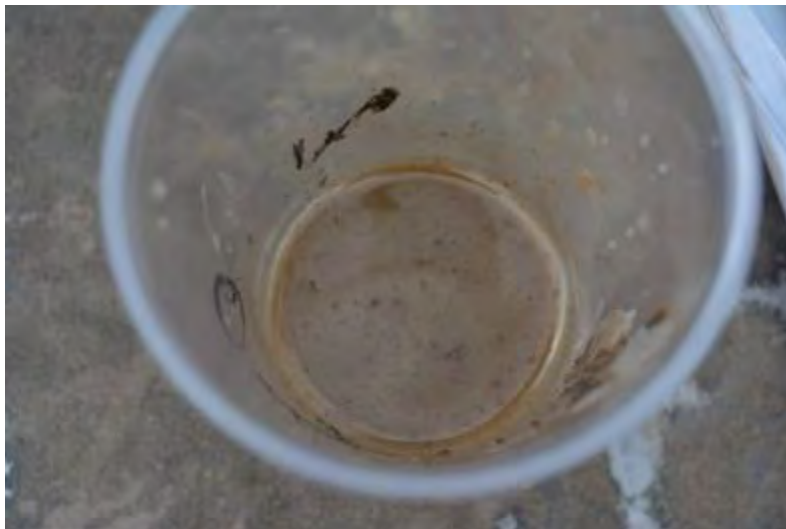
Sheen Stir-Test:

0-6 inches : Patches/streamers of rainbow sheen with oil spots (Heavier)

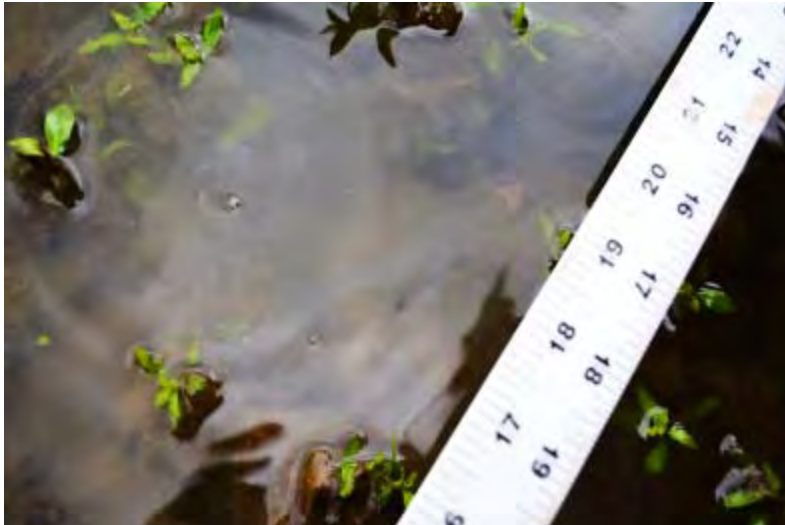
Probing Observation:

Surface : Streamers of non-brittle silver gray sheen
0-6 inches : Streamers of non-brittle silver gray sheen

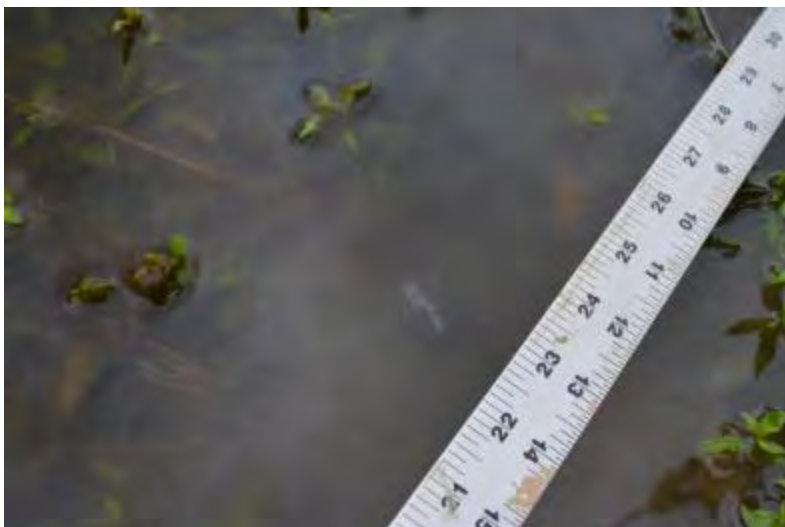
Probing Observation:

6-12 inches : Patches/streamers of non-brittle silver gray sheen with four oil spots (0.1 to 0.25-inch wide)

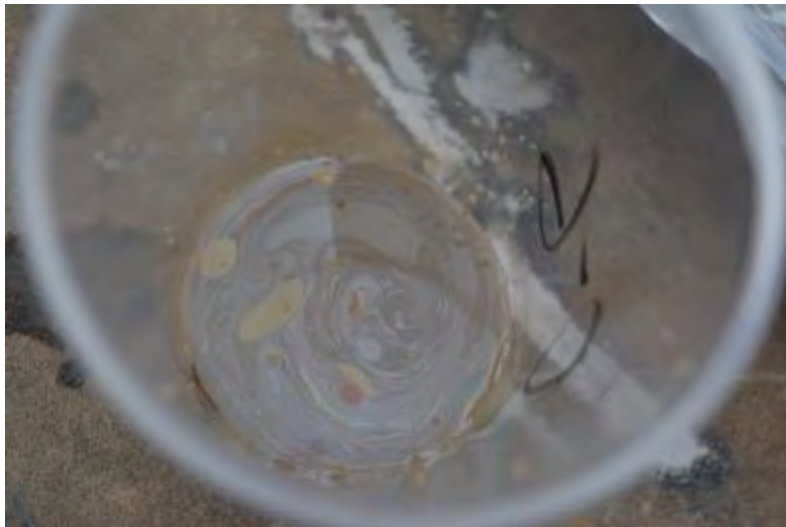
Sheen Stir-Test:

0-6 inches : Patches/streamers of rainbow sheen (Medium)

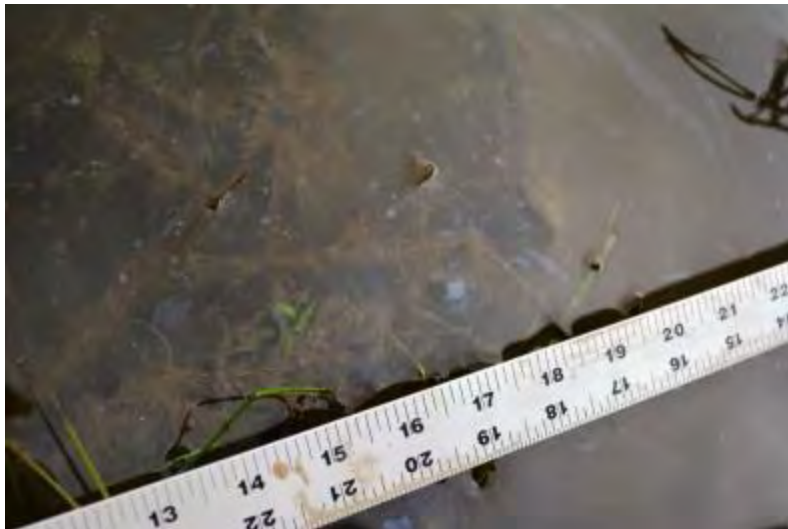
Probing Observation:

Surface : Patches/streamers of non-brittle silver gray sheen with three oil spots (0.1-inch wide)
0-6 inches : Patches/streamers of non-brittle silver gray sheen with 0.1-inch wide oil spots

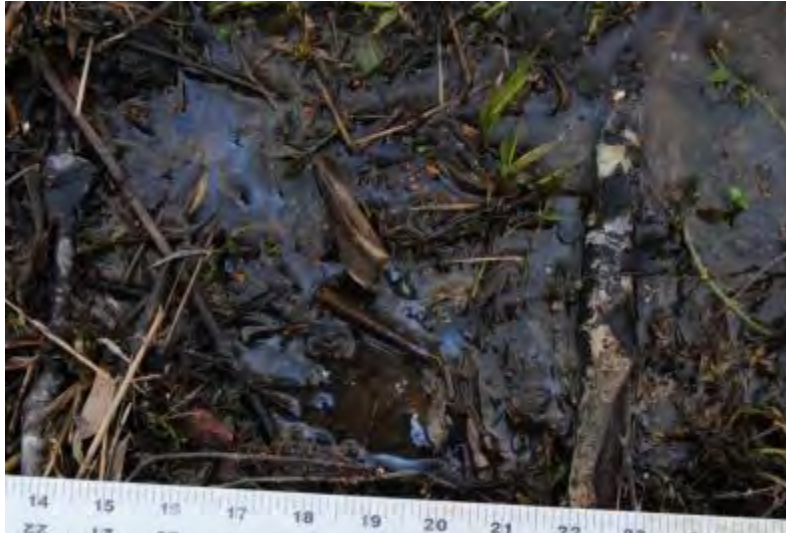
Initial Observation:

Streamers of brittle and non-brittle silver gray sheen

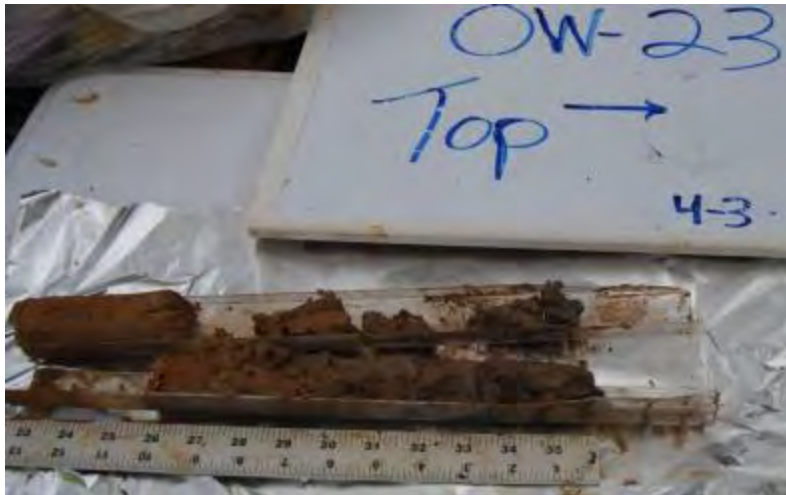
Core Description:

0-6 inches : Gray and reddish brown silt with clay (MH)
6-12 inches : Light brown and reddish brown mottled silt with clay (MH), soft

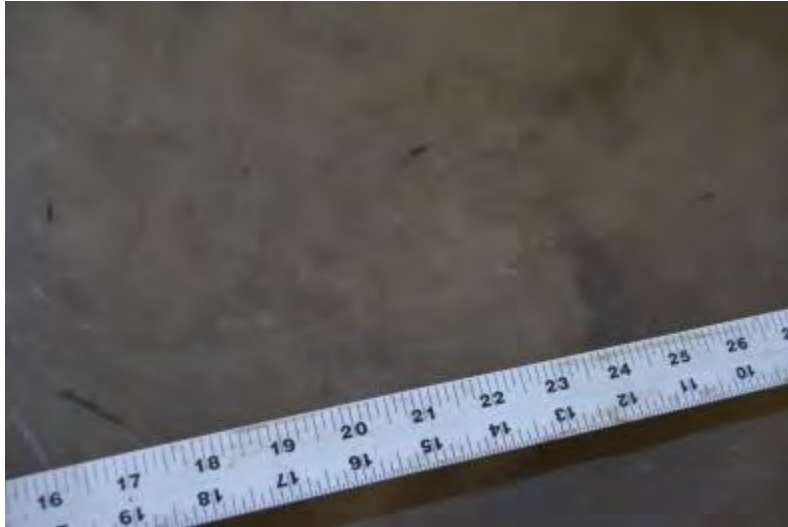
Probing Description:

Surface : Patches/streamers of non-brittle silver gray sheen with 10 oil spots (0.1-inch wide)
0-6 inches : Patches/streamers of non-brittle silver gray sheen
6-12 inches : Patches/streamers of non-brittle silver gray sheen

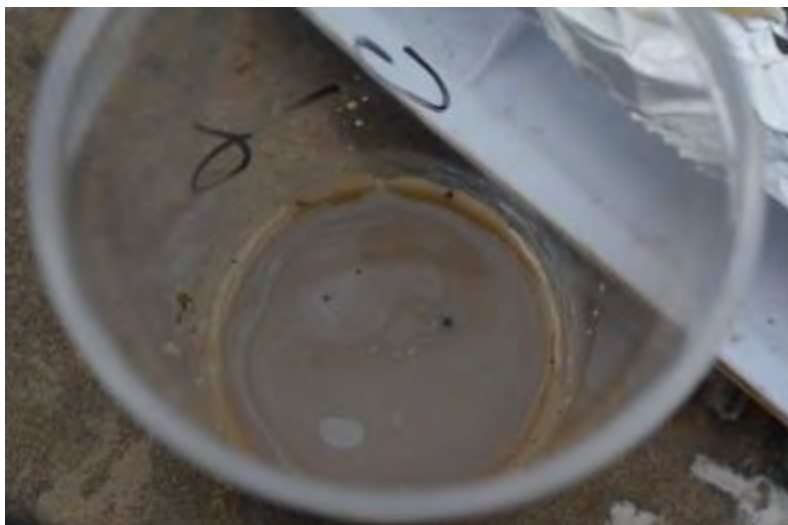
Sheen Stir-Test:

0-6 inches : Patches/streamers of silver gray sheen with 0.25-inch wide oil spot (Heavier)
