Pre-Design Study Results

**Pre-Design Study – Revision 1
Mayflower Pipeline Incident Response, Mayflower, Arkansas**

Downstream Areas Pre-Design Study Photolog

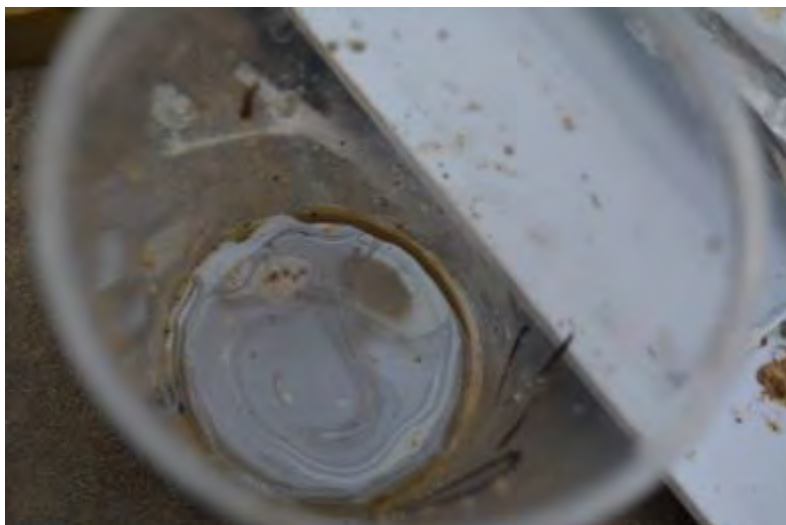
Sheen Stir-Test:

0-6 inches : Patches/streamers of silver gray sheen with three oil spots (Heavier)

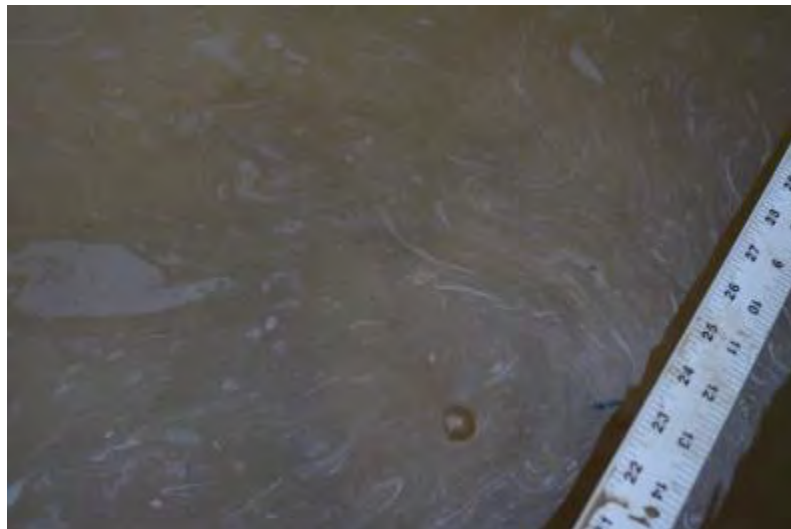
Probing Description:

Surface : Patches/streamers of silver gray sheen
0-6 inches : Patches/streamers of silver gray sheen
6-12 inches : Patches/streamers of silver gray sheen

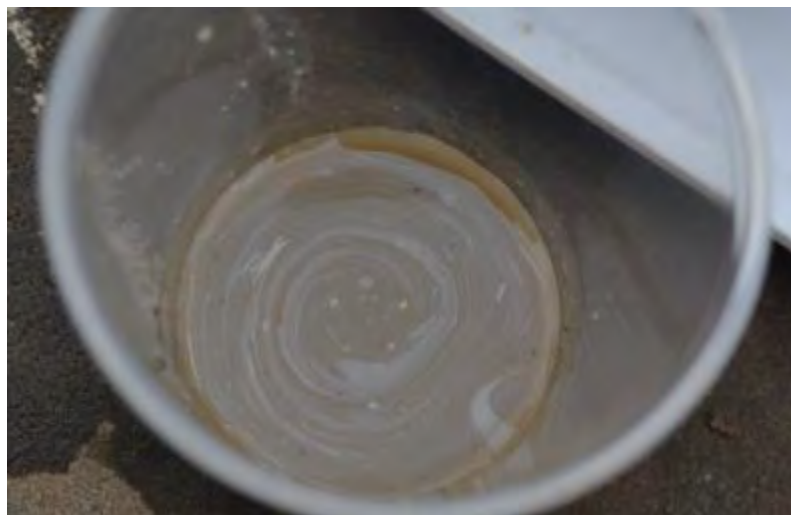
Sheen Stir-Test:

0-6 inches : Patches/streamers of silver gray sheen (Medium)

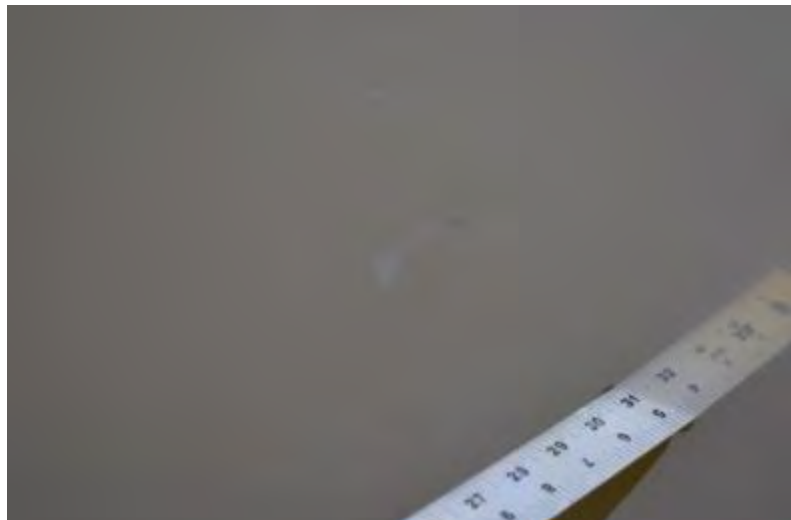
Initial Observation:

Patch/streamer of non-brittle silver gray sheen

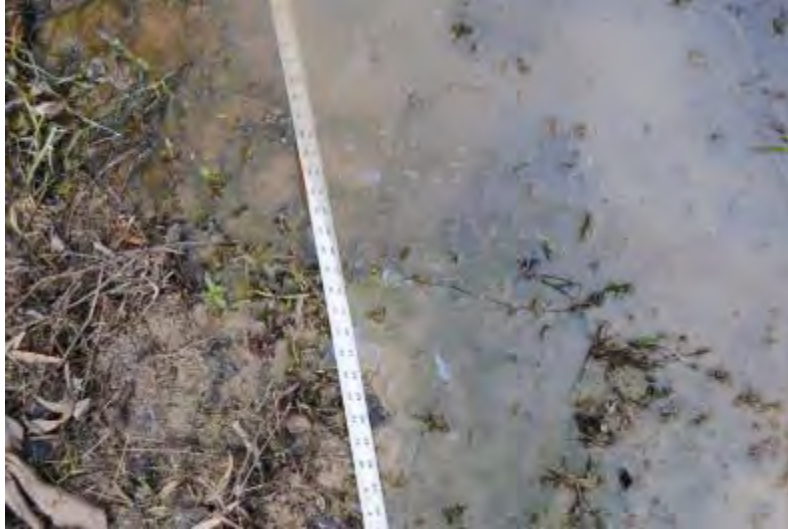
Initial Observation:

Cover/patches of brittle silver gray sheen

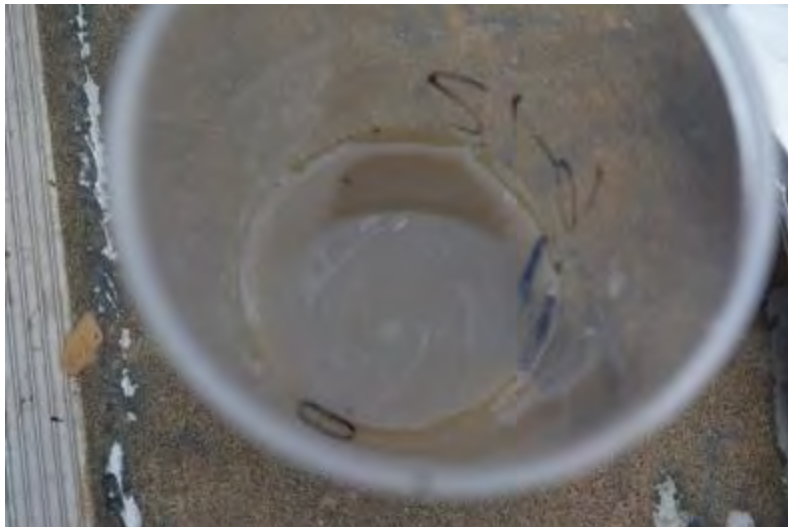
Sheen Stir-Test:

6-12 inches : Patches/streamers of silver gray sheen (Medium)

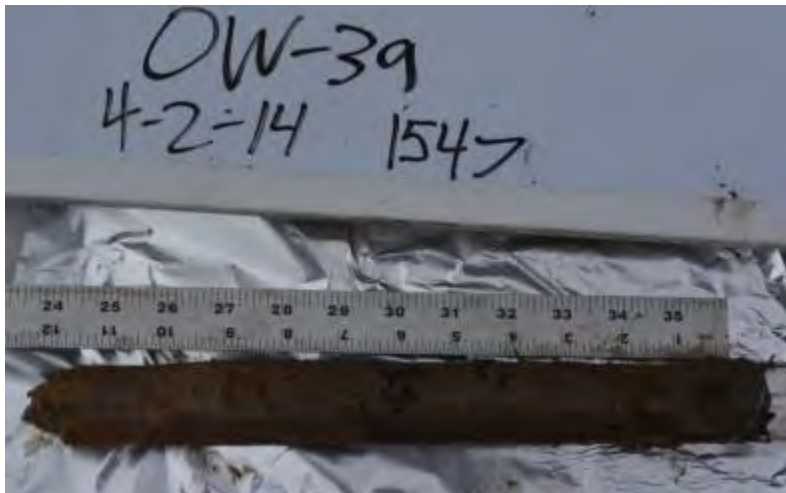
Core Description:

0-6 inches : Brown silty clay, algae 0-2.4"
6-12 inches : Reddish brown clay, soft

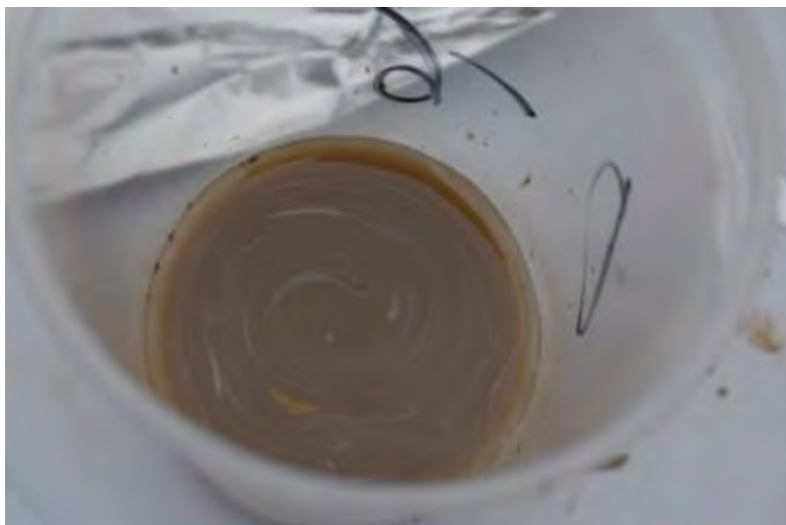
Sheen Stir-Test:

0-6 inches : Streamers of silver gray sheen (Lighter)

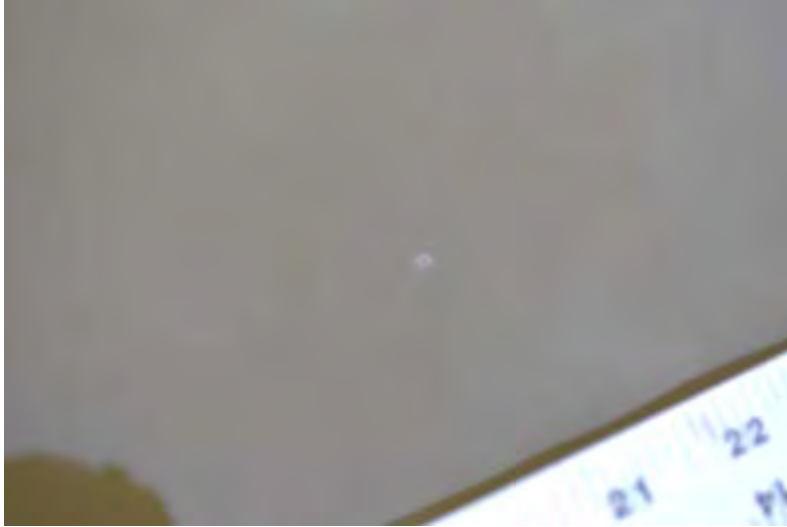
Probing Description:

0-6 inches : Patches/streamers of silver gray sheen with one oil spot (0.25-inch wide)

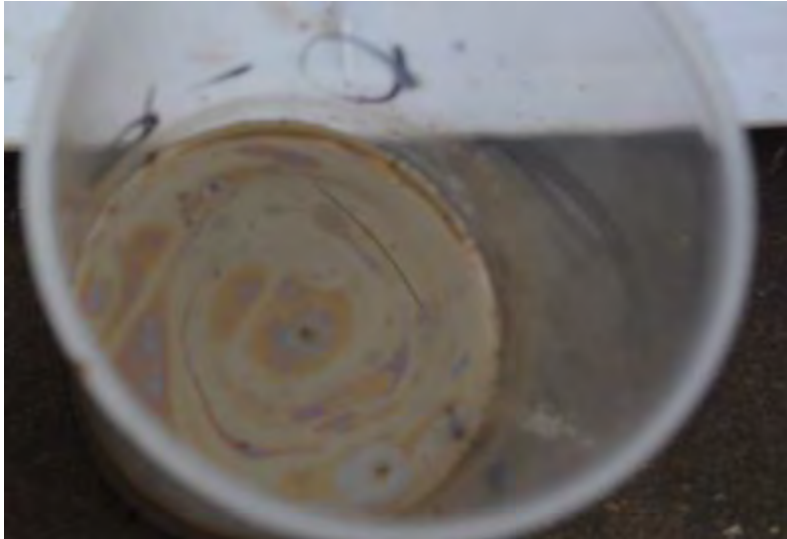
Sheen Stir-Test:

0-6 inches : Patches/streamers of rainbow sheen with 20 oil spots (Heavier)

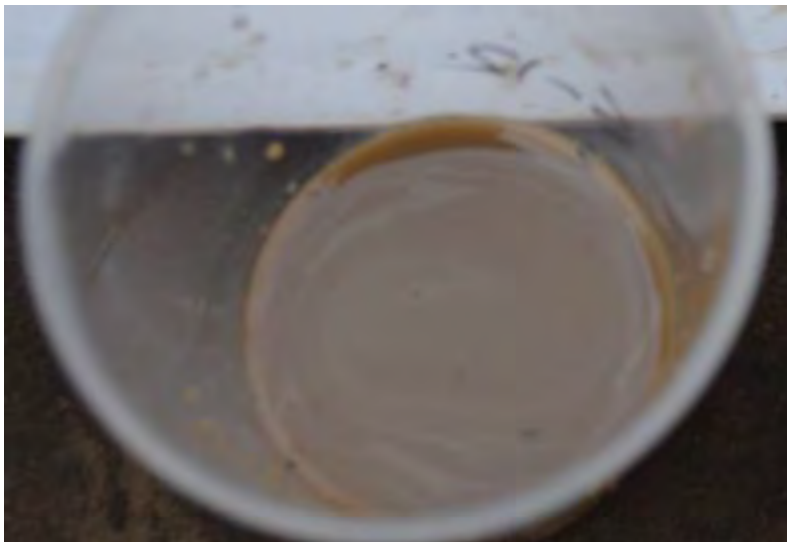
Sheen Stir-Test:

6-12 inches : Streamers of silver gray sheen with oil spot (Medium)

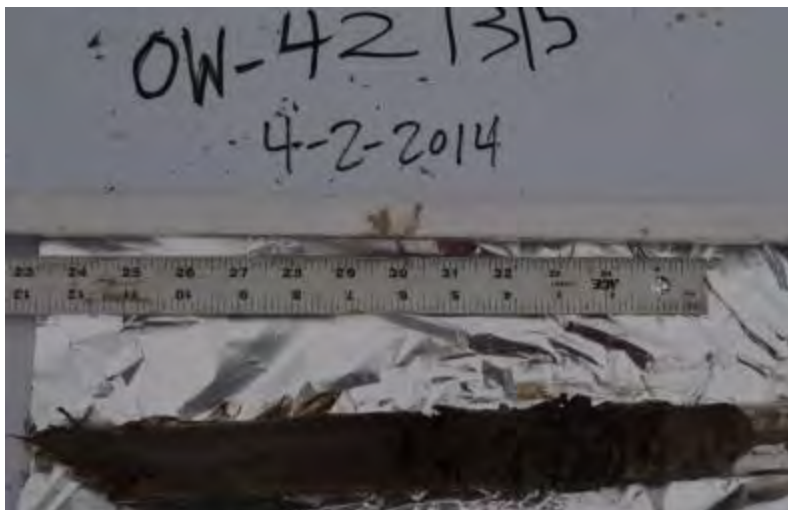
Core Description:

0-6 inches : Brown silt, humic material at 3", light sheen at 0-6"
6-12 inches : Brown clay

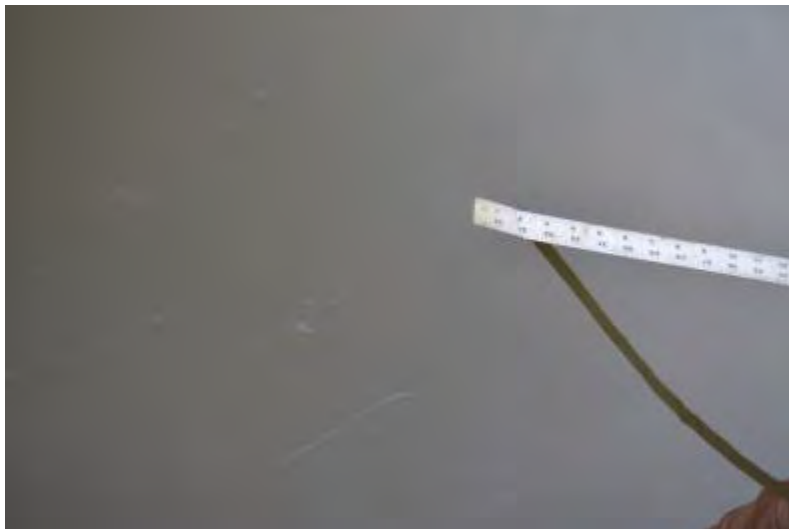
Initial Observation:

Patches/streamers of non-brittle silver gray sheen

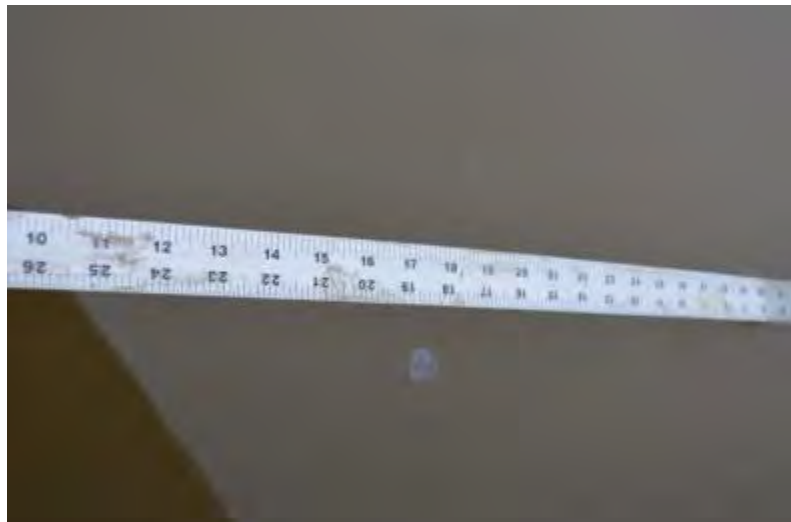
Initial Observation:

Patches (four to five) of non-brittle silver gray sheen

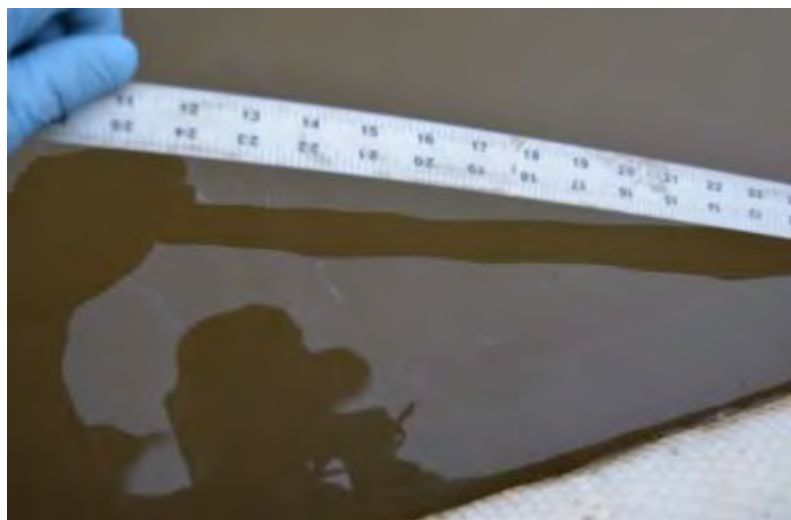
Probing Observation:

Surface : Streamers of non-brittle silver gray sheen
0-6 inches : Streamers of non-brittle silver gray sheen
6-12 inches : Streamers of non-brittle silver gray sheen

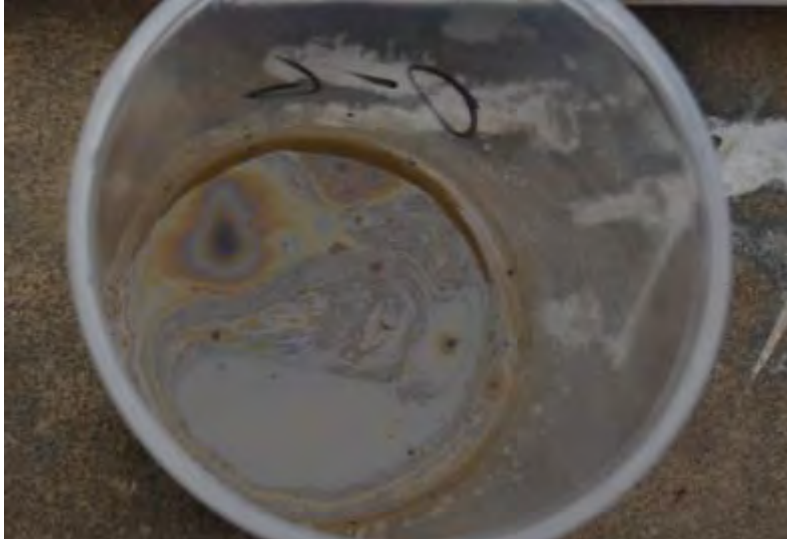
Sheen Stir-Test:

0-6 inches : Patches/streamers of rainbow sheen with oil spots (Heavier)

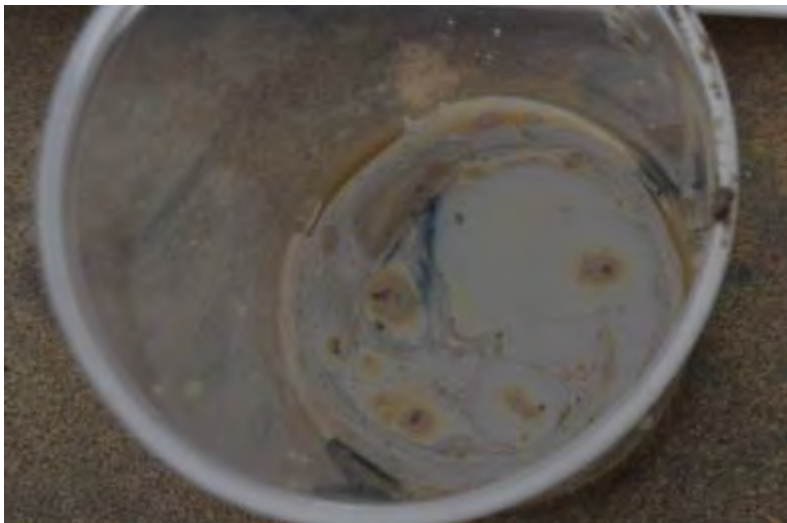
Sheen Stir-Test:

6-12 inches : Patches/streamers of rainbow sheen with oil spots (Heavier)

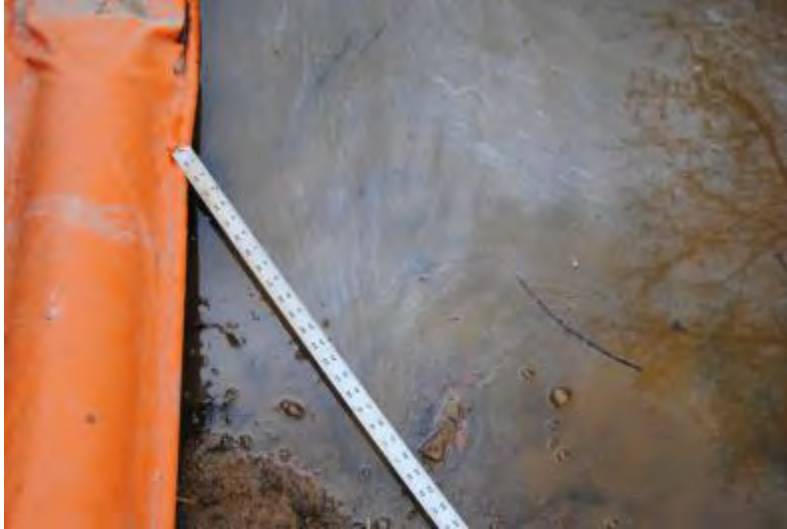
Initial Observation:

Streamers of non-brittle rainbow sheen

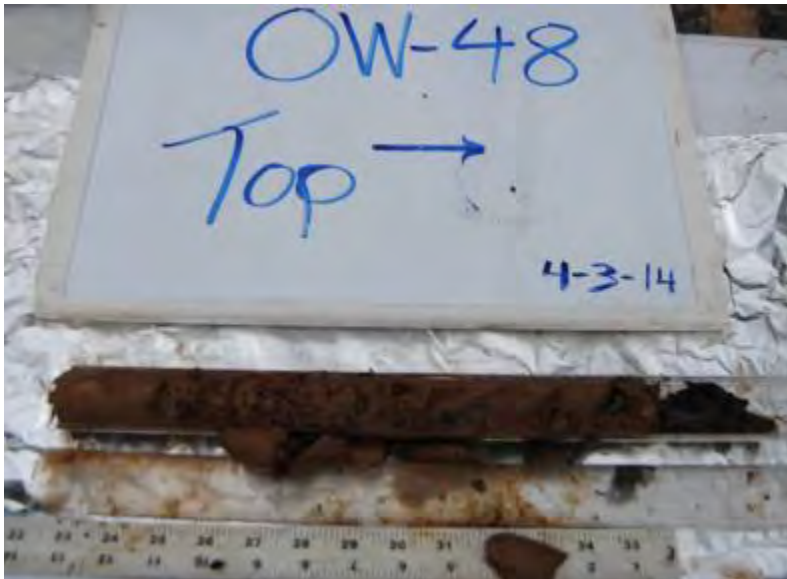
Initial Observation:

Patches/streamers of non-brittle silver gray sheen with oil spot (<0.25-inch wide)

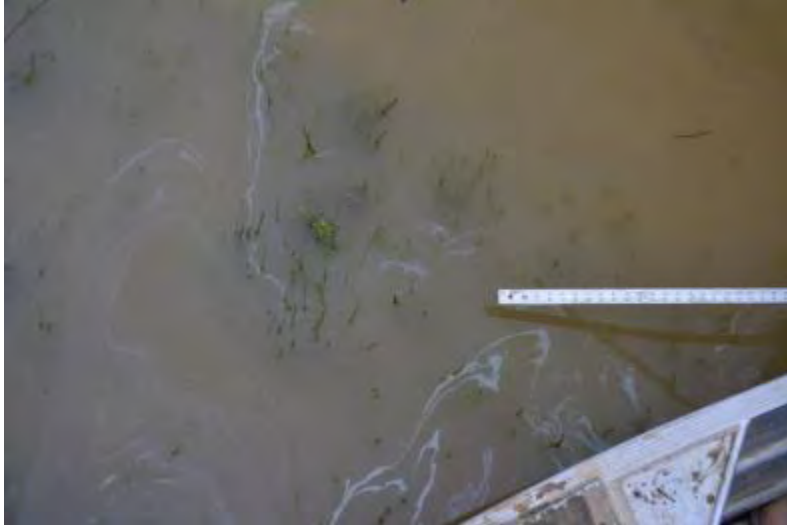
Initial Observation:

Streamers of non-brittle rainbow sheen with eight oil spots (<0.25-inch wide)

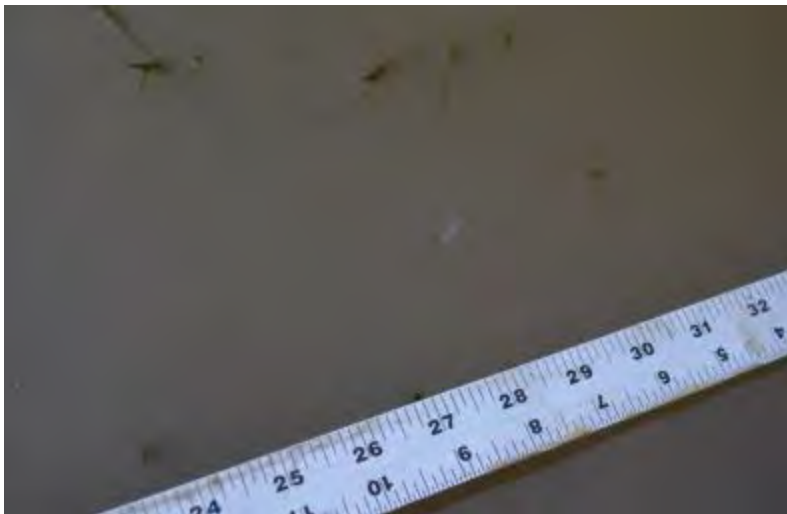
Probing Observation:

Surface : Patches of non-brittle silver gray sheen
0-6 inches : Patches of non-brittle silver gray sheen

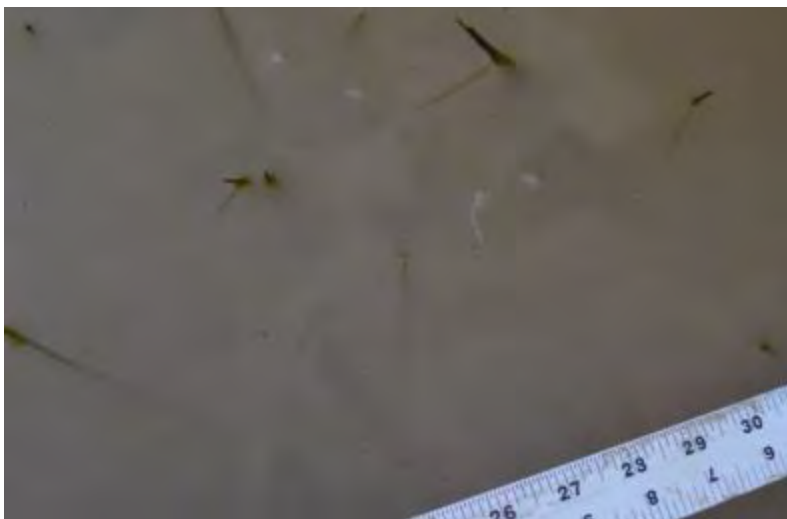
Probing Observation:

6-12 inches : Streamers of non-brittle silver gray sheen

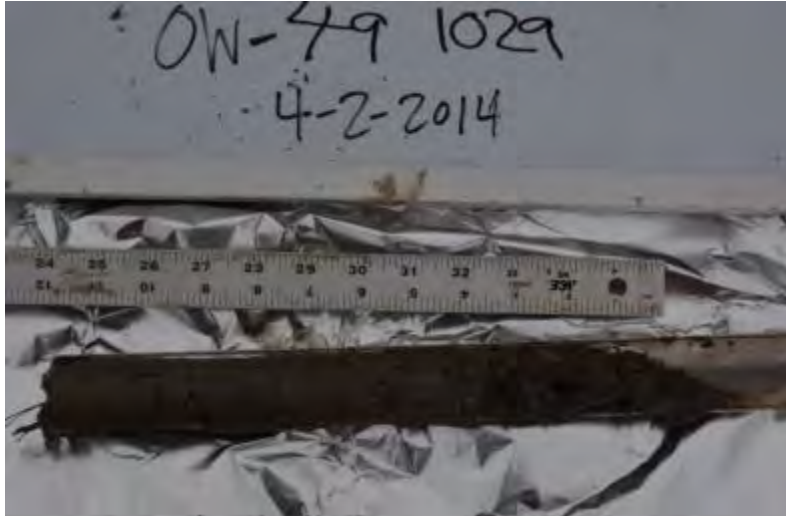
Core Description:

0-6 inches : Humic material, visible sheen at 0-5"
6-12 inches : Brown silty clay, roots

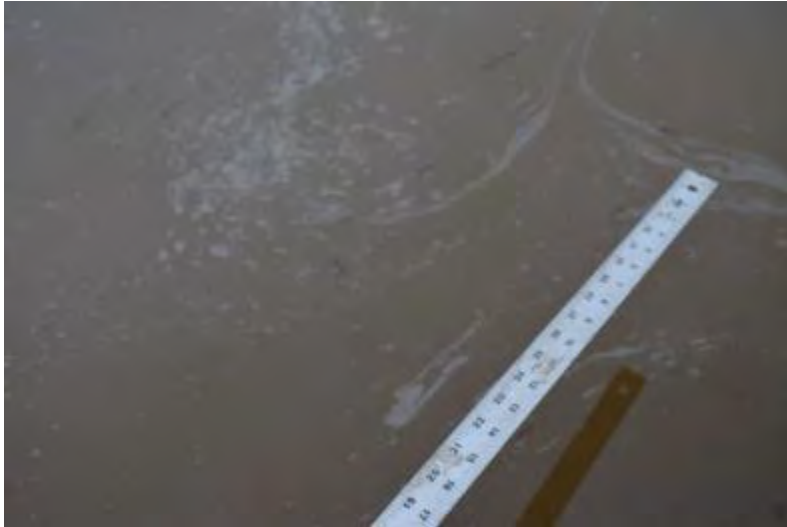
Initial Observation:

Patch/streamer of non-brittle rainbow sheen with about 100 oil spots

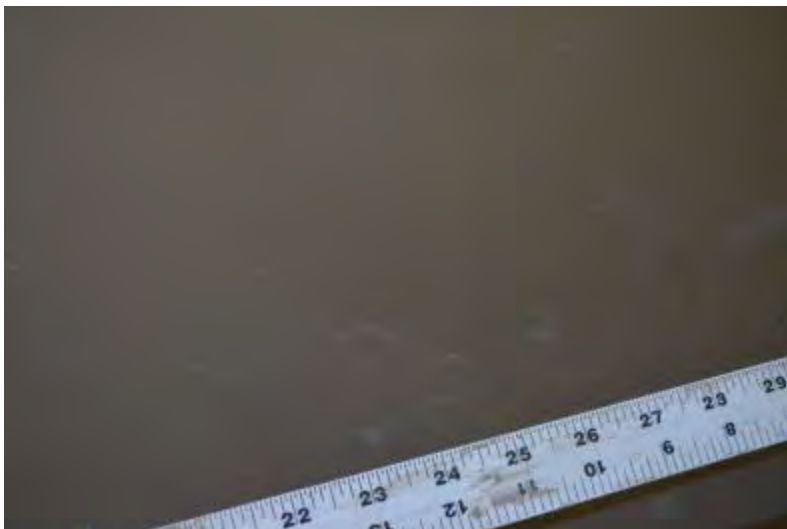
Probing Observation:

Surface : Patches/streamers of non-brittle silver gray sheen with two oil spots (<0.25-inch wide)
0-6 inches : Patches/streamers of non-brittle silver gray sheen with four oil spots (<0.25-inch wide)
6-12 inches : Patches/streamers of non-brittle silver gray sheen with five oil spots (0.1-inch wide)

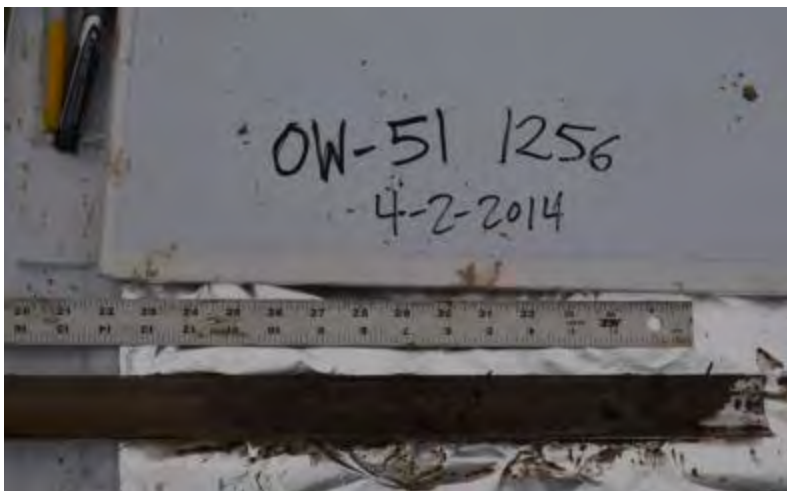
Core Description:

0-6 inches : Brown silt, twigs, odor of benzene, medium sheen at 0-4"
6-12 inches : Brown clayey silt

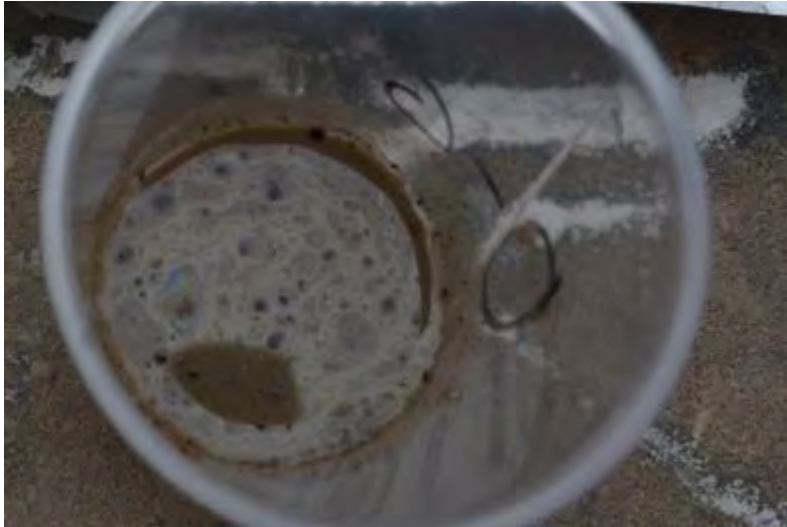
Sheen Stir-Test:

0-6 inches : Patches/streamers of rainbow sheen with oil spots (Heavier)

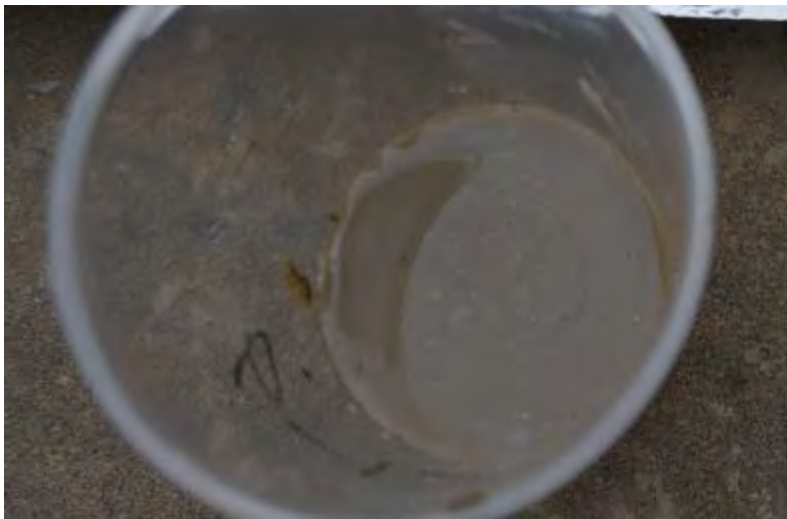
Sheen Stir-Test:

6-12 inches : Streamers of silver gray sheen (Lighter)

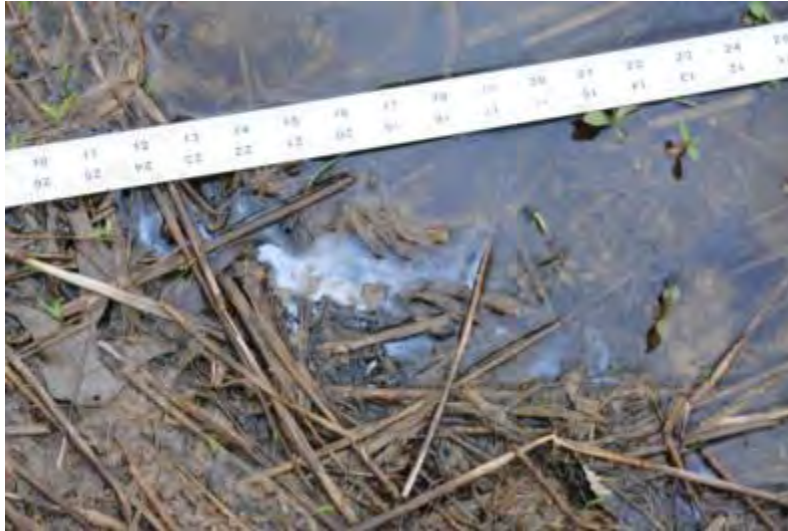
Initial Observation:

Cover of brittle rainbow sheen

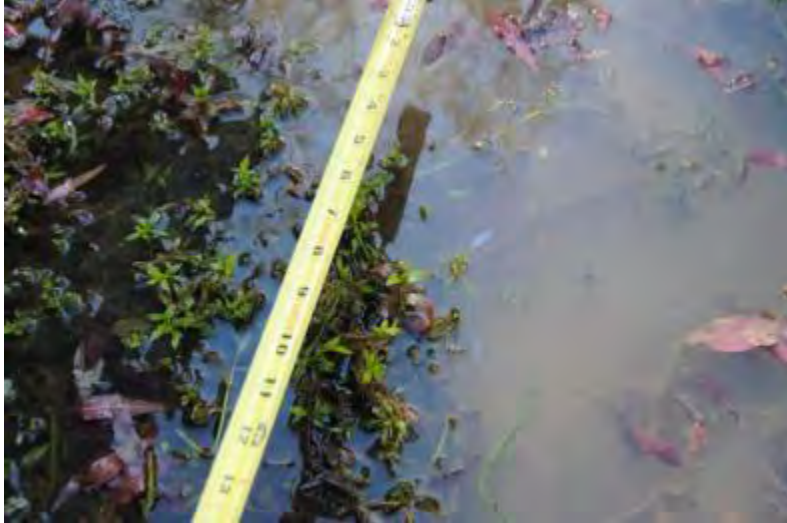
Probing Description:

0-6 inches : Streamers of non-brittle silver gray sheen
6-12 inches : Streamers of non-brittle silver gray sheen

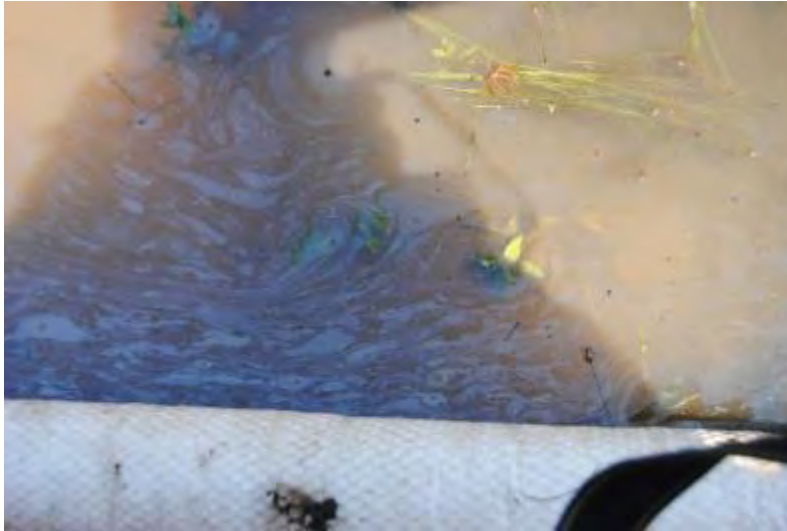
0-6 inches : Heavier
6-12 inches : Lighter

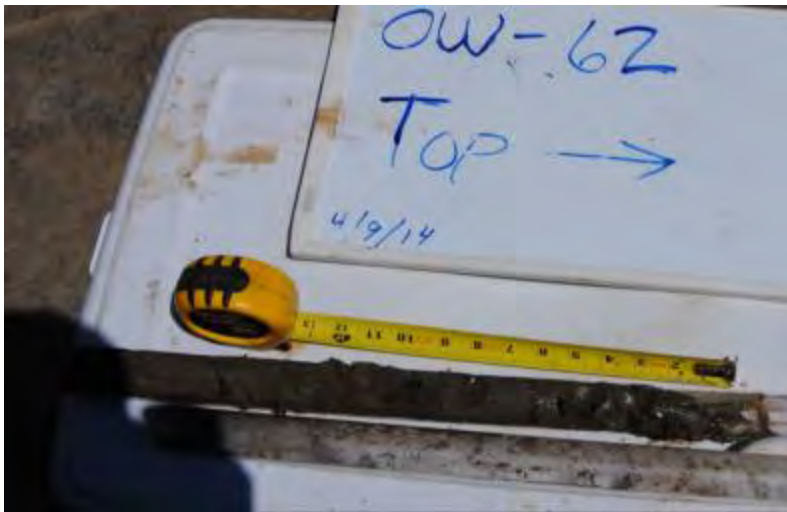
Surface : Streamers of non-brittle silver gray sheen with oil spots (<0.5-inch wide)
0-6 inches : Streamers of non-brittle silver gray sheen with oil spots (<0.5-inch wide)
6-12 inches : Streamers of non-brittle silver gray sheen with oil spots (<0.5-inch wide)

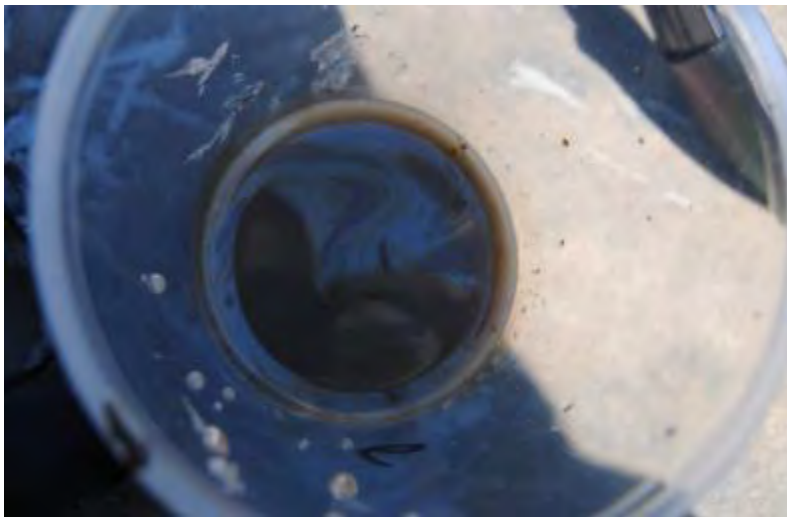
0-6 inches : Streamers of rainbow sheen (Heavier)

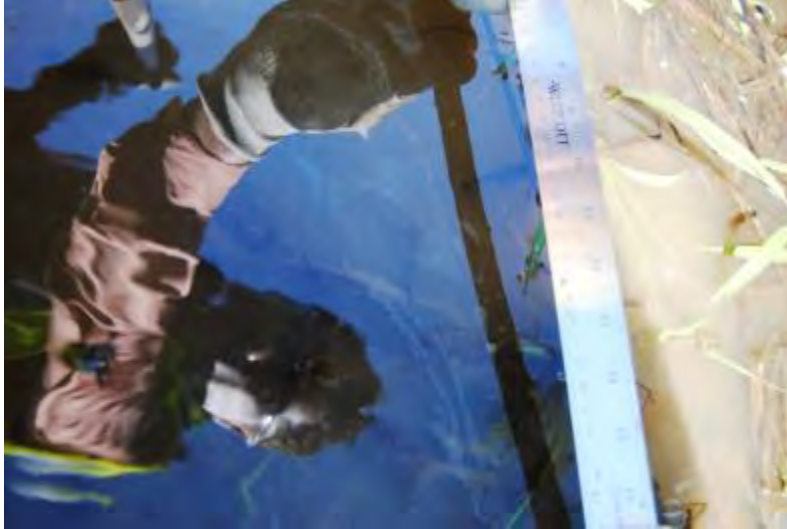
0-6 inches : No Sheen
6-12 inches : Lighter

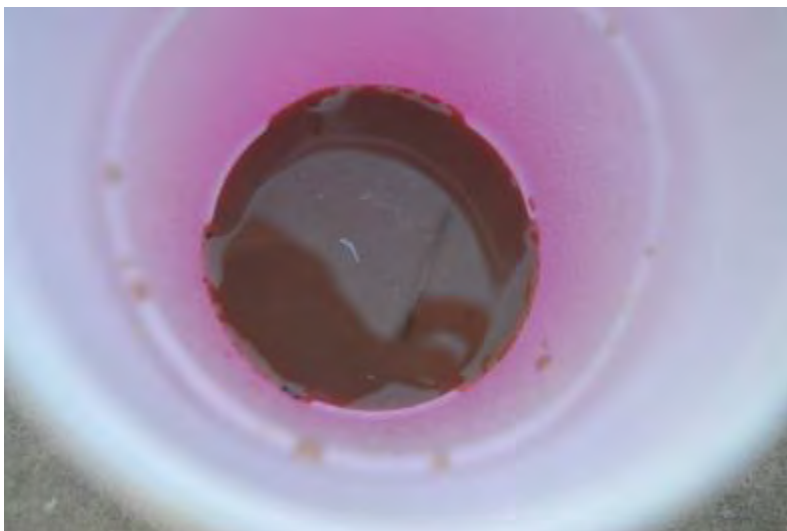
6-12 inches : Streamers of silver gray sheen (Lighter)

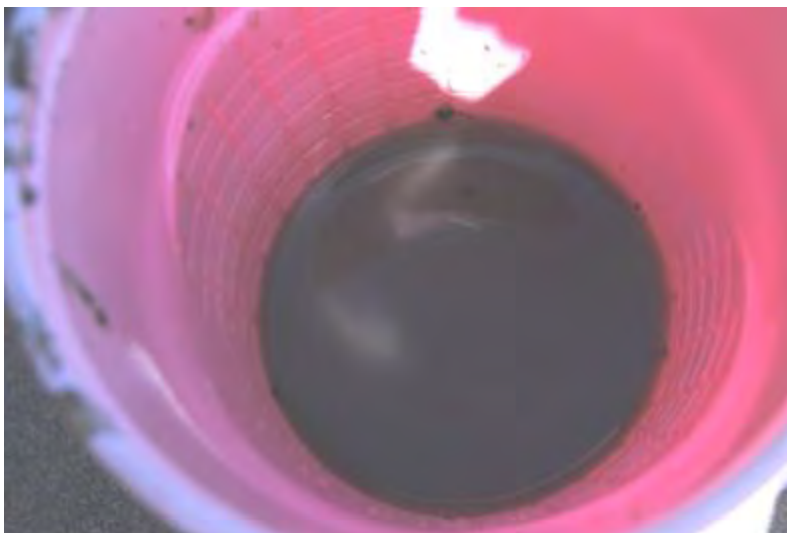
0-6 inches : Streamers of silver gray sheen (Lighter)

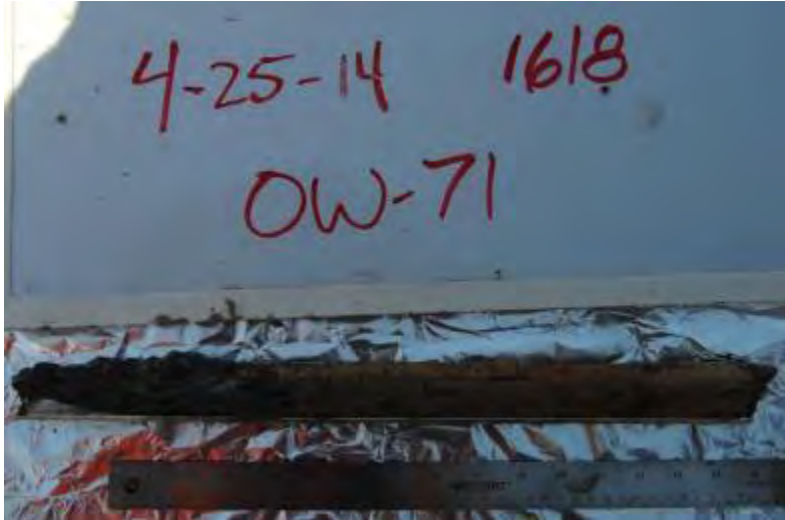
0-6 inches : Lighter
6-12 inches : No Sheen

0-6 inches : Brownish gray silt loam, some sheen at 0-4"
6-12 inches : Brown silt-clay loam, friable

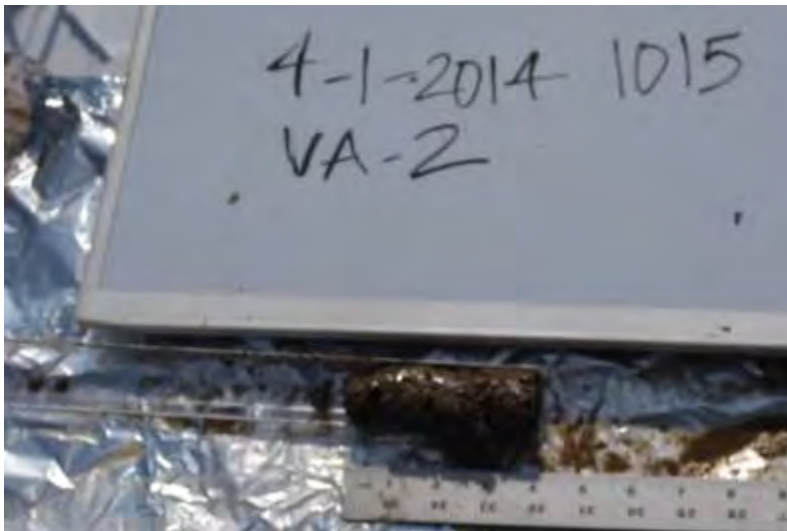
Patches of brittle silver gray sheen

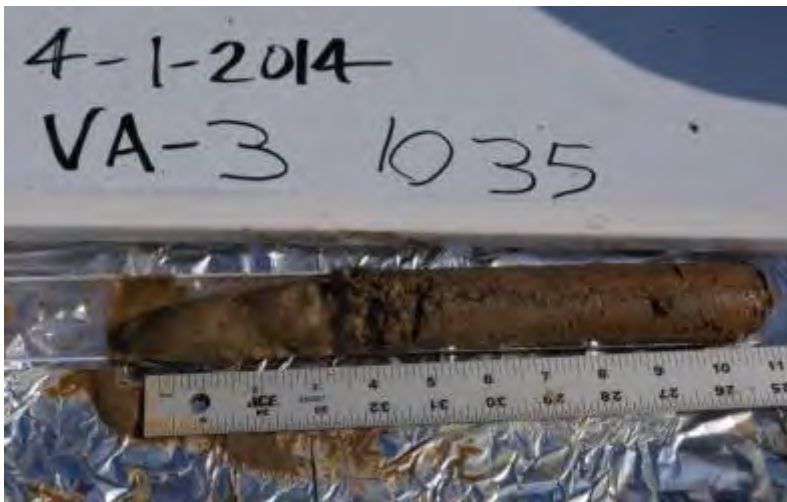
Surface : Patches/streamers of non-brittle silver gray sheen (light sheen)
0-6 inches : Patches/streamers of non-brittle silver gray sheen (light sheen)

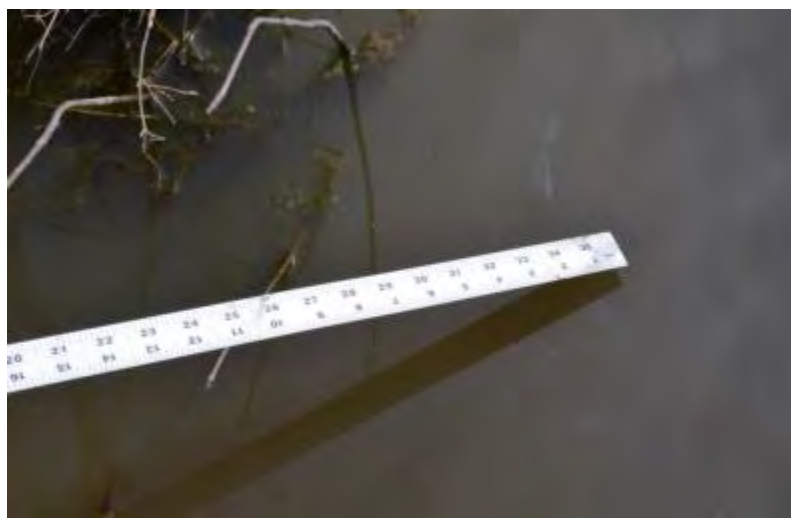
Patches of non-brittle silver gray sheen

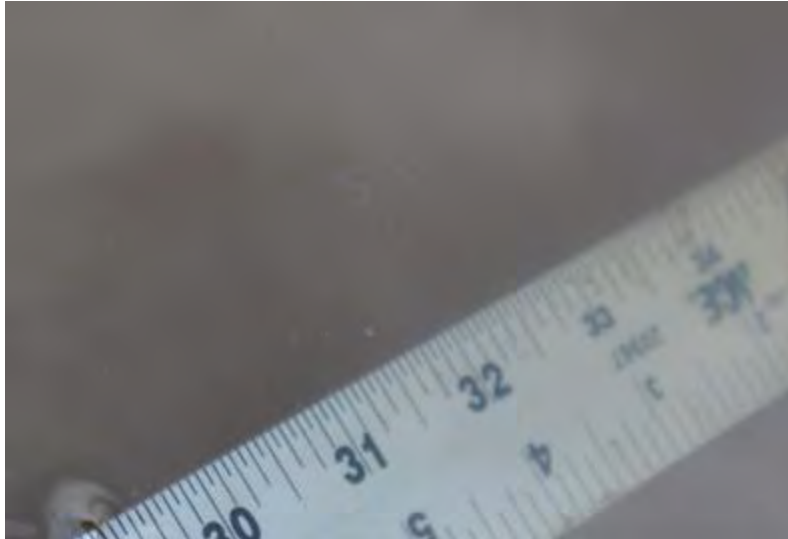
Lighter

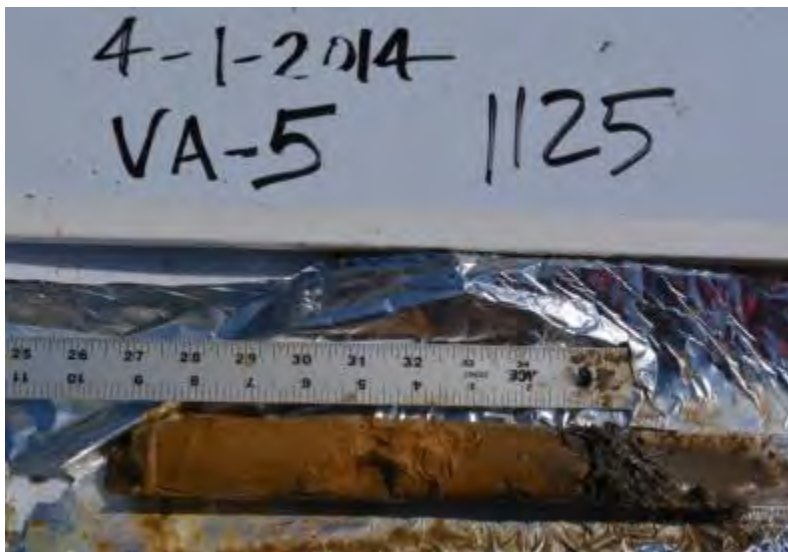
6-12 inches : Patch (< 1") of non-brittle silver gray sheen

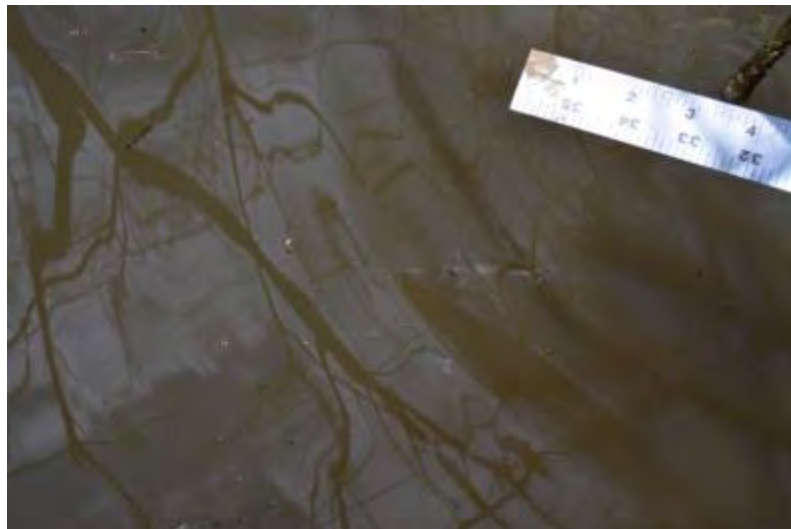
Heavier

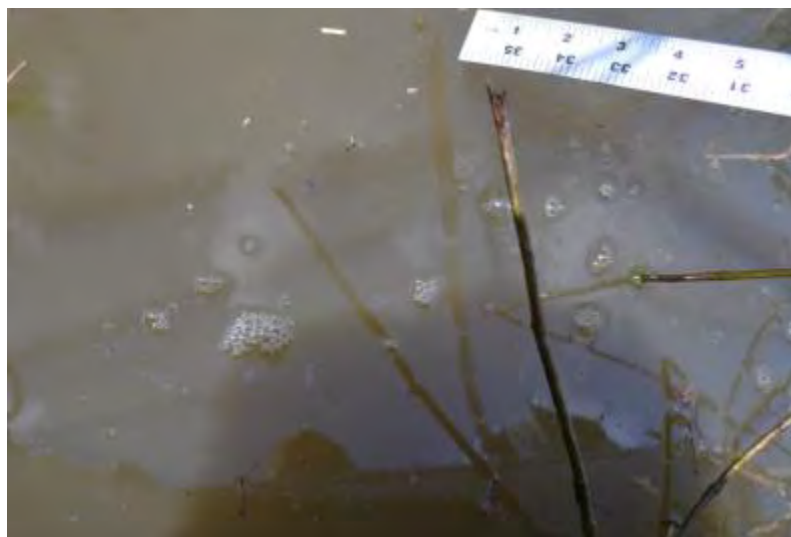
Streamer of non-brittle silver gray sheen with four oil spots (<0.1-inch)

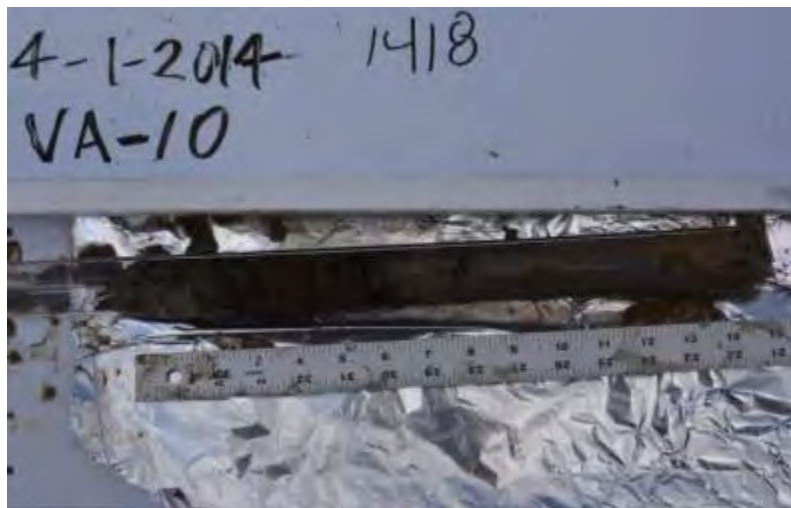
Surface : Patches/streamers of non-brittle silver gray sheen
0-6 inches : Patches/streamers of non-brittle silver gray sheen
6-12 inches : Patches/streamers of non-brittle silver gray sheen

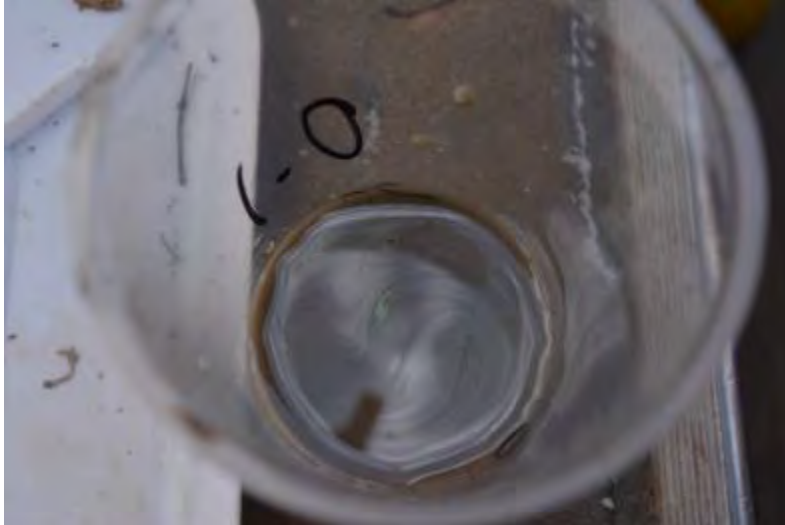
Heavier

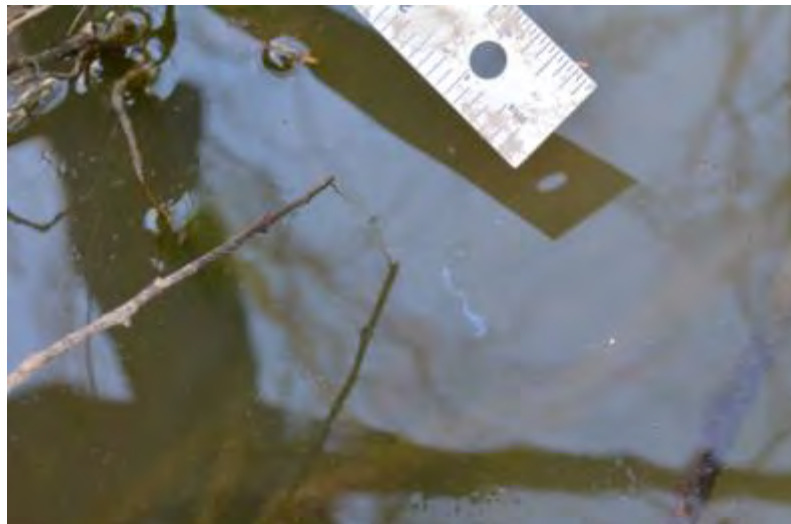
Medium

Patches/streamers of non-brittle silver gray sheen

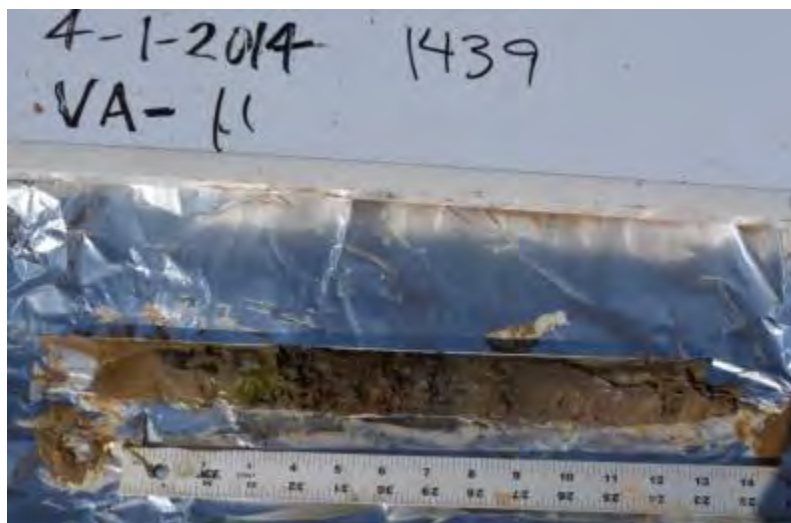
Probing Observation:

Surface : Patches/streamers of non-brittle silver gray sheen
0-6 inches : Patches/streamers of non-brittle silver gray sheen (light sheen)
6-12 inches : Patches/streamers of non-brittle silver gray sheen

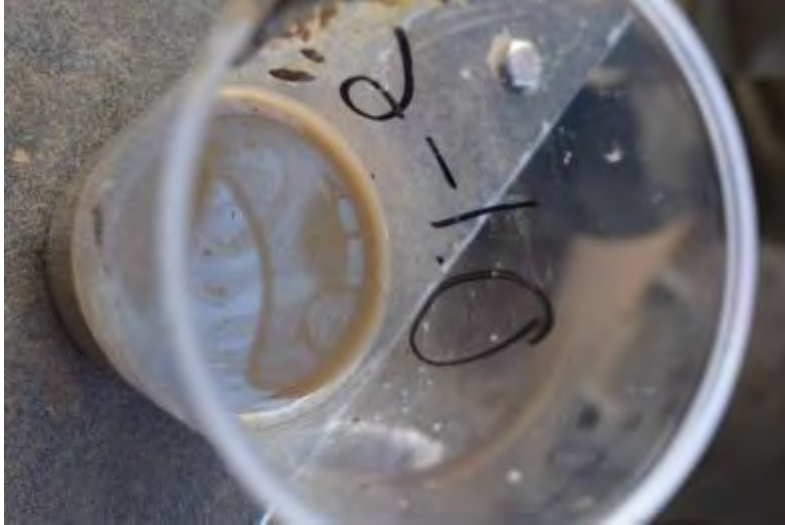
Core Description:

0-0.1 inches : Brown silt, very little visible sheen
0.1-6 inches : Silt, humic material, roots, very little sheen in 0.1-4"

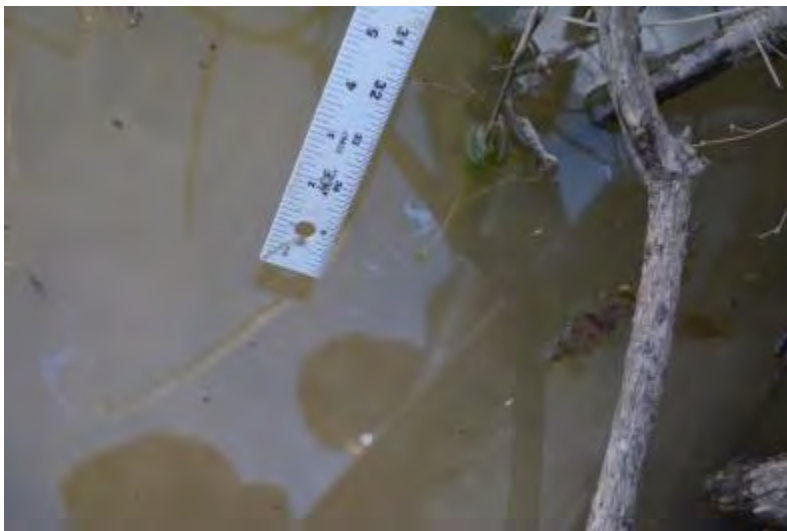
Initial Observation:

Patches/streamers of non-brittle silver gray sheen

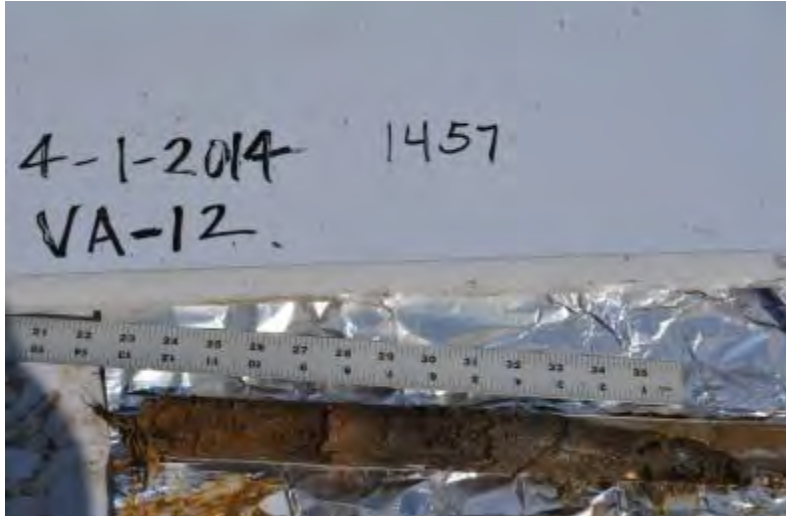
Probing Observation:

0-6 inches : Streamer of non-brittle rainbow sheen with three oil spots (<0.25-inch wide)
6-12 inches : Streamer of non-brittle silver gray sheen

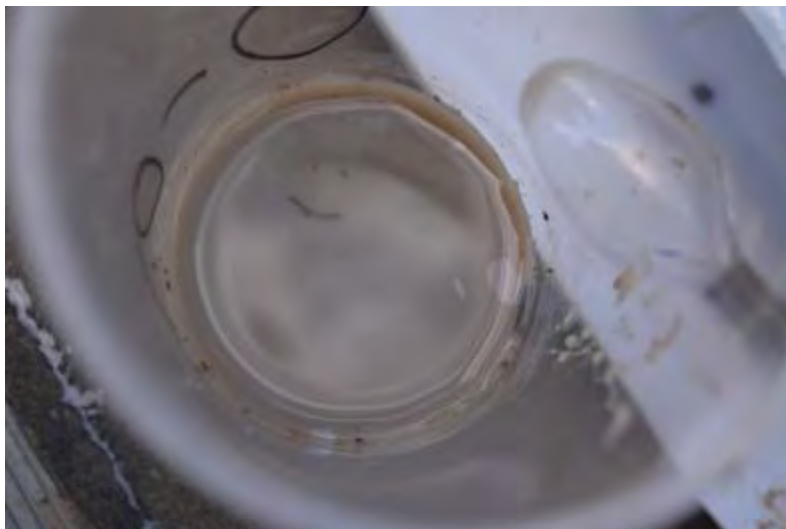
Core Description:

0-0.1 inches : Dark brown silt, very little sheen
0.1-6 inches : Brown silty clay
