Pre-Design Study Results

**Pre-Design Study – Revision 1
Mayflower Pipeline Incident Response, Mayflower, Arkansas**

Downstream Areas Pre-Design Study Photolog

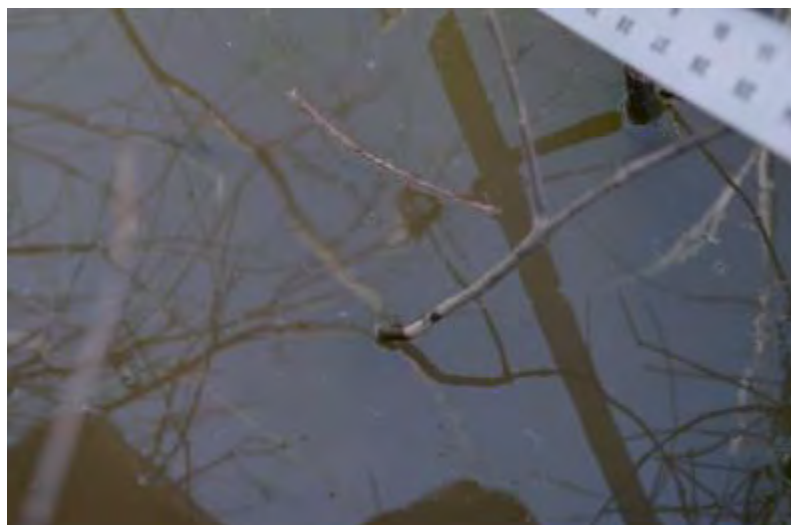
Initial Observation:

Patches of non-brittle silver gray sheen

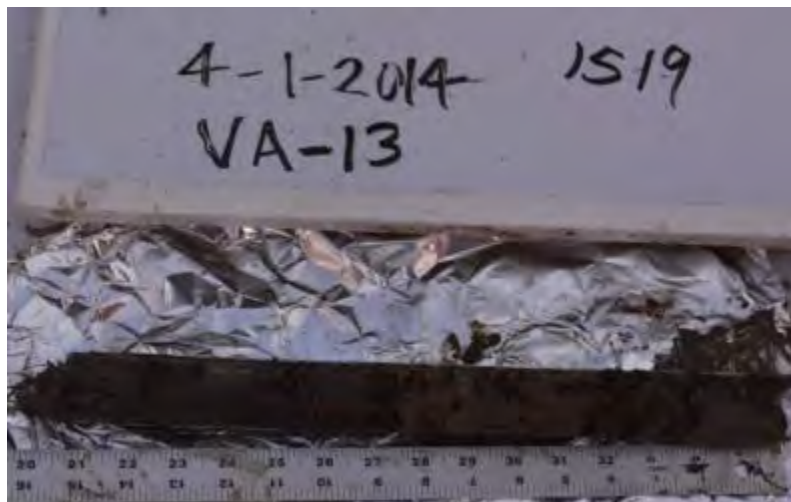
Probing Observation:

Surface : Patches of non-brittle silver gray sheen
0-6 inches : Patches of non-brittle silver gray sheen
6-12 inches : Patches/streamers of non-brittle silver gray sheen

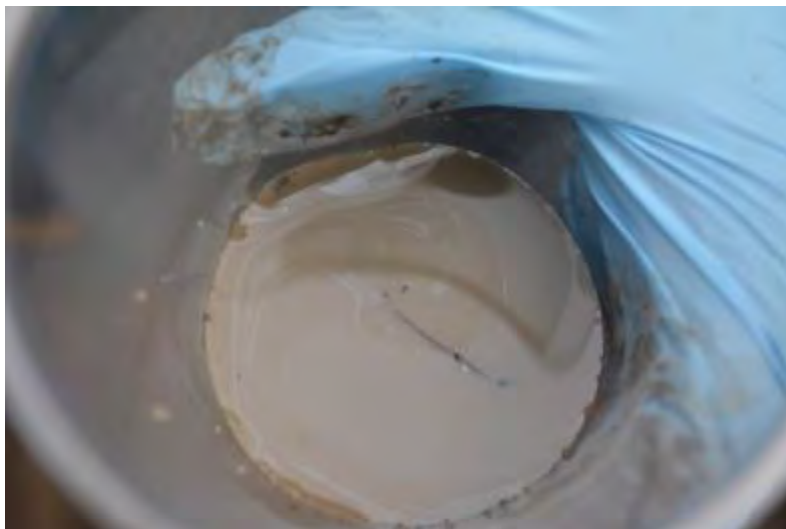
Core Description:

0-0.1 inches : Brown silt with humic material
0.1-6 inches : Brown silt with some clay

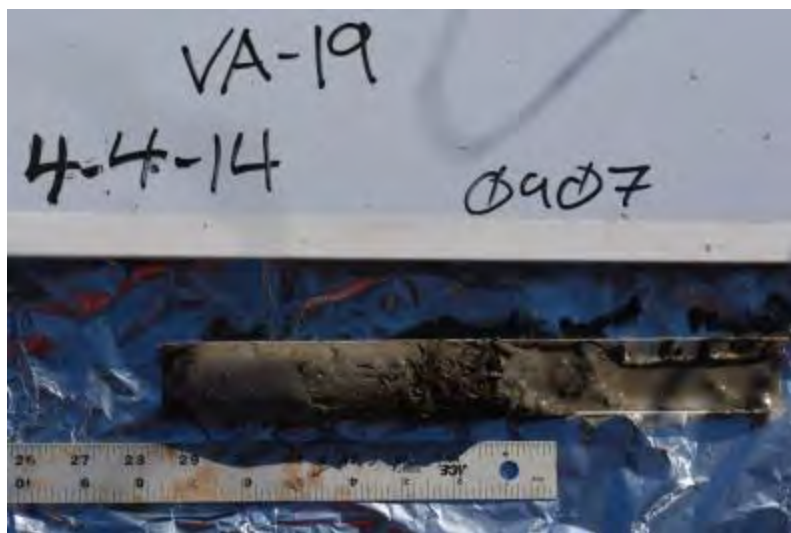
Initial Observation:

Streamers of non-brittle silver gray sheen

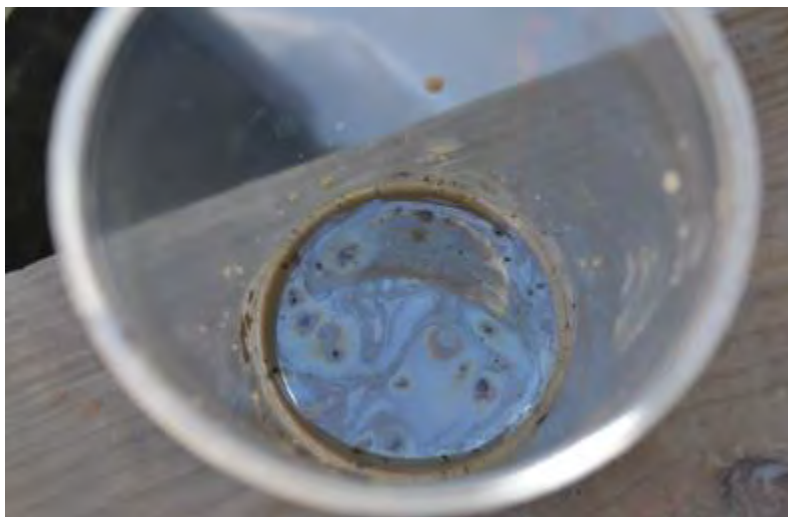
Core Description:

0-0.1 inches : Brown silt, soft, light sheen at 0-0.1"
0.1-6 inches : Brown silt, roots, light sheen at 0.1-3"

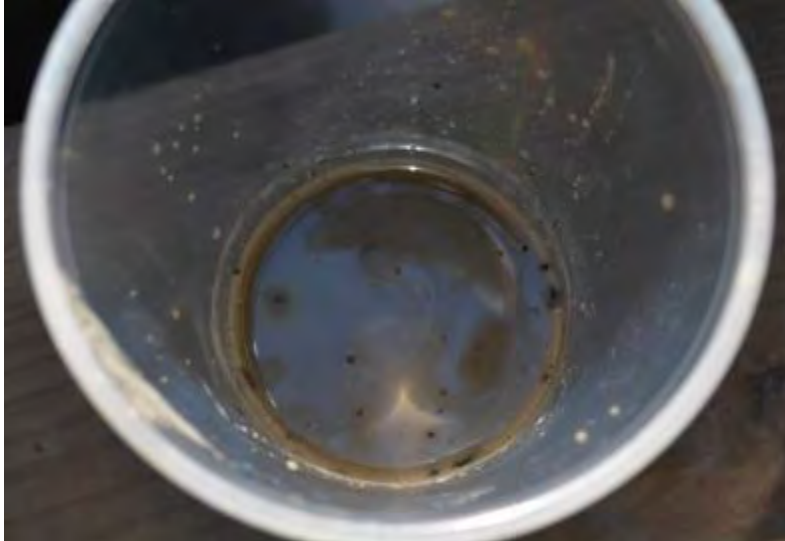
Sheen Stir-Test:

0.1-6 inches : Patches/Streamers of rainbow sheen with five oil spots (Medium)

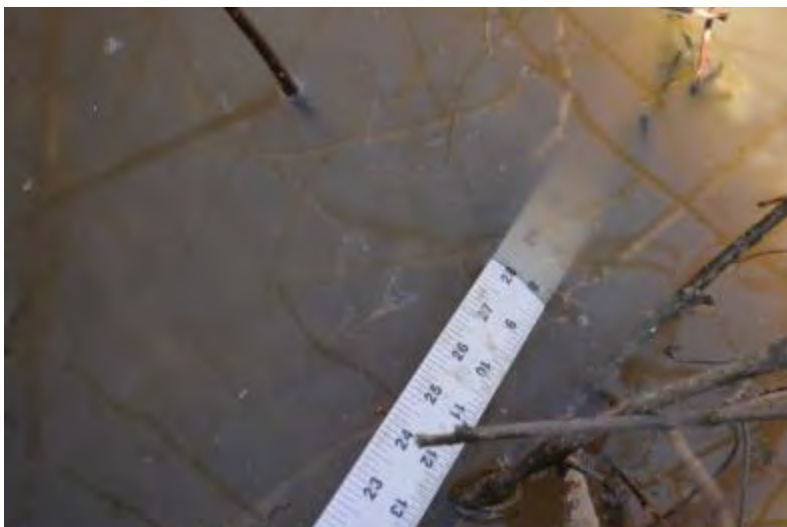
Probing Observation:

0-6 inches : Patches/streamers of non-brittle rainbow sheen
6-12 inches : Patches/streamers of non-brittle rainbow sheen

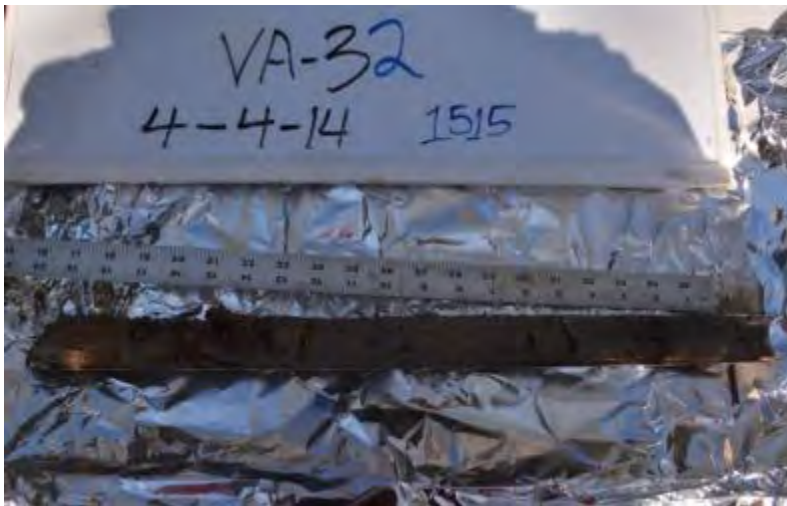
Core Description:

0-0.1 inches : Humic material, rootlets
0.1-6 inches : Brown silt, minor sheet spot at 5"

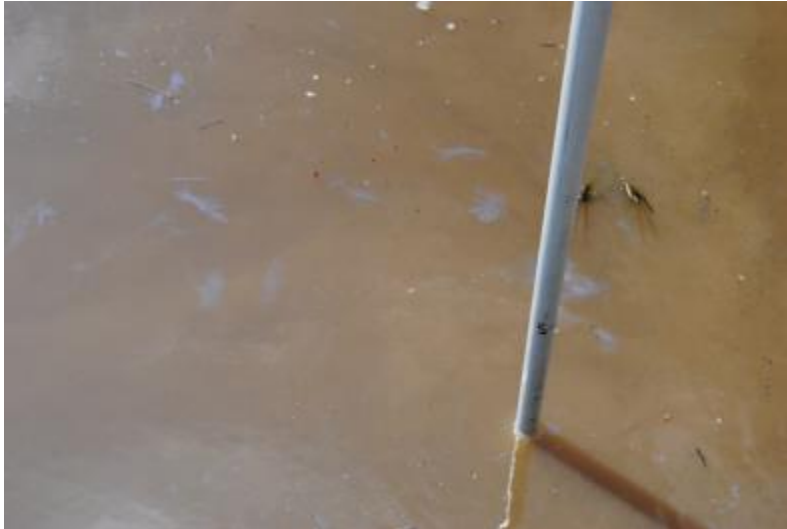
Probing Description:

0-6 inches : Patches/streamers of brittle and non-brittle silver gray sheen
