**Downstream Areas Pre-Design
Study**

**Pre-Design Study
Mayflower Pipeline Incident Response, Mayflower, Arkansas**

Downstream Areas Pre-Design Study
ExxonMobil Environmental Services Company
Mayflower Pipeline Incident Response, Mayflower, Arkansas

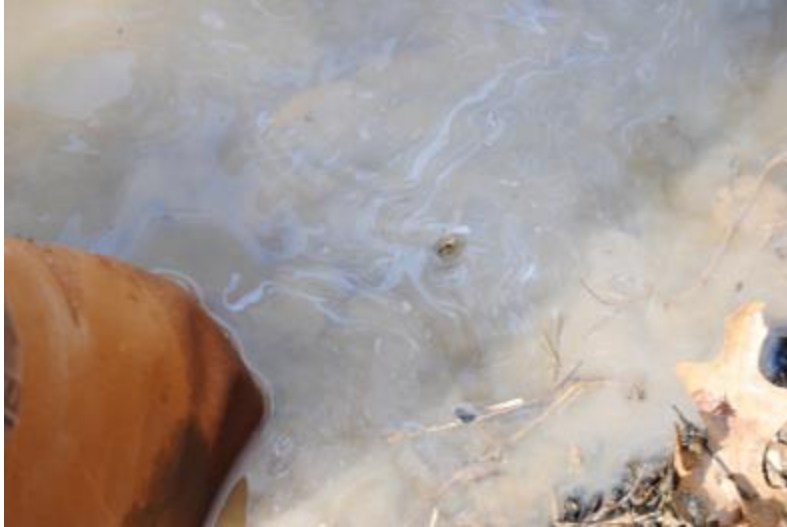
Probing Observation:

Surface : Patches/streamers of non-brittle silver gray sheen
0-6 inches : Patches/streamers of non-brittle silver gray sheen

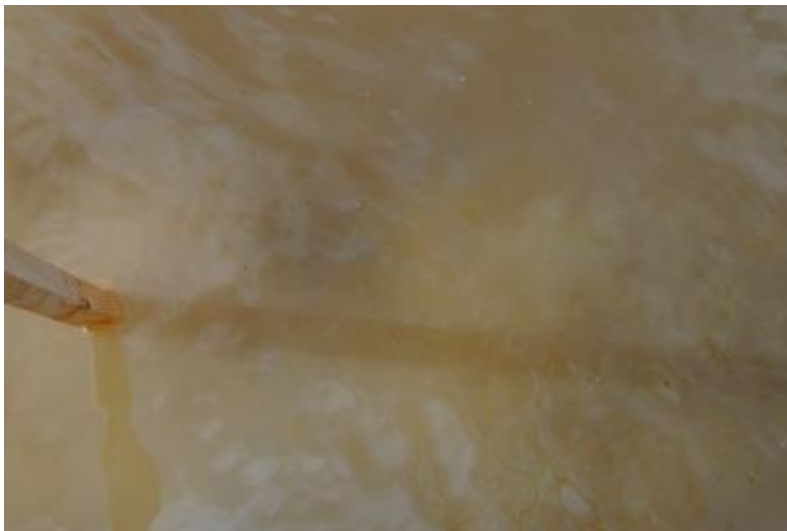
Probing Observation:

6-12 inches : Patches/streamers of non-brittle silver gray sheen with oil spots (<0.25-inch wide)

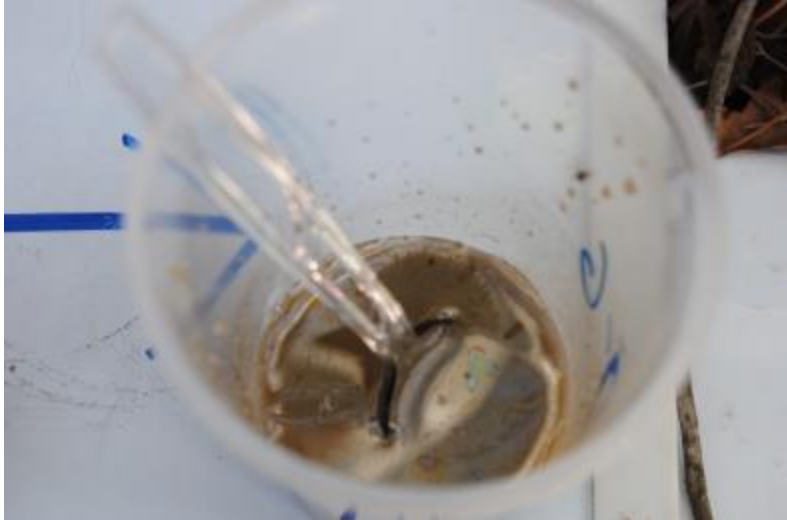
Sheen Stir-Test:

0-6 inches : Cover of rainbow sheen
(Heavier)

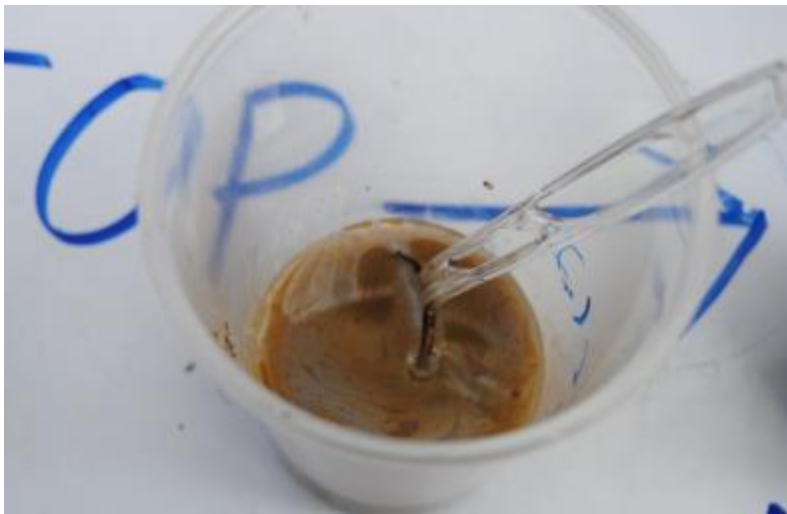
Sheen Stir-Test:

6-12 inches : Cover of rainbow sheen
(Heavier)

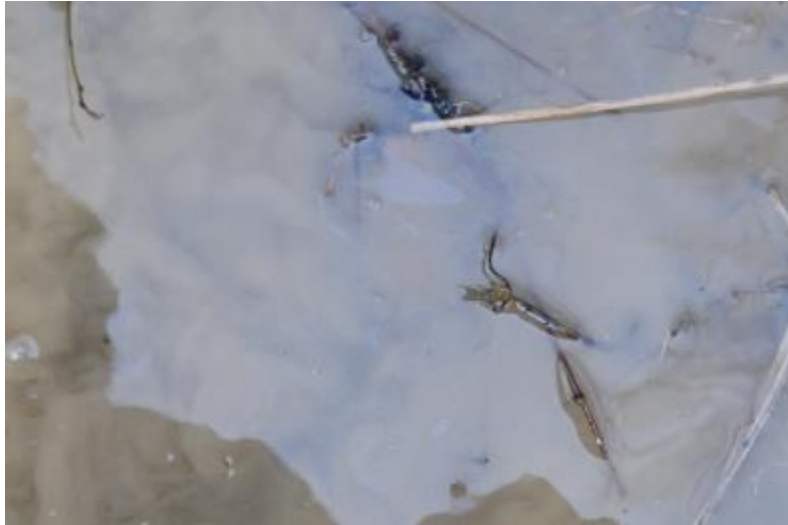
Probing Observation:

0-6 inches : Patches/streamers of non-brittle silver gray sheen

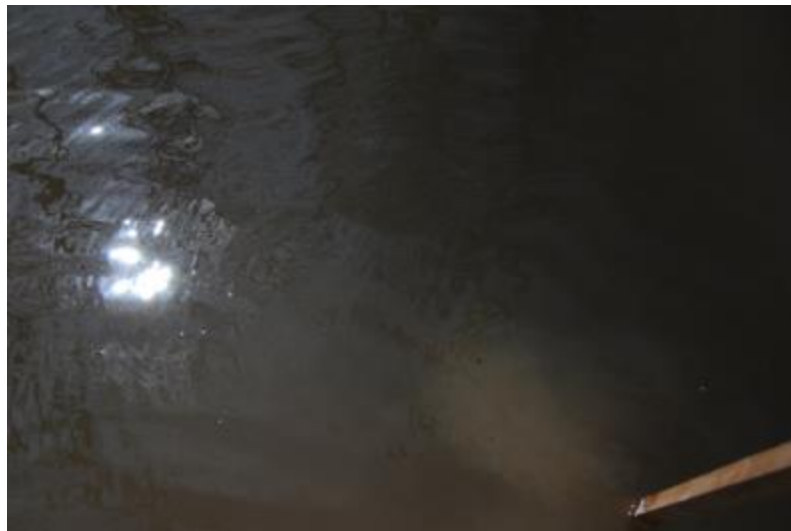
Probing Observation:

0-6 inches : Patches of non-brittle silver gray sheen
6-12 inches : Patches of non-brittle silver gray sheen

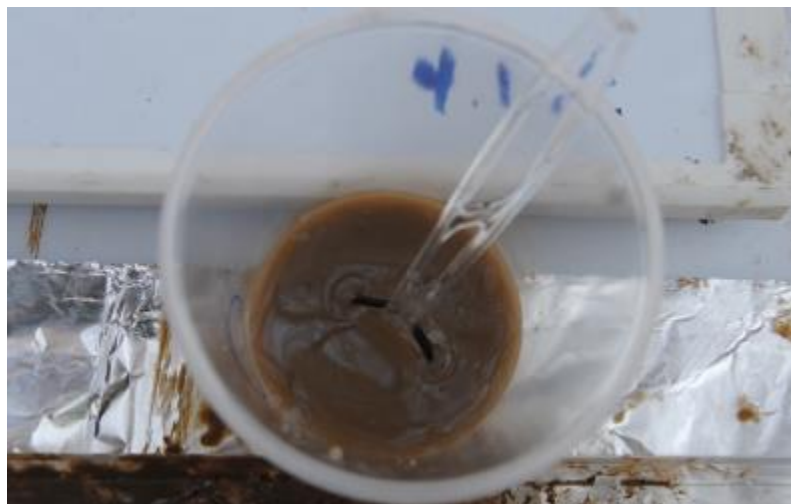
Sheen Stir-Test:

0-6 inches : Streamers of silver gray sheen (Medium)

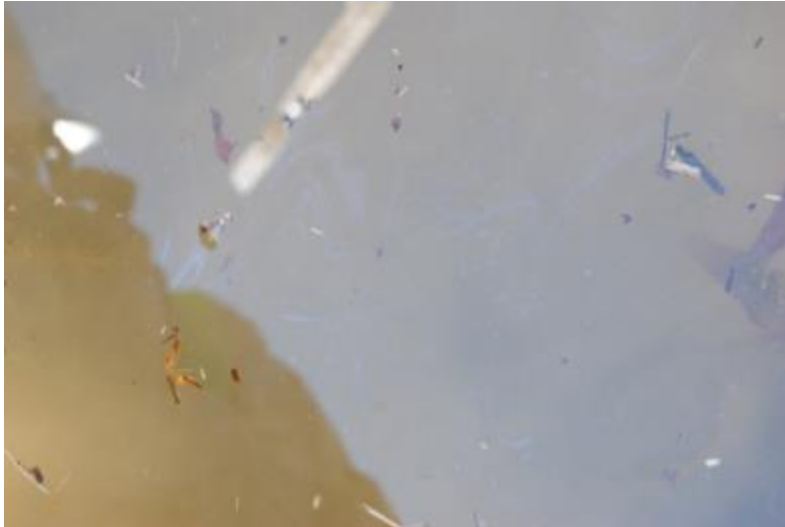
Probing Observation:

0-6 inches : Patches/streamers of non-brittle silver gray sheen with oil spots (<0.25-inch wide)
6-12 inches : Patches/streamers of non-brittle silver gray sheen with oil spots (<0.25-inch wide)

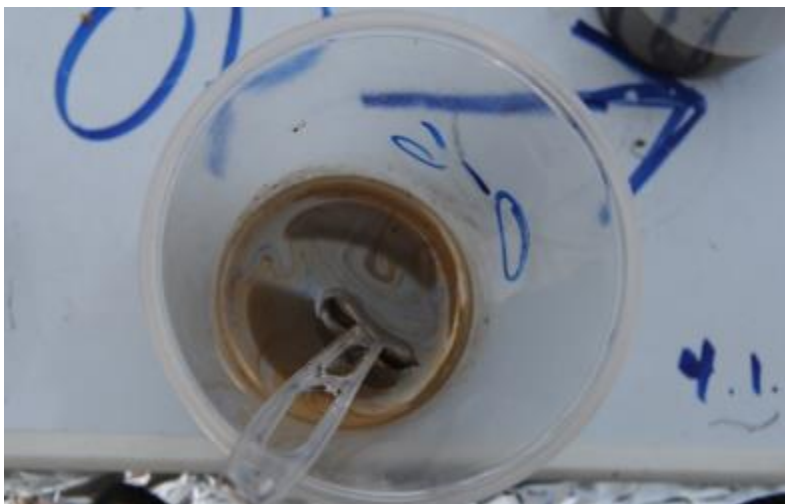
Sheen Stir-Test:

0-6 inches : Cover of rainbow sheen (Heavier)

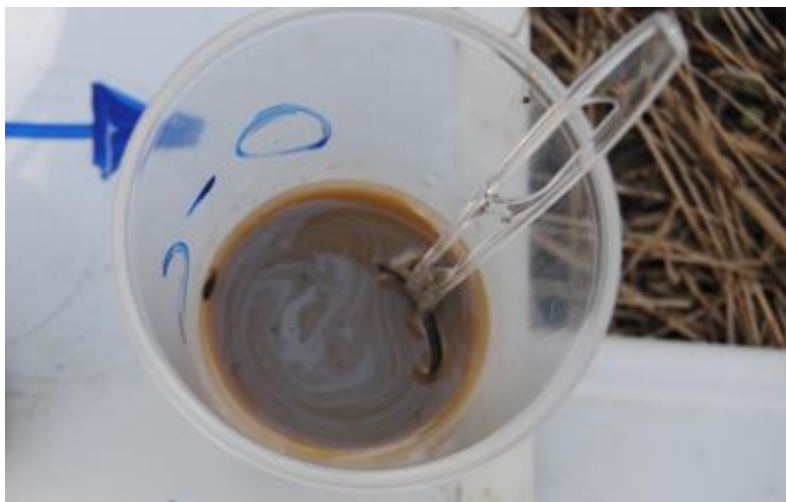
Sheen Stir-Test:

0-6 inches : Streamers of silver gray sheen (Medium)

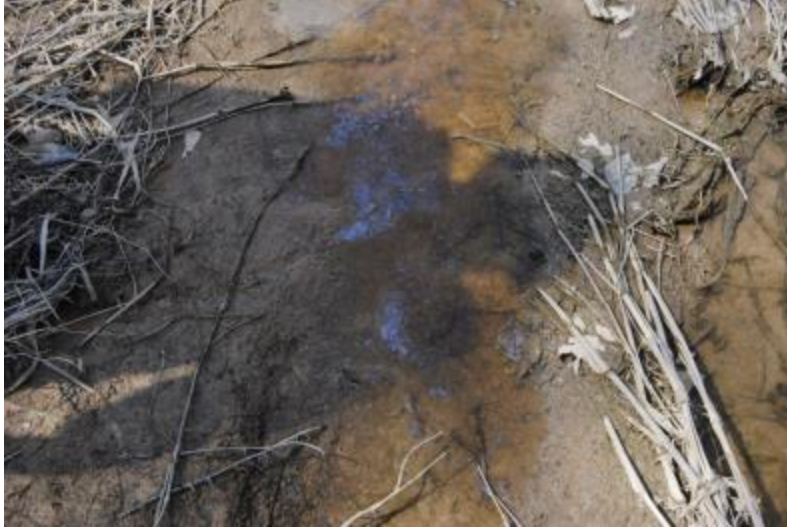
Initial Observation:

Patches of brittle silver gray sheen

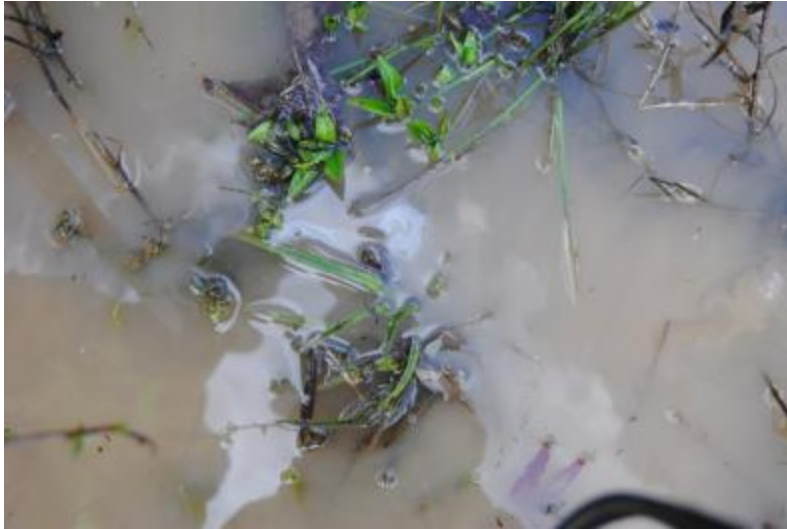
Probing Observation:

0-6 inches : Patches/streamers of non-brittle silver gray sheen (quickly dissipated)
6-12 inches : Patches/streamers of non-brittle silver gray sheen (quickly dissipated)

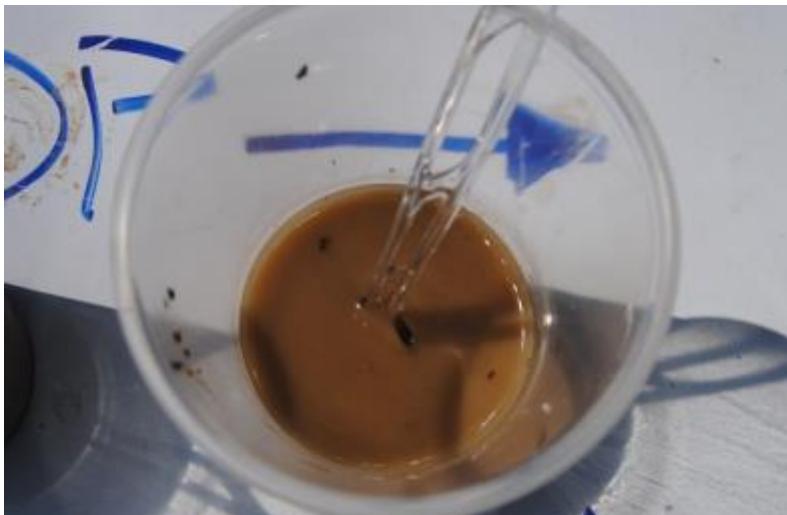
Sheen Stir-Test:

0-6 inches : Streamer of silver gray sheen (Lighter)

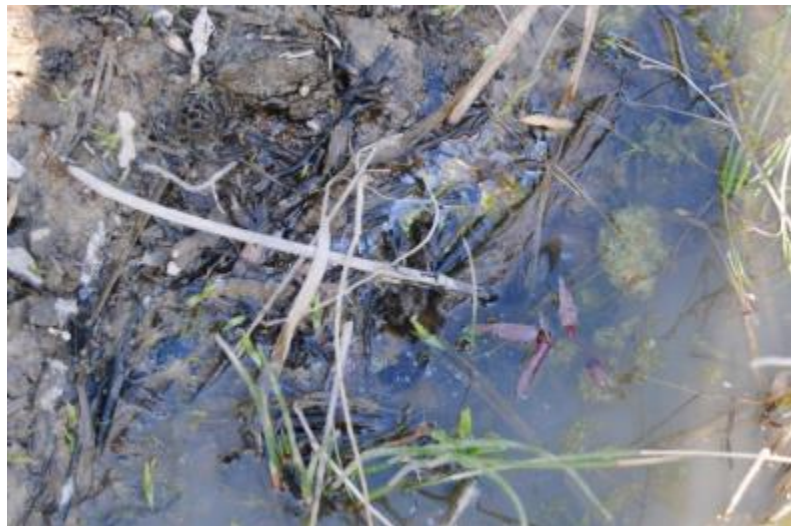
Initial Observation:

Cover of brittle silver gray sheen

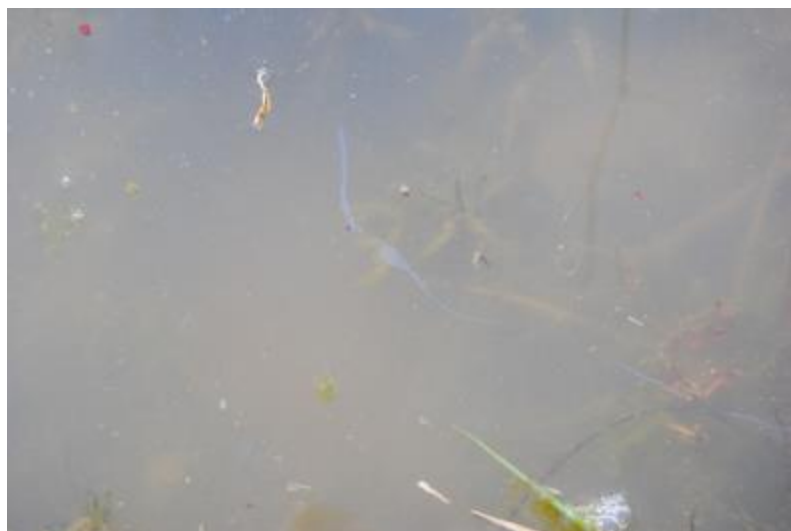
Probing Observation:

0-6 inches : Streamers (< 2 inches) of non-brittle silver gray sheen
6-12 inches : Streamers (< 2 inches) of non-brittle silver gray sheen

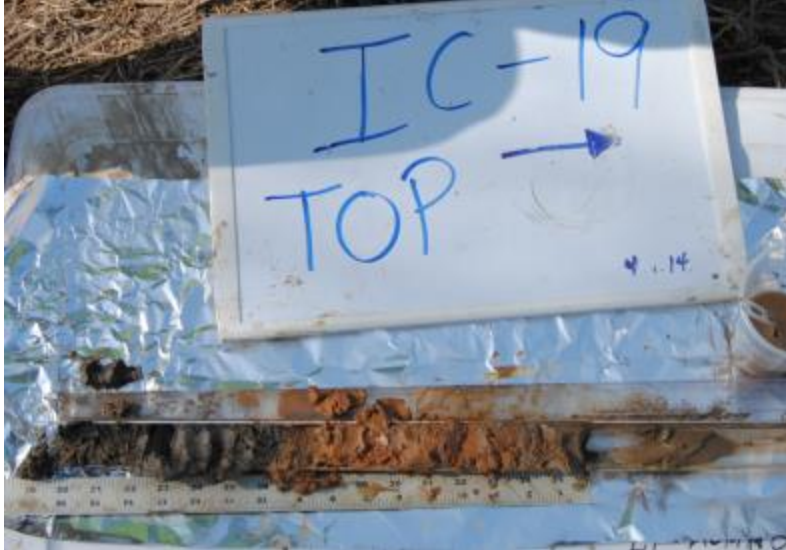
0-4 inches : Gray clayey silt (MH), soft
4-10 inches : Reddish brown silty sand (SM)
10-16 inches : Gray silt with clay (MH) and humic material, wood at 13"

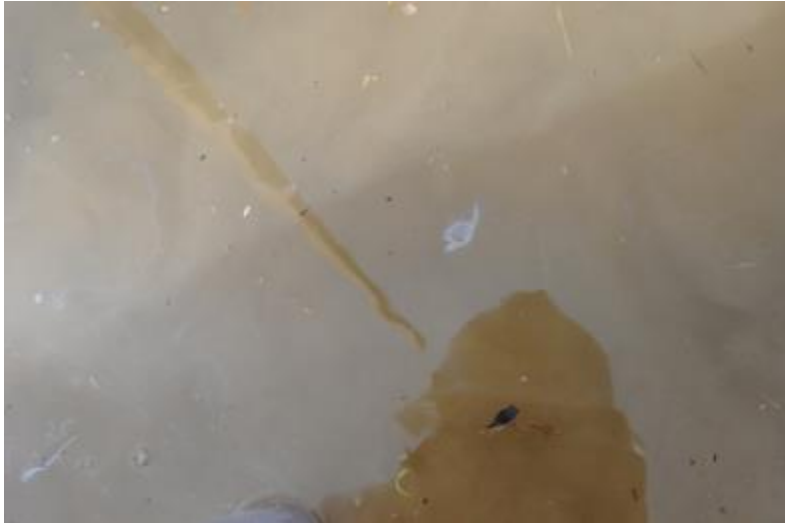
0-6 inches : Patches/streamers of non-brittle silver gray sheen (quickly dissipated)
6-12 inches : Patches/streamers of non-brittle silver gray sheen (quickly dissipated)

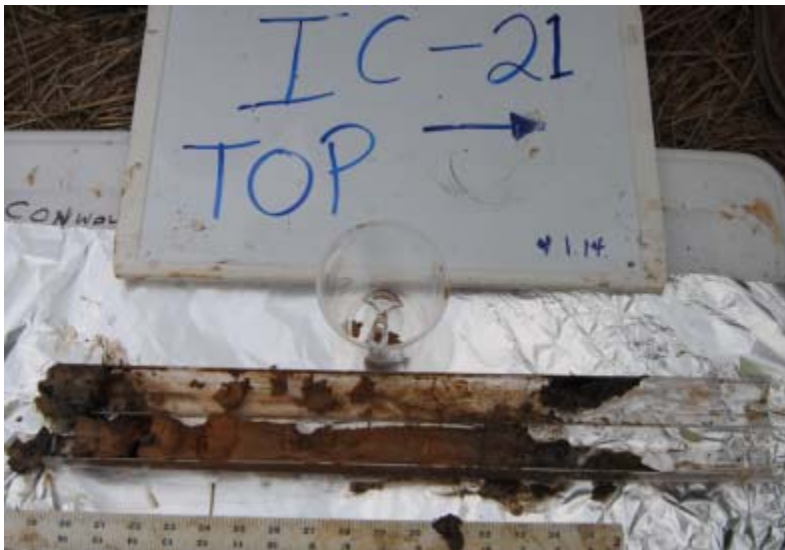
0-3 inches : Gray humic material with silty clay
3-15 inches : Light reddish brown clayey sand (SC)
15-17 inches : Gray silty clay with humic material

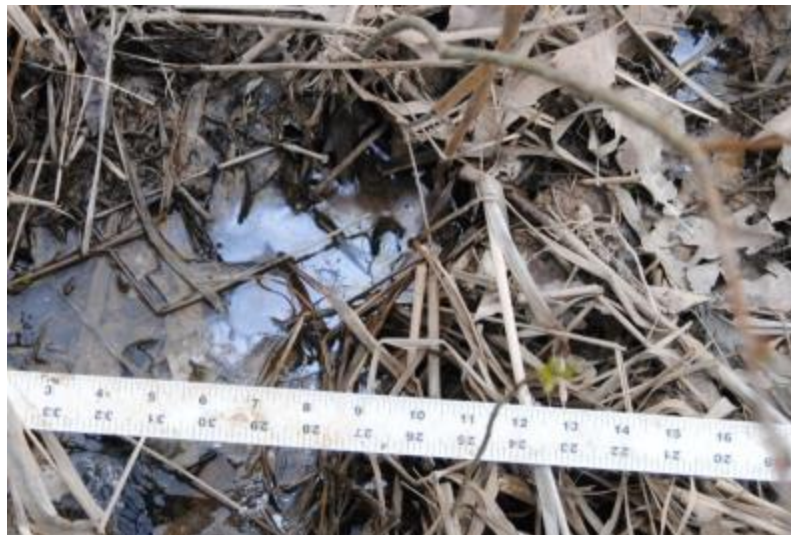
Cover of brittle rainbow sheen

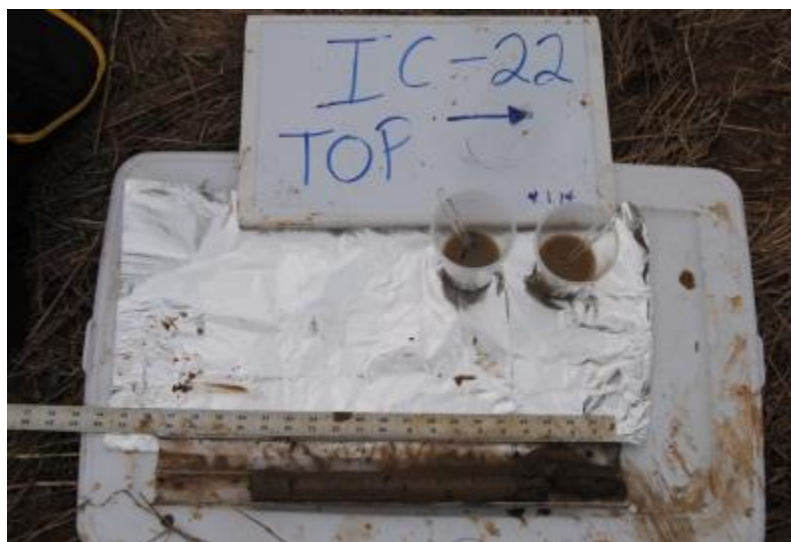
0-12 inches : Gray silty clay with humic material
12-24 inches : Light brown clayey silt

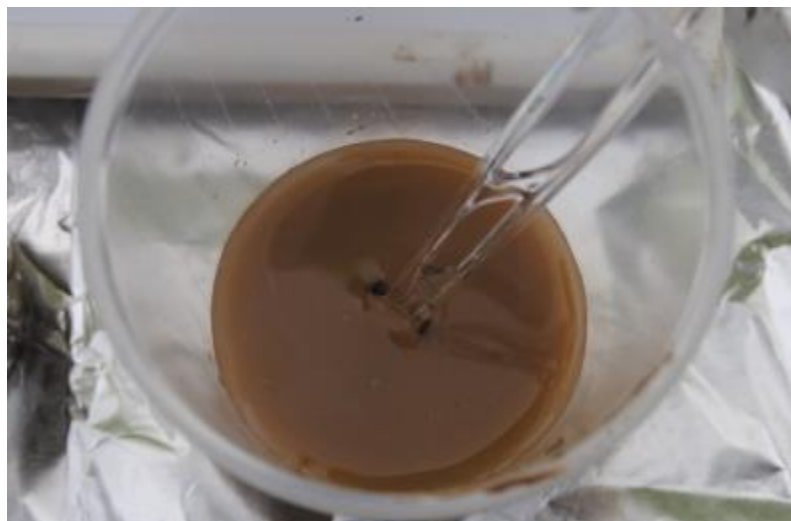
0-6 inches : Streamer of silver gray sheen (Lighter)

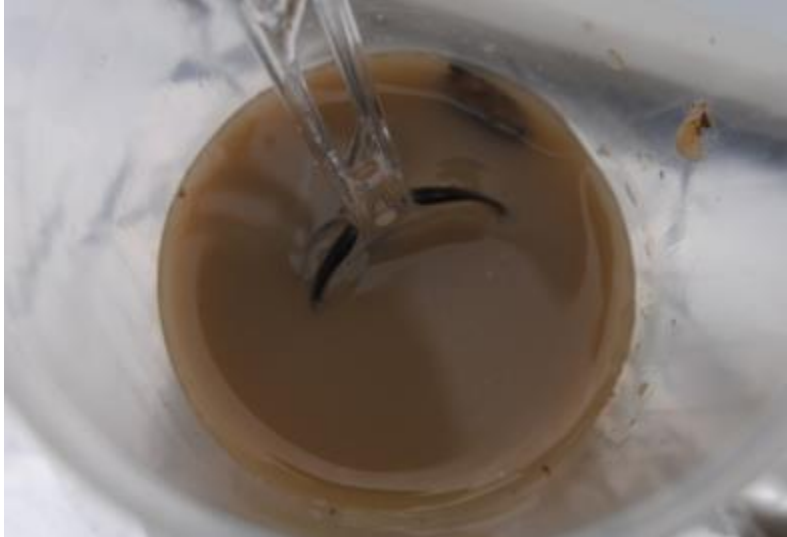
6-12 inches : Streamer of silver gray sheen (Lighter)

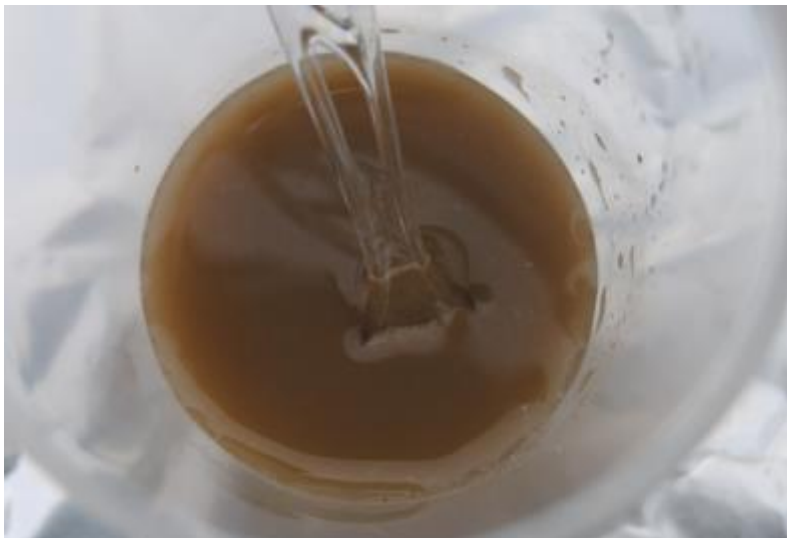
12-15 inches : Streamer of silver gray sheen (Lighter)

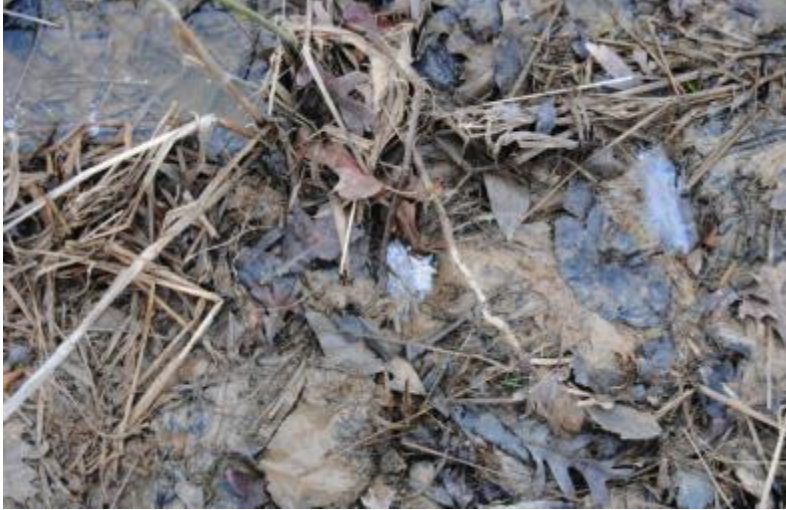
Cover of non-brittle rainbow sheen

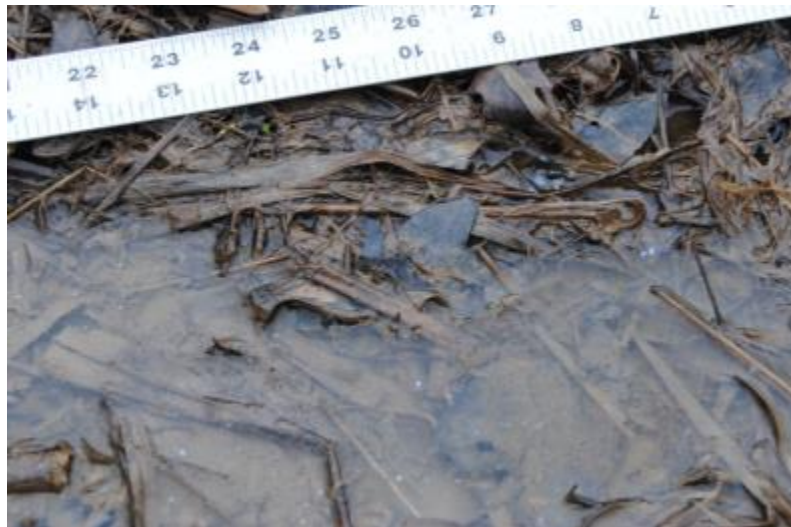
Patches of brittle silver gray sheen

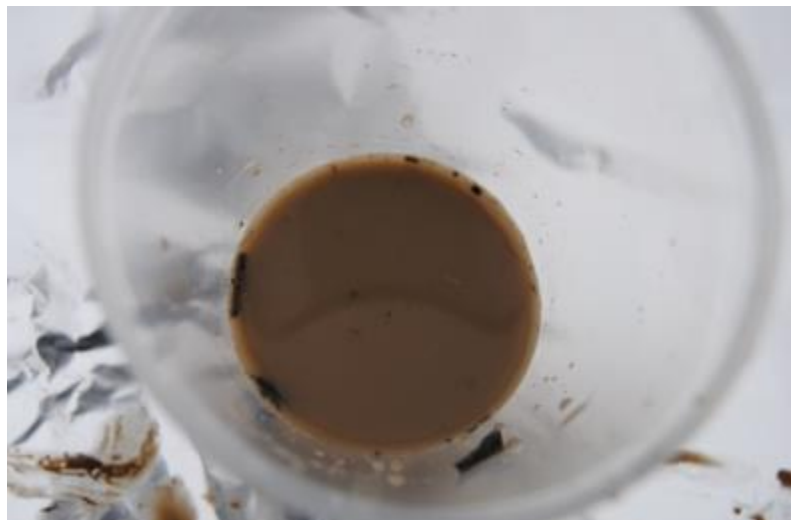
6-12 inches : Patch of silver gray sheen (Lighter)

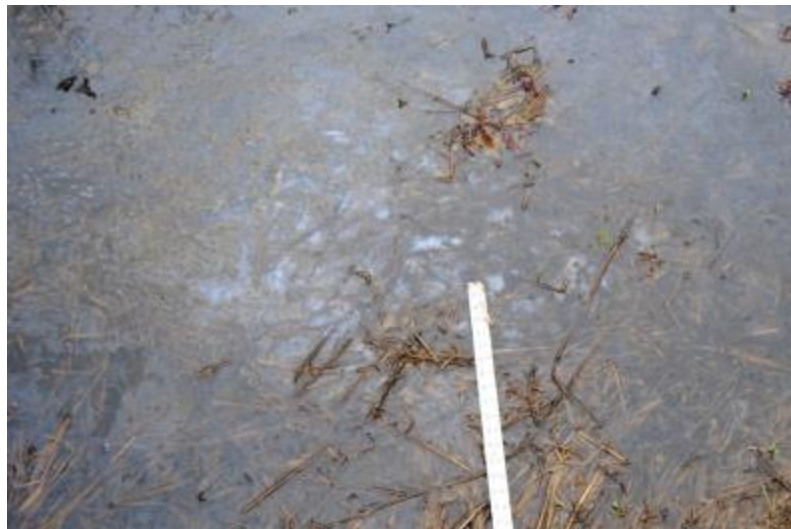
Cover of brittle and non-brittle silver gray sheen

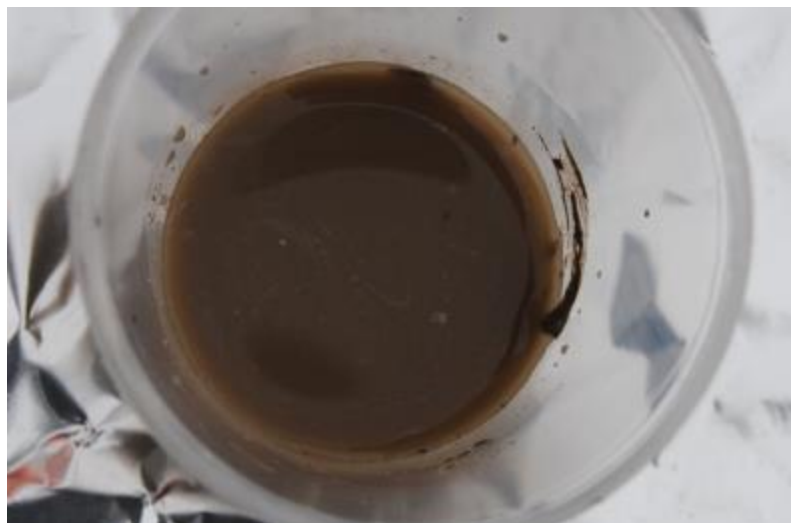
6-12 inches : Patches/streamers of silver gray sheen (Lighter)

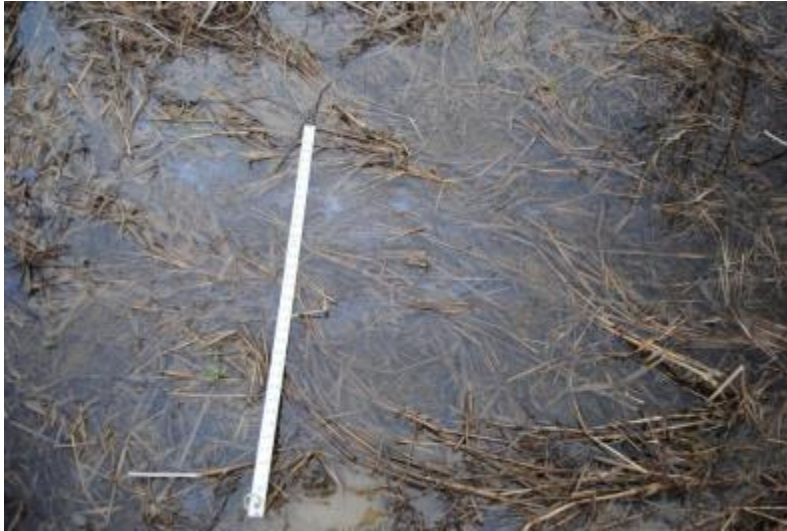
Cover of brittle silver gray sheen

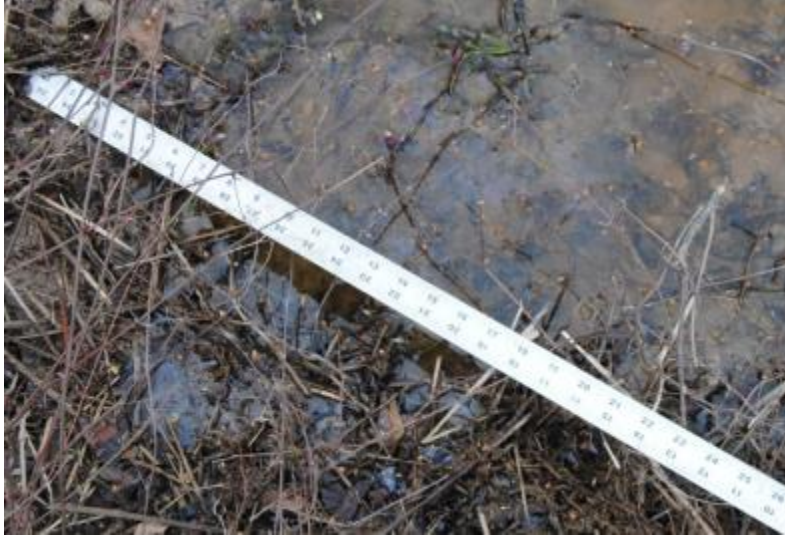
Cover of brittle silver gray sheen

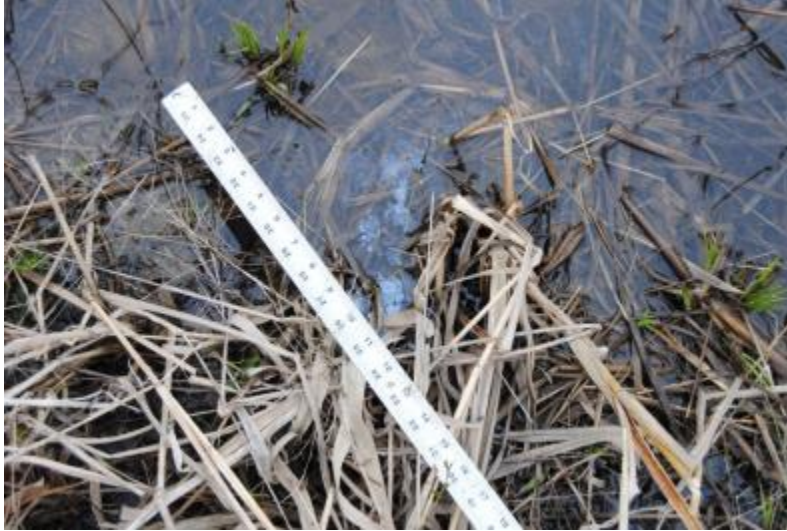
Cover of brittle silver gray sheen

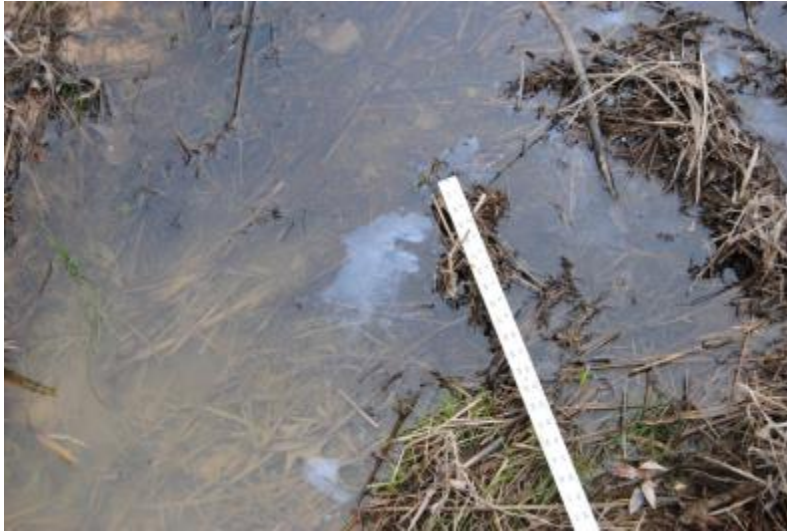
Patches of brittle silver gray sheen

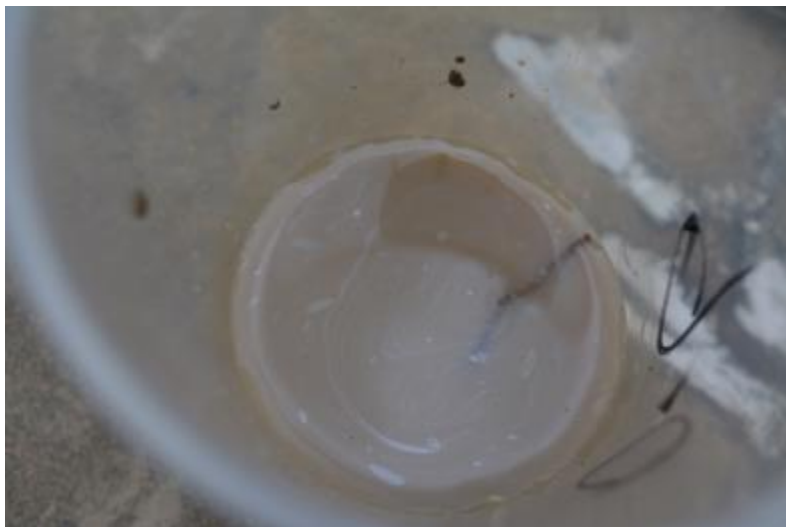
0-6 inches : Patches/streamers of silver gray sheen (Lighter)

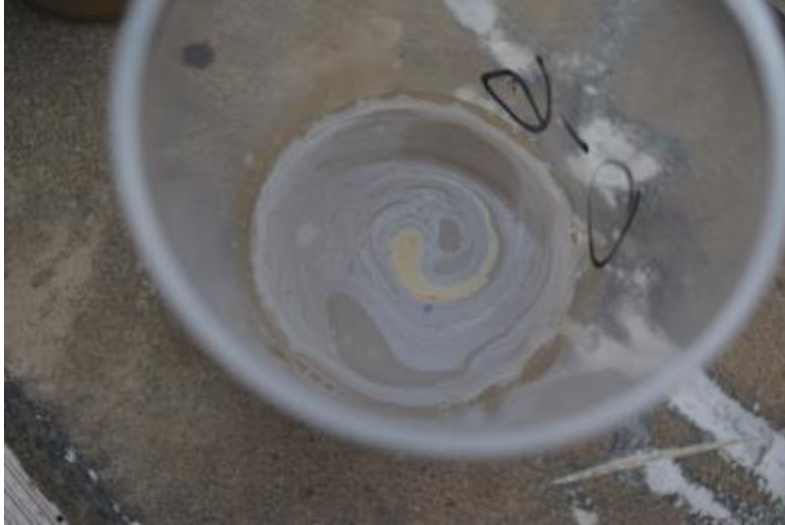
Cove Open Water
Location – OW-16

0-6 inches : Patches/streamers of rainbow sheen with 10 oil spots (0.1- to 0.25-inch wide) (Medium)

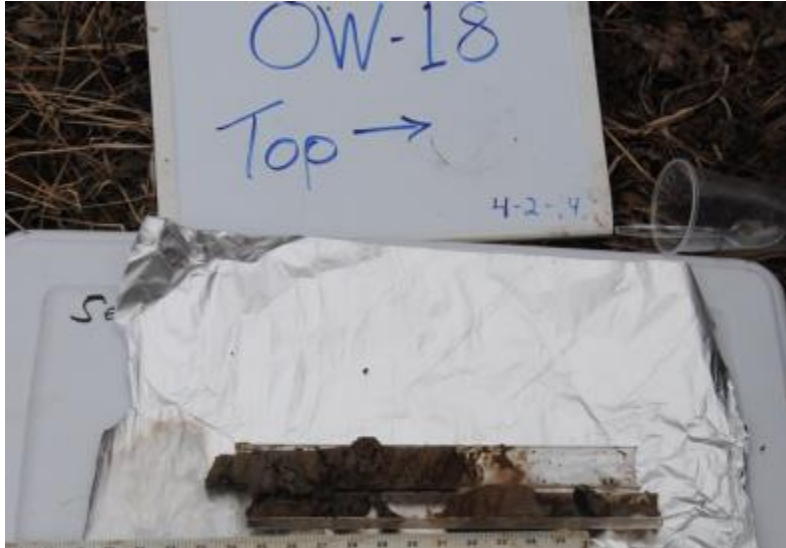
Core Description:

0-3 inches : Gray silty clay (CL), soft
3-10 inches : Gray and reddish brown clayey silt (MH)
10-12 inches : Gray silty clay (CL)

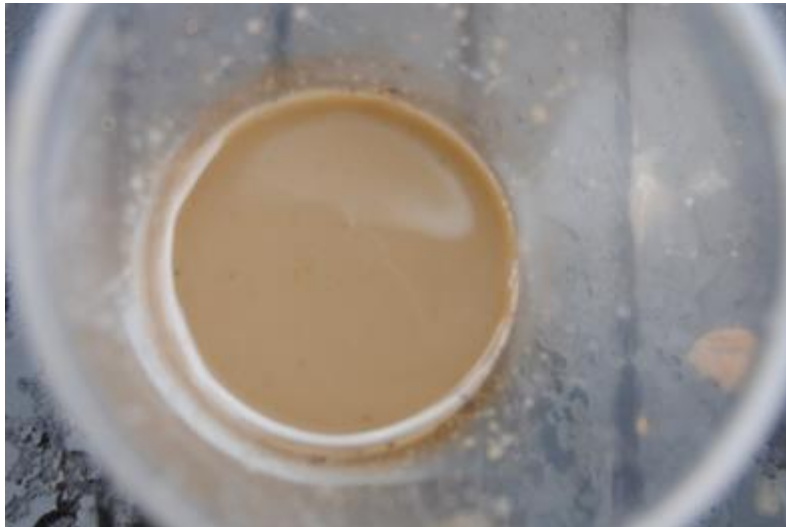
Sheen Stir-Test:

0-6 inches : Streamer of rainbow sheen (Heavier)

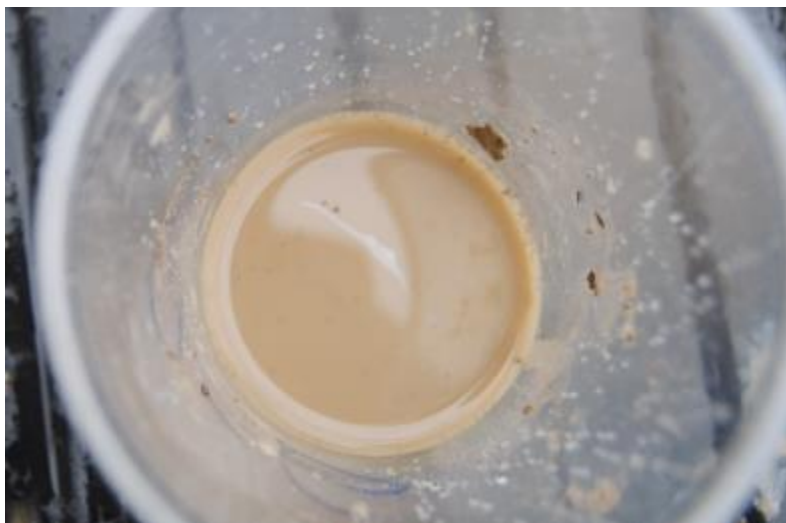
Sheen Stir-Test:

6-12 inches : Patch of silver gray sheen (Lighter)

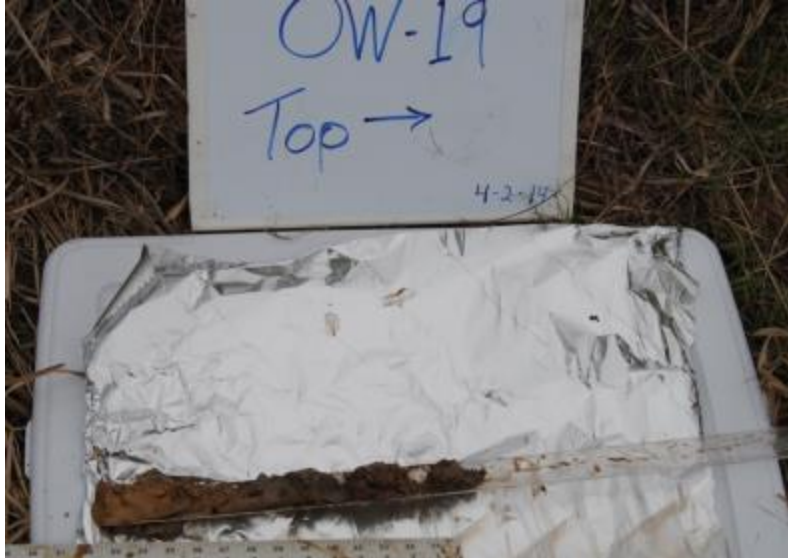
Core Description:

0-12 inches : Gray and reddish brown silt with clay (MH), roots and plant material at 0-2"

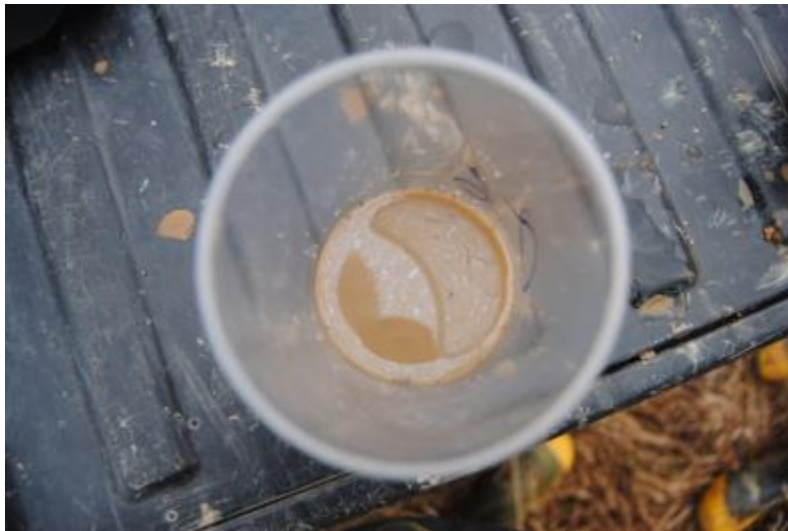
Sheen Stir-Test:

0-6 inches : Patches of silver gray sheen (Medium)

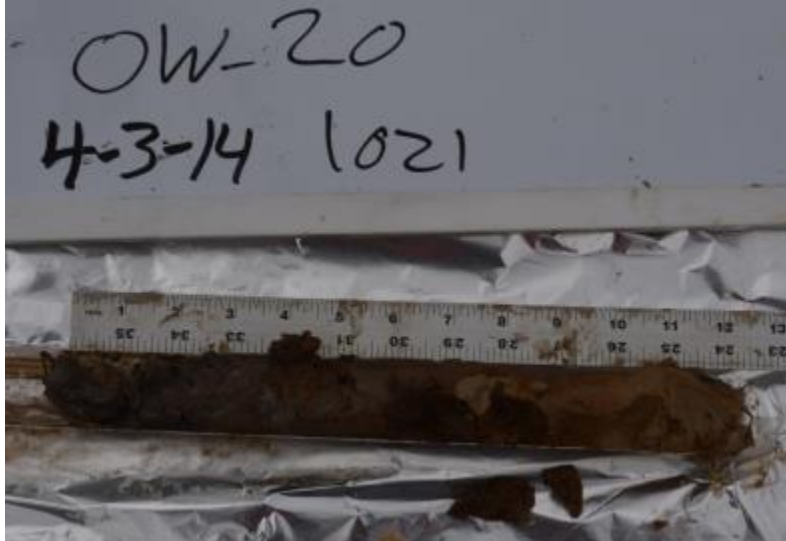
Core Description:

0-6 inches : Brown silt, soft, light sheen 0-5"
6-11 inches : Reddish brown clay, soft

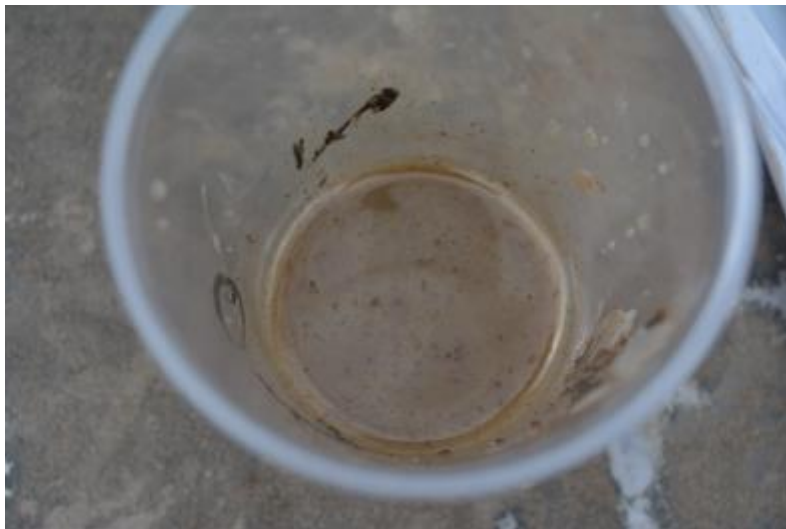
Sheen Stir-Test:

0-6 inches : Patches/streamers of rainbow sheen with oil spots (Heavier)

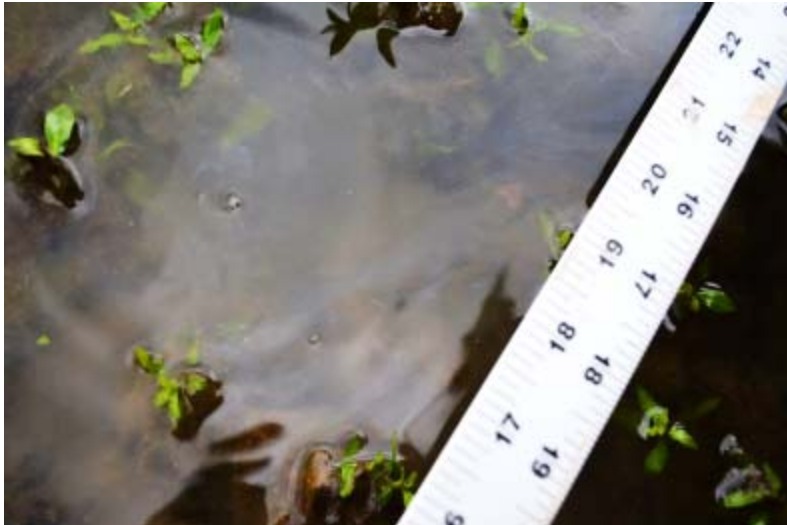
Probing Observation:

Surface : Streamers of non-brittle silver gray sheen
0-6 inches : Streamers of non-brittle silver gray sheen

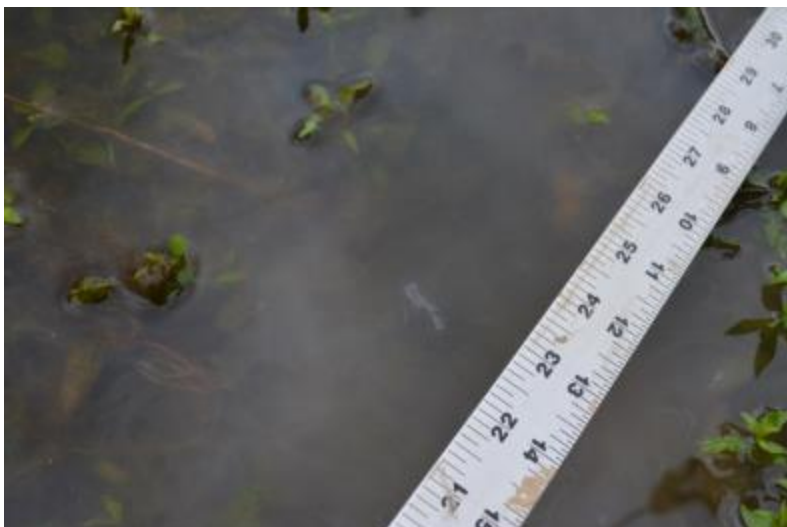
Probing Observation:

6-12 inches : Patches/streamers of non-brittle silver gray sheen with four oil spots (0.1 to 0.25-inch wide)

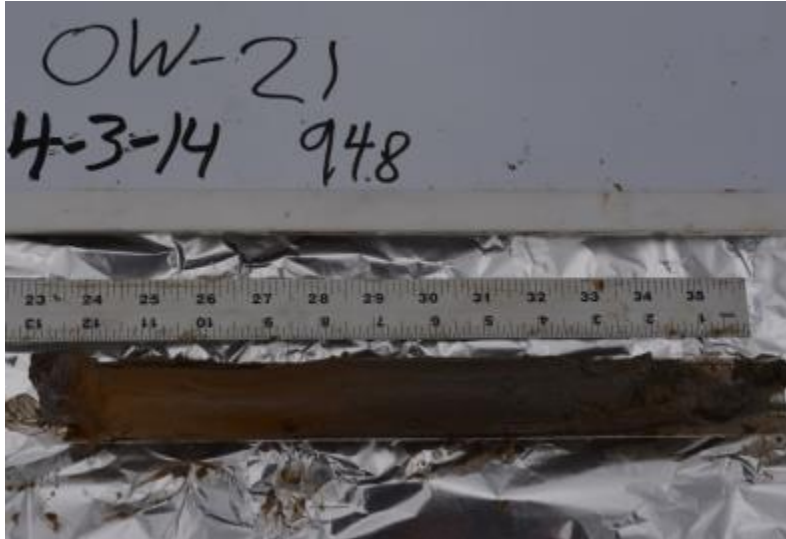
Core Description:

0-6 inches : Brown silt, light sheen 0-4"
6-12 inches : Red brown clay, soft

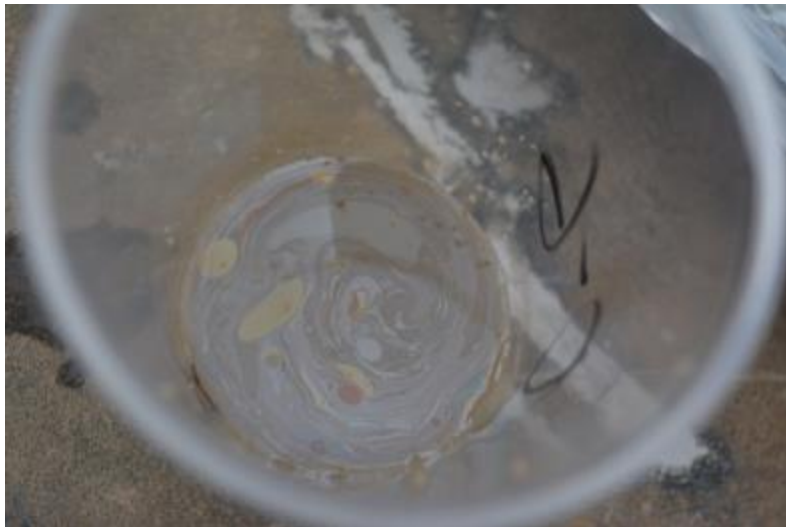
Sheen Stir-Test:

0-6 inches : Patches/streamers of rainbow sheen (Medium)

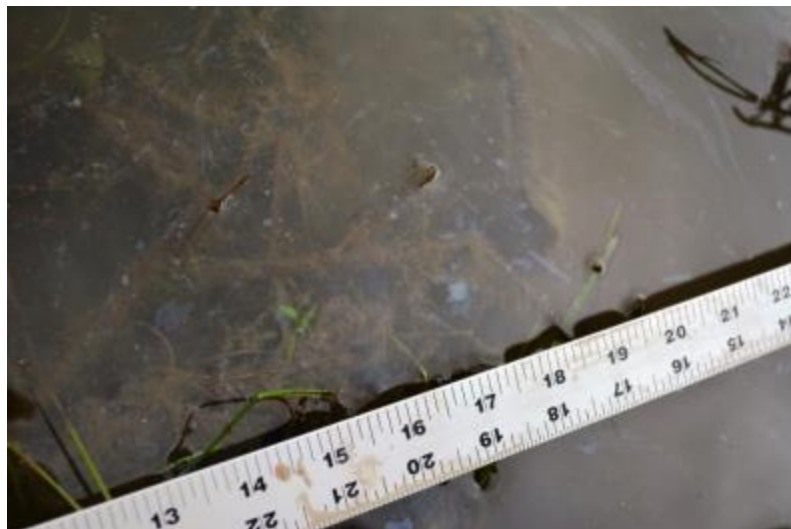
Probing Observation:

Surface : Patches/streamers of non-brittle silver gray sheen with three oil spots (0.1-inch wide)
0-6 inches : Patches/streamers of non-brittle silver gray sheen with 0.1-inch wide oil spots

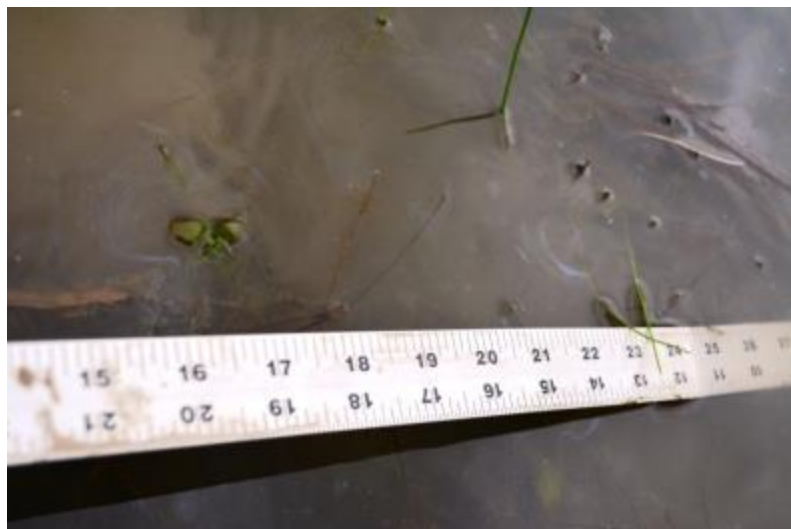
Probing Observation:

6-12 inches : Patches/streamers of non-brittle silver gray sheen with 10 oil spots (0.1-inch wide)

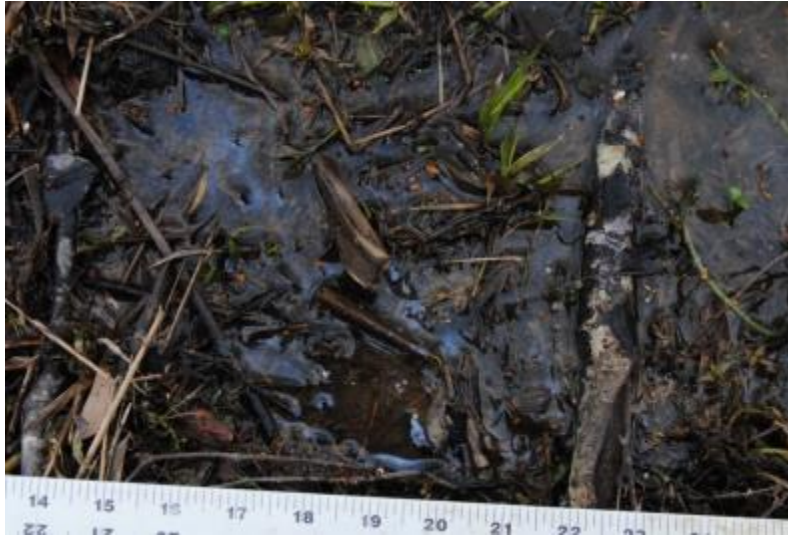
Initial Observation:

Streamers of brittle and non-brittle silver gray sheen

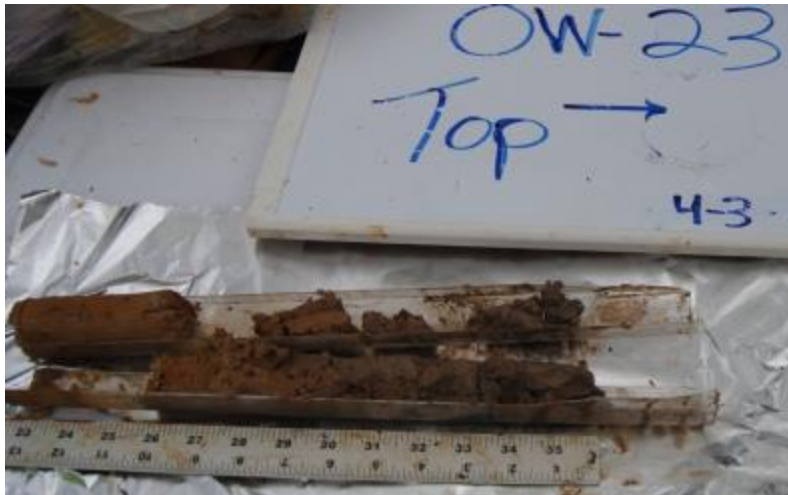
Core Description:

0-6 inches : Gray and reddish brown silt with clay (MH)
6-12 inches : Light brown and reddish brown mottled silt with clay (MH), soft

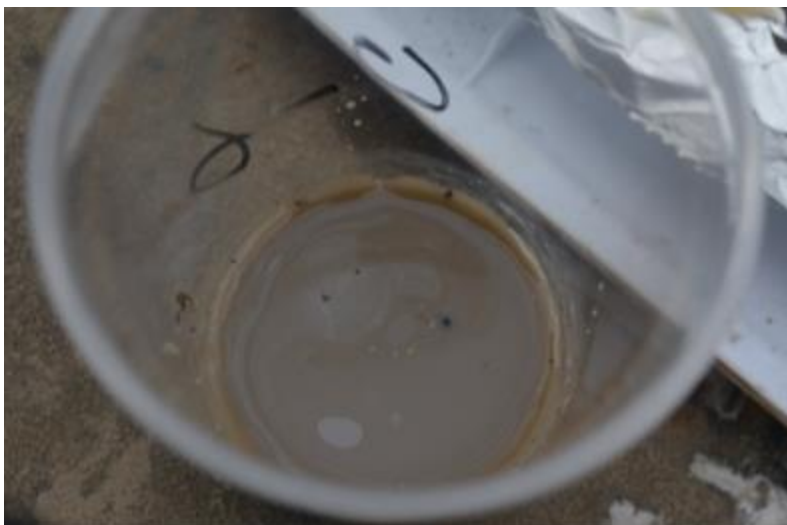
Sheen Stir-Test:

0-6 inches : Patches/streamers of silver gray sheen with 0.25-inch wide oil spot (Heavier)

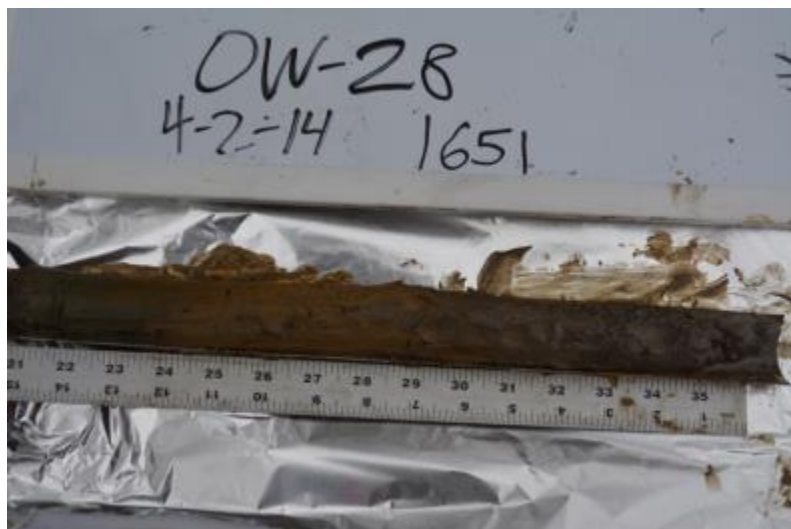
Core Description:

0-6 inches : Silty clay, light sheen at 0-2.4"
6-12 inches : Reddish brown clay, stiff

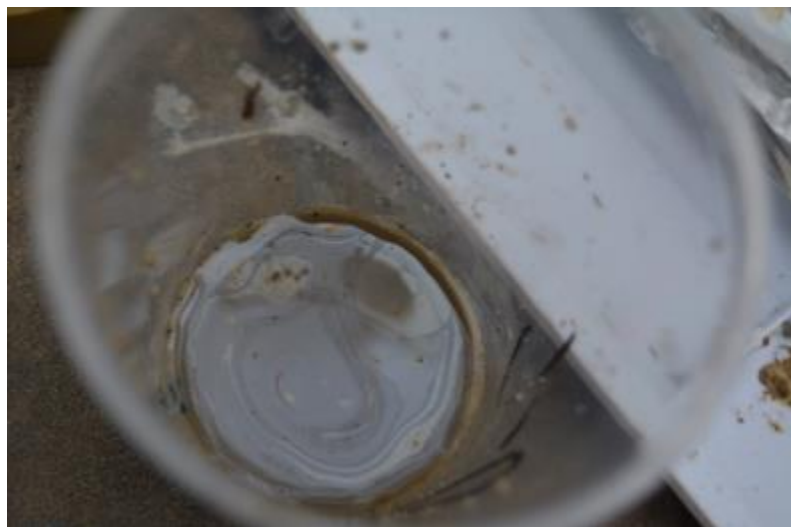
Sheen Stir-Test:

0-6 inches : Patches/streamers of silver gray sheen with three oil spots (Heavier)
