**Downstream Areas Pre-Design
Study**

**Pre-Design Study
Mayflower Pipeline Incident Response, Mayflower, Arkansas**

Downstream Areas Pre-Design Study
ExxonMobil Environmental Services Company
Mayflower Pipeline Incident Response, Mayflower, Arkansas

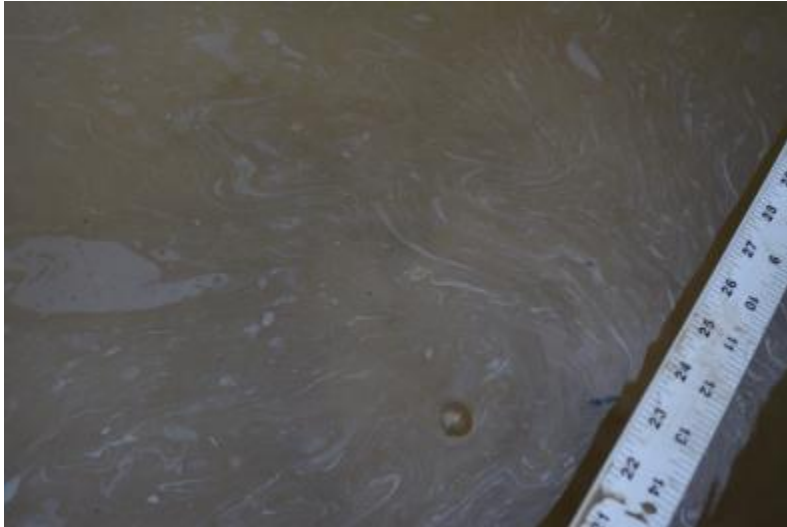
Probing Description:

Surface : Patches/streamers of silver gray sheen
0-6 inches : Patches/streamers of silver gray sheen
6-12 inches : Patches/streamers of silver gray sheen

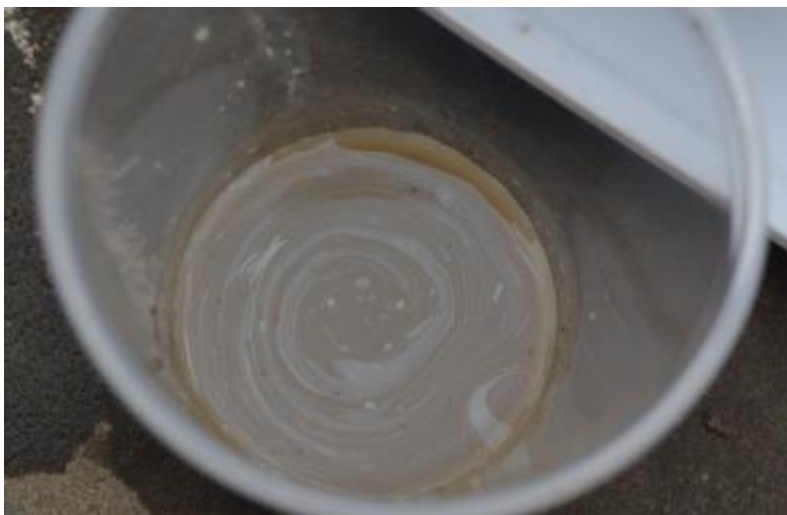
Sheen Stir-Test:

0-6 inches : Patches/streamers of silver gray sheen (Medium)

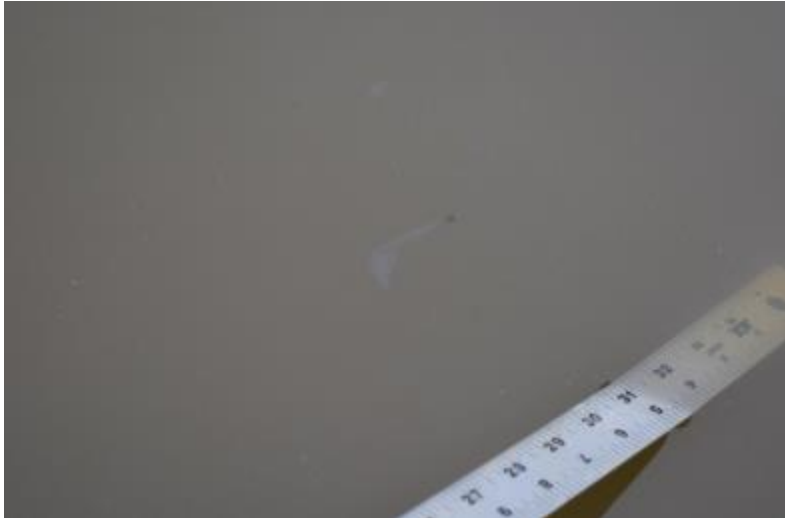
Initial Observation:

Patch/streamer of non-brittle silver gray sheen

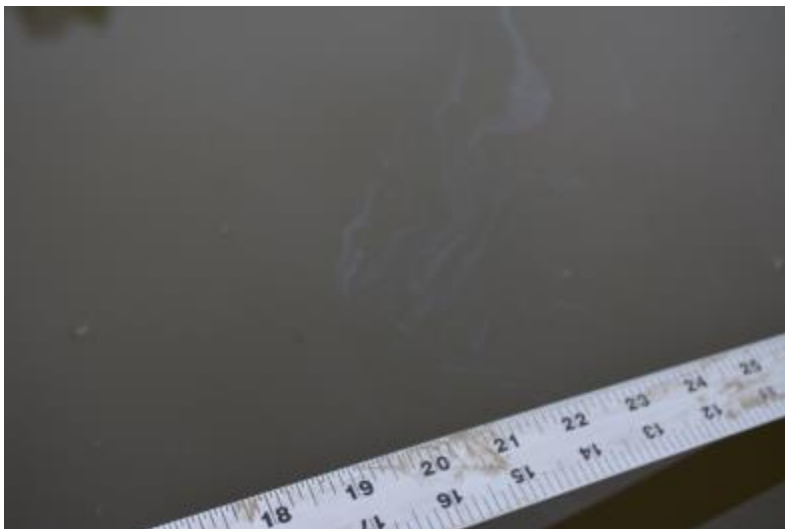
Probing Observation:

Surface : Patch/streamer of non-brittle silver gray sheen
0-6 inches : Patch/streamer of non-brittle silver gray sheen with four oil spots (0.1-inch wide)
6-12 inches : Patch/streamer of non-brittle silver gray sheen

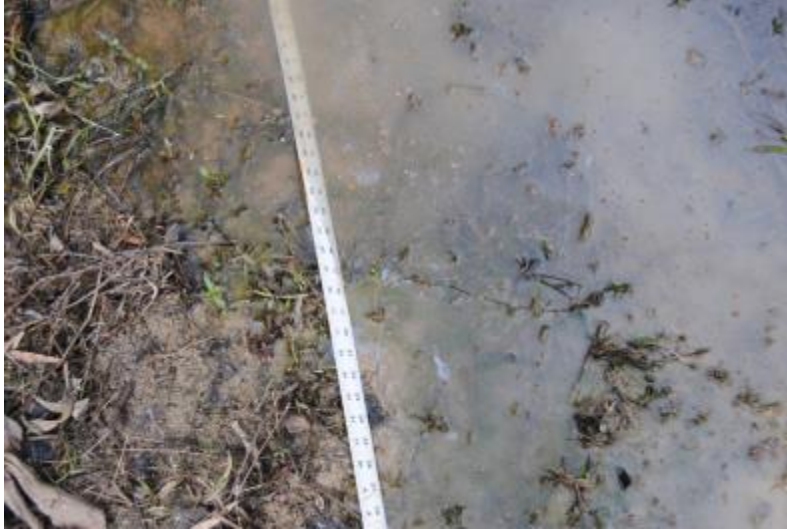
Initial Observation:

Cover/patches of brittle silver gray sheen

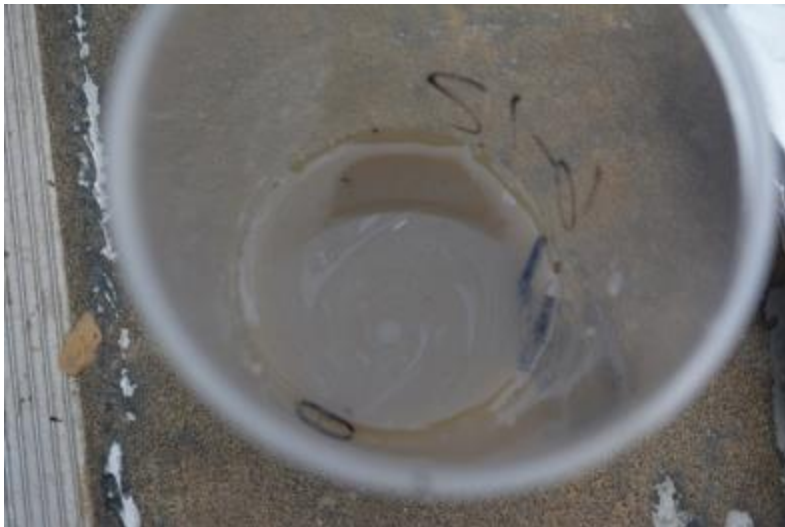
Core Description:

0-6 inches : Brown clay
6-12 inches : Brown silty clay

Sheen Stir-Test:

6-12 inches : Patches/streamers of silver gray sheen (Medium)

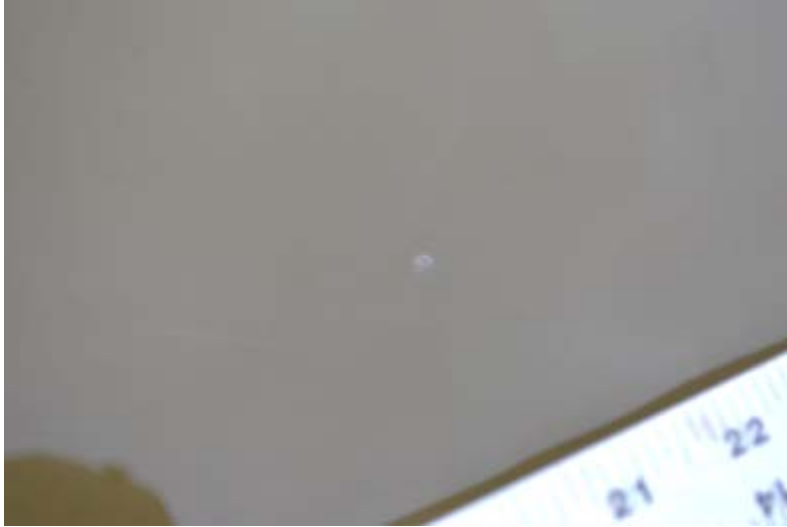
Probing Description:

0-6 inches : Patches/streamers of silver gray sheen with one oil spot (0.25-inch wide)

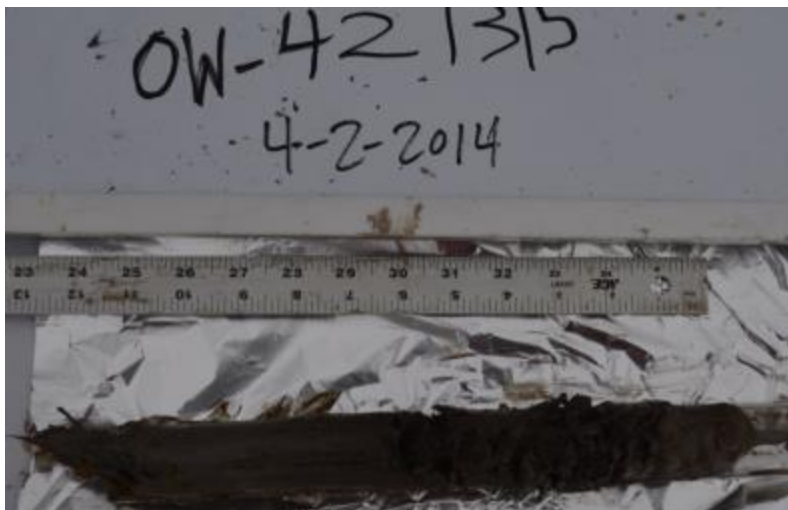
Probing Observation:

Surface : Patch/streamer of non-brittle silver gray sheen
0-6 inches : Patch/streamer of non-brittle silver gray sheen
6-12 inches : Patch/streamer of non-brittle silver gray sheen

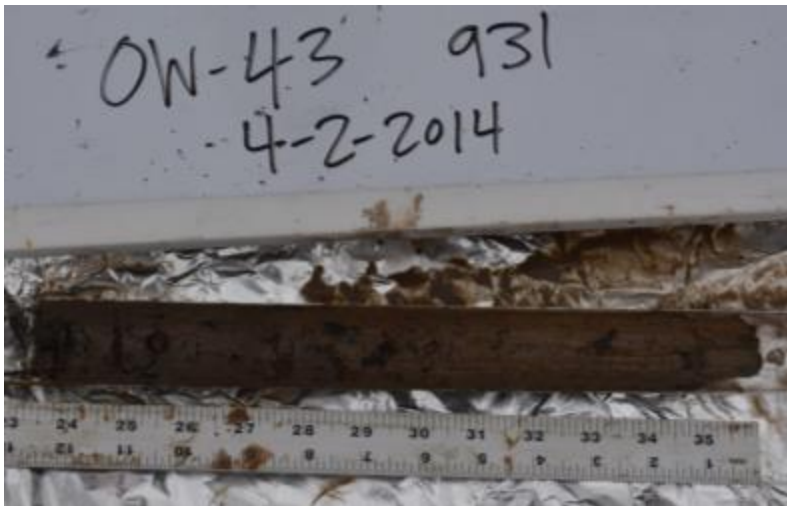
Probing Description:

0-6 inches : Patch of silver gray sheen
6-12 inches : Patch of silver gray sheen

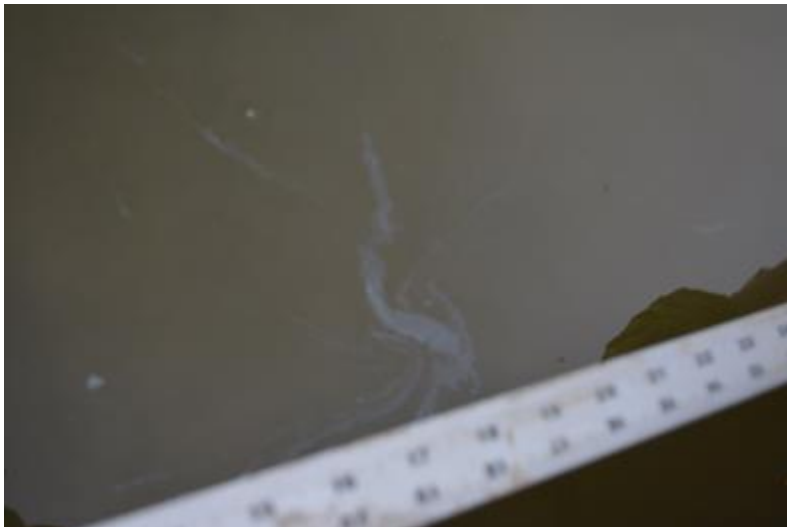
Initial Observation:

Patches/streamers of non-brittle silver gray sheen

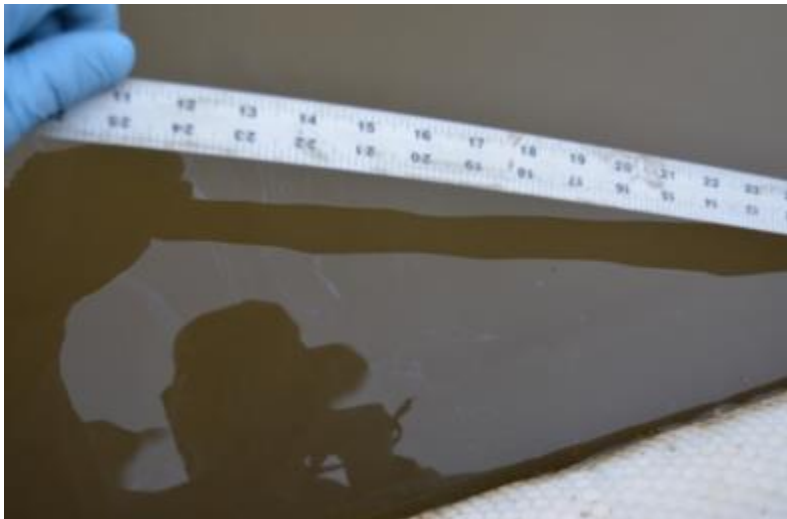
Initial Observation:

Patches (four to five) of non-brittle silver gray sheen

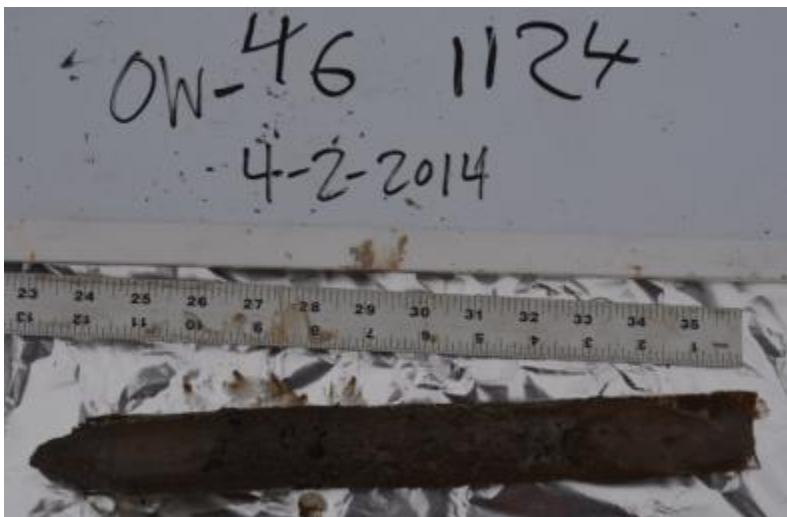
Probing Observation:

Surface : Streamers of non-brittle silver gray sheen
0-6 inches : Streamers of non-brittle silver gray sheen
6-12 inches : Streamers of non-brittle silver gray sheen

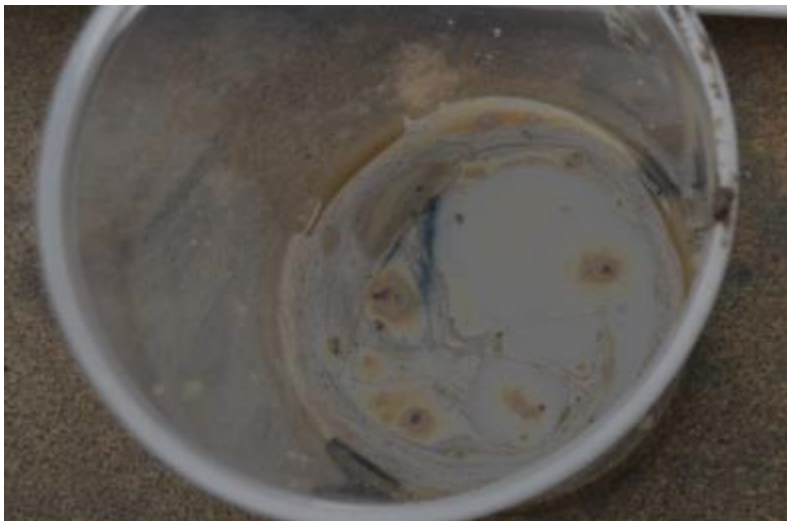
Sheen Stir-Test:

0-6 inches : Patches/streamers of rainbow sheen with oil spots (Heavier)

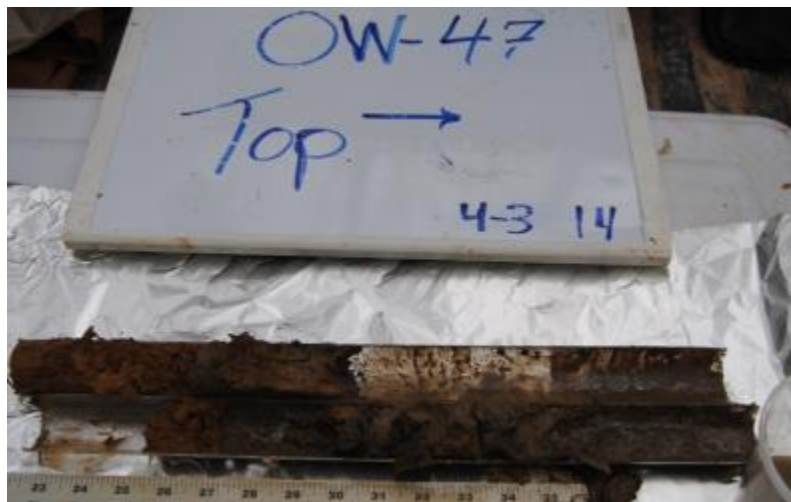
Probing Observation:

Surface : Patches of non-brittle silver gray sheen
0-6 inches : Patches of non-brittle silver gray sheen
6-12 inches : Patches of non-brittle silver gray sheen

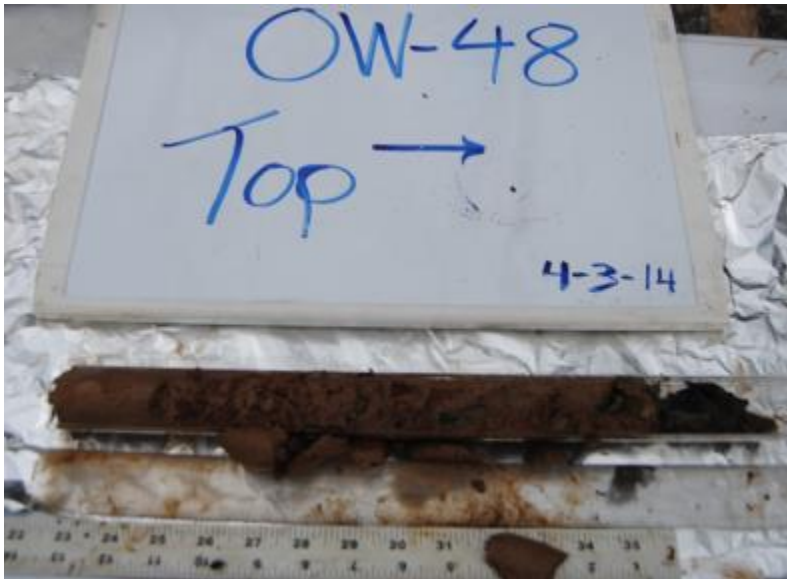
Initial Observation:

Patches/streamers of non-brittle silver gray sheen with oil spot (<0.25-inch wide)

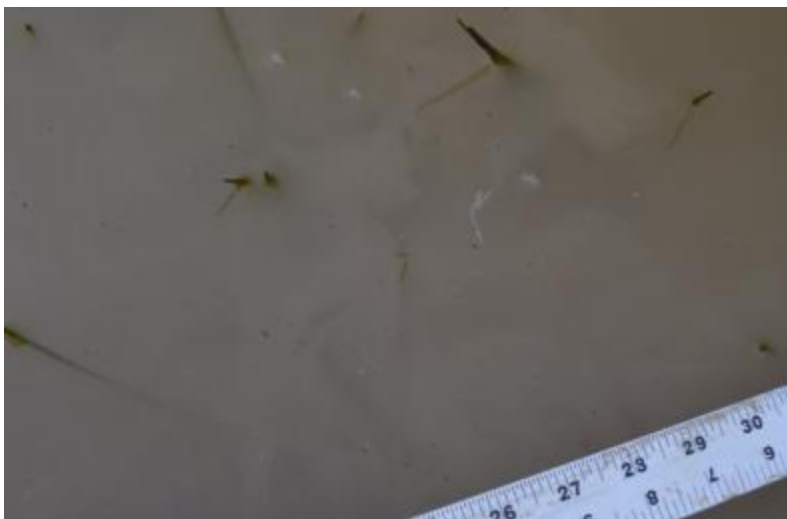
Probing Observation:

Surface : Patches of non-brittle silver gray sheen
0-6 inches : Patches of non-brittle silver gray sheen

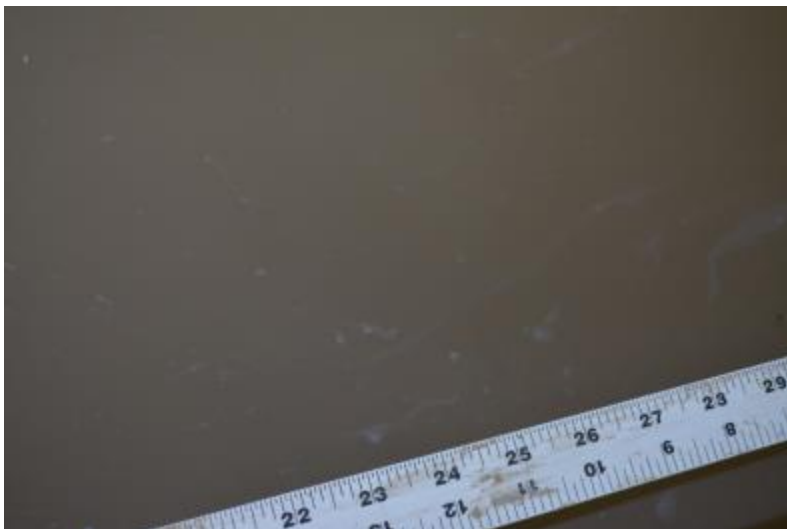
Initial Observation:

Patch/streamer of non-brittle rainbow sheen with about 100 oil spots

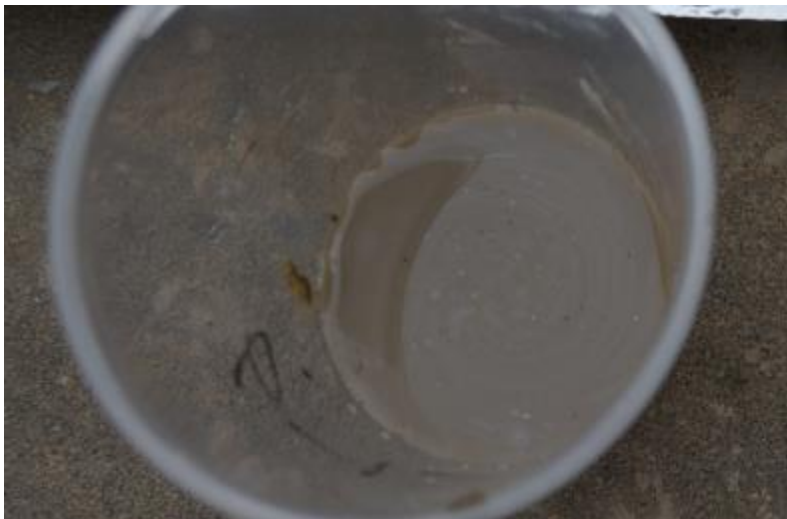
Sheen Stir-Test:

0-6 inches : Patches/streamers of rainbow sheen with oil spots (Heavier)

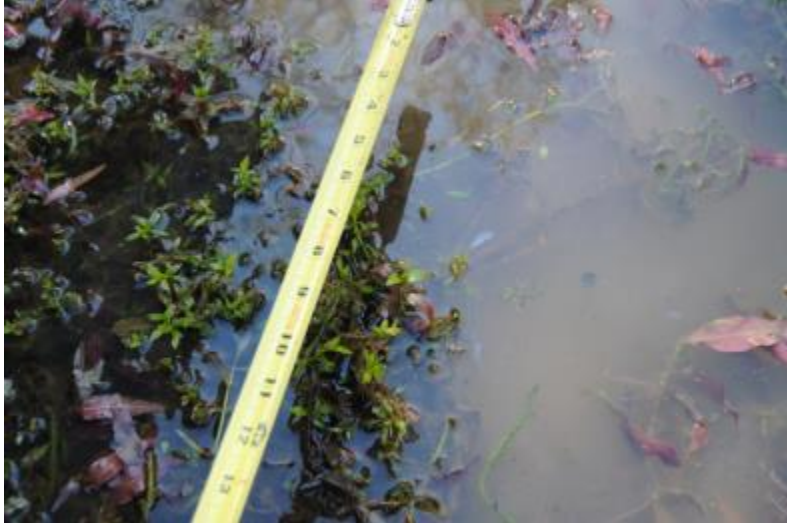
Probing Description:

0-6 inches : Streamers of non-brittle silver gray sheen
6-12 inches : Streamers of non-brittle silver gray sheen

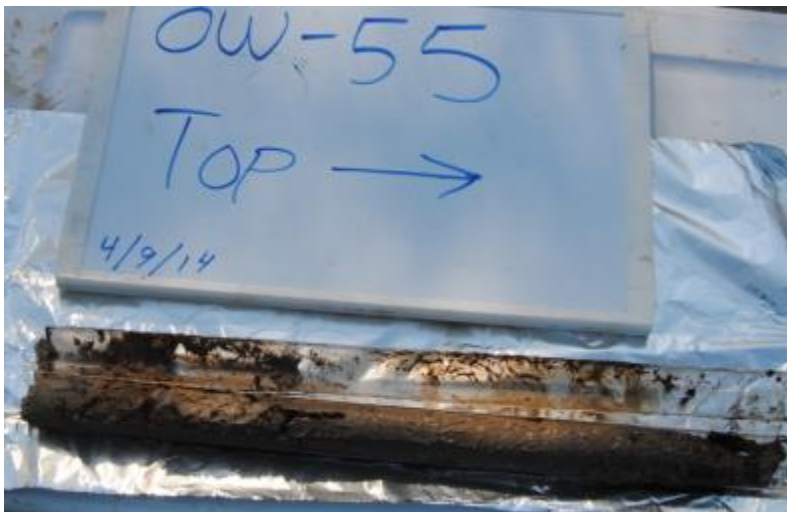
Core Description:

0-6 inches : Gray clayey silt with organic material
6-12 inches : Gray and reddish brown mottled clayey silt (MH)

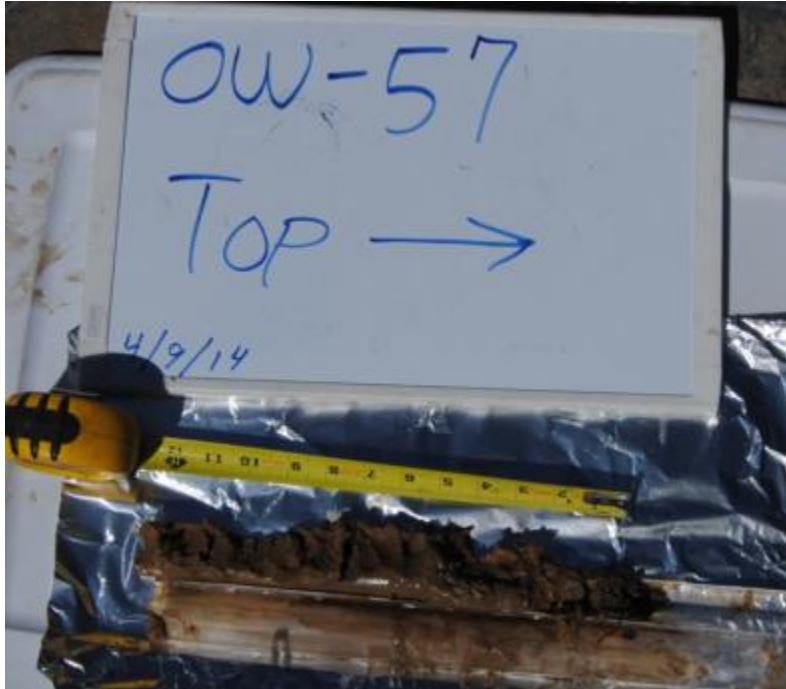
Core Description:

0-4 inches : Gray silty clay with organic material
4-12 inches : Gray and reddish brown clayey silt (MH)

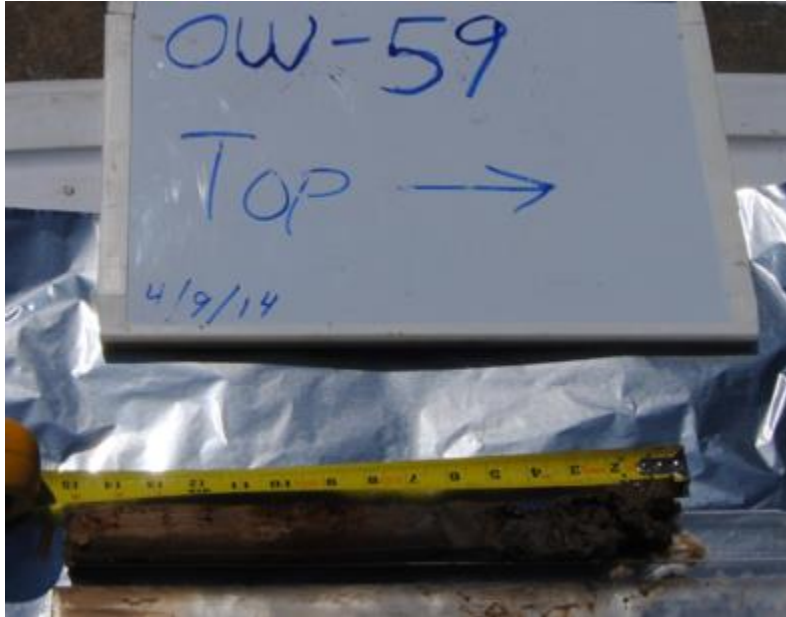
Core Description:

0-4 inches : Gray silty clay (CL) with organic material, soft
4-12 inches : Gray and reddish brown clayey silt (MH)

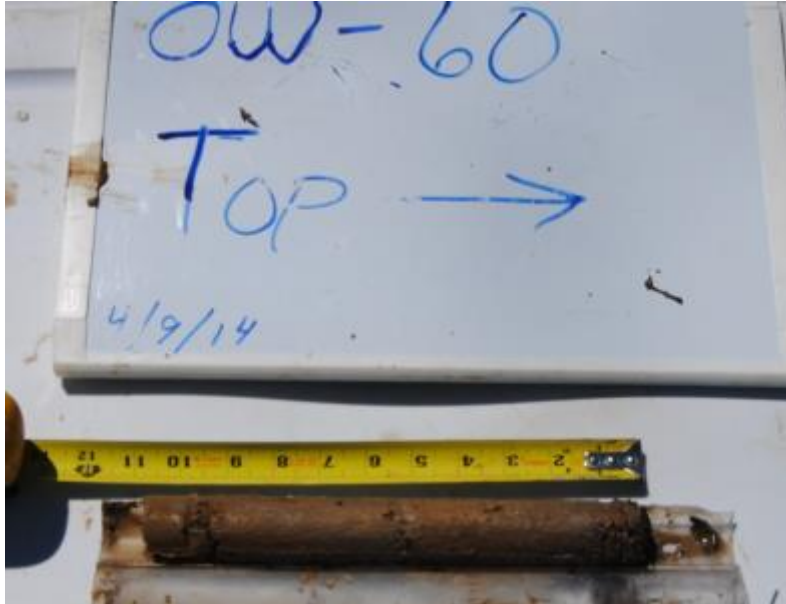
Core Description:

0-2 inches : Gray silty clay (CL) with organic material
2-10.5 inches : Gray and reddish brown clayey silt (MH)

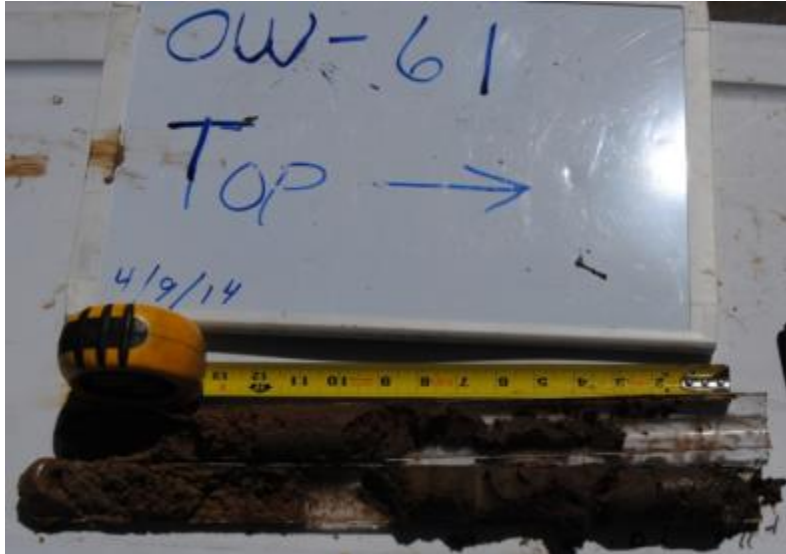
Core Description:

0-12 inches : Gray and reddish brown mottled silt with clay

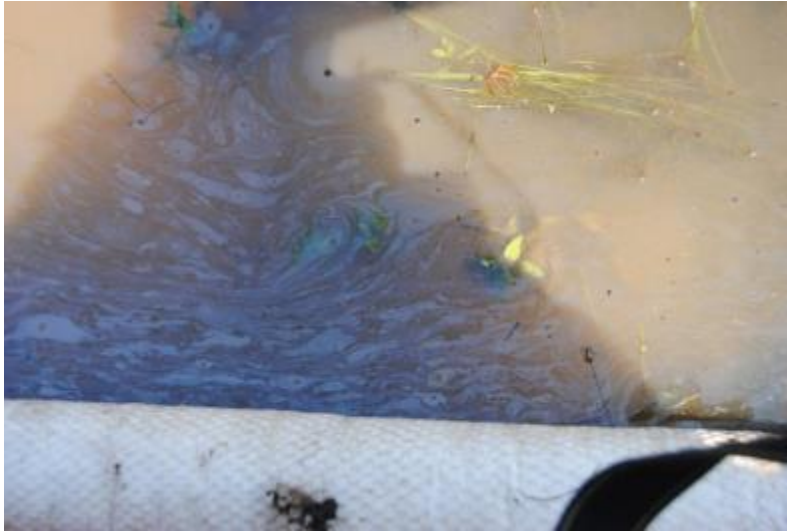
Probing Description:

Surface : Streamers of non-brittle silver gray sheen with oil spots (<0.5-inch wide)
0-6 inches : Streamers of non-brittle silver gray sheen with oil spots (<0.5-inch wide)
6-12 inches : Streamers of non-brittle silver gray sheen with oil spots (<0.5-inch wide)

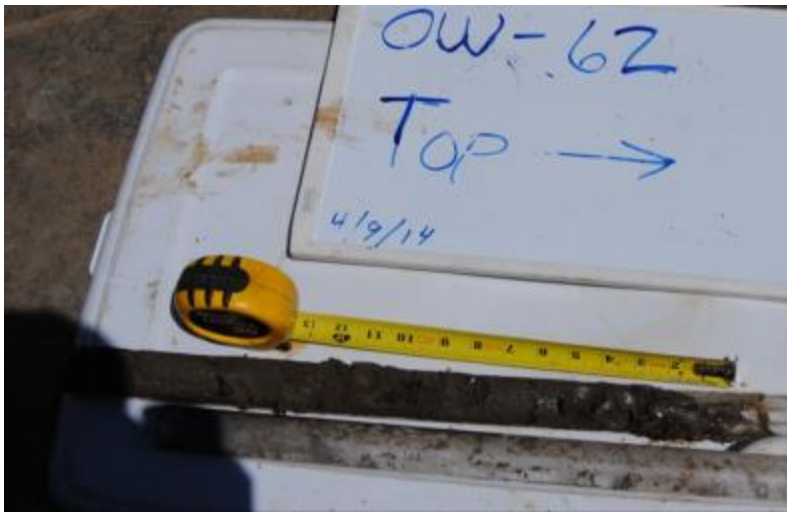
Core Description:

0-12 inches : Gray silty clay (CL), soft

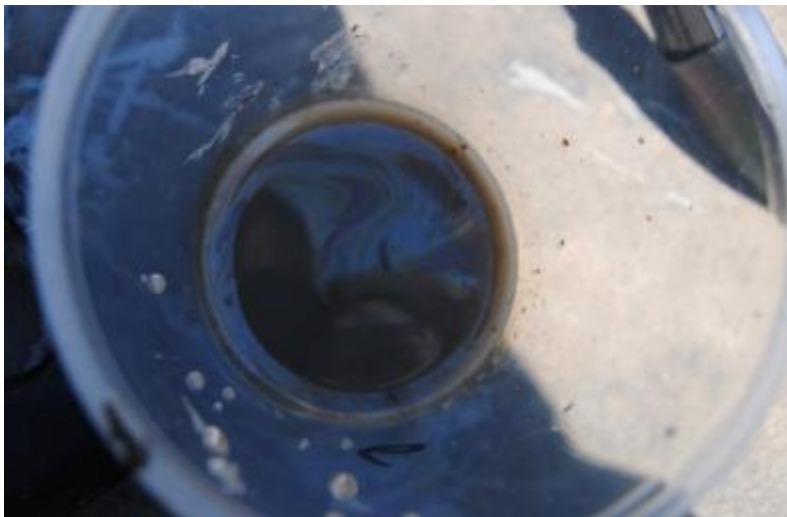
Sheen Stir-Test:

0-6 inches : Streamers of rainbow sheen (Heavier)

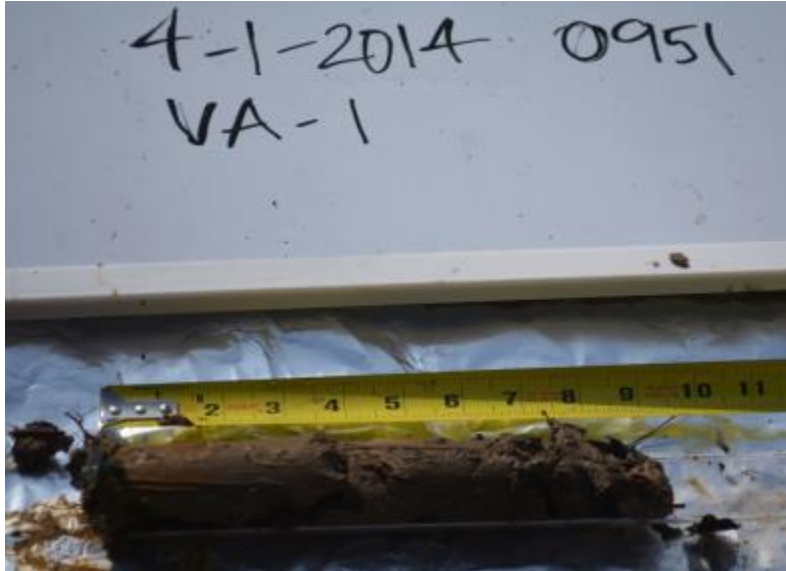
Core Description:

0-0.1 inches : Humic material with organics
0.1-6 inches : Reddish brown clay, no plasticity

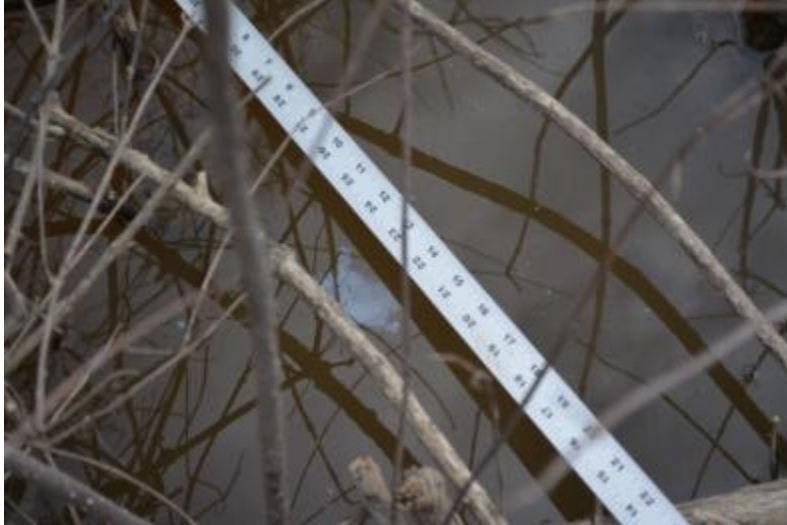
Initial Observation:

Patches of brittle silver gray sheen

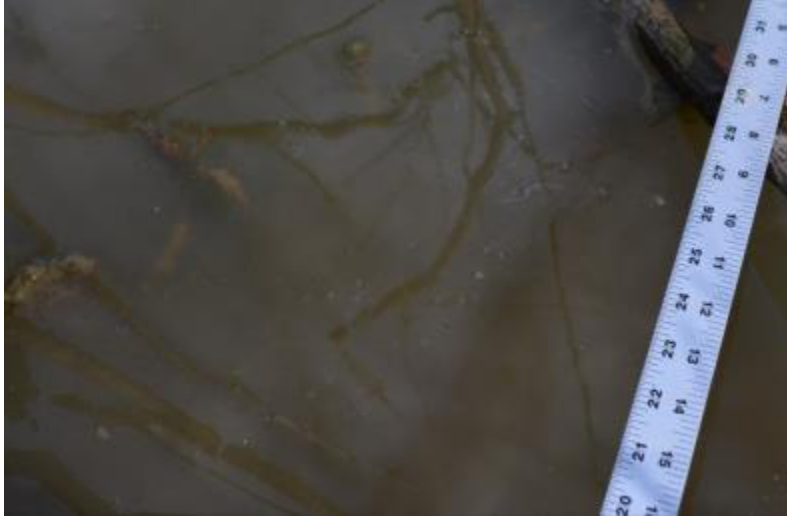
Probing Description:

Surface : Patches/streamers of non-brittle silver gray sheen (light sheen)
0-6 inches : Patches/streamers of non-brittle silver gray sheen (light sheen)

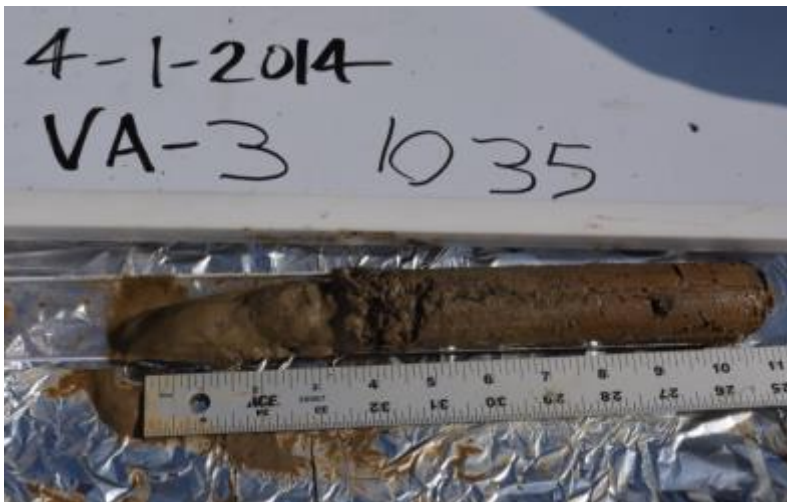
Core Description:

0-0.1 inches : Humic material with organics
0.1-6 inches : Brown silty clay with rootlets

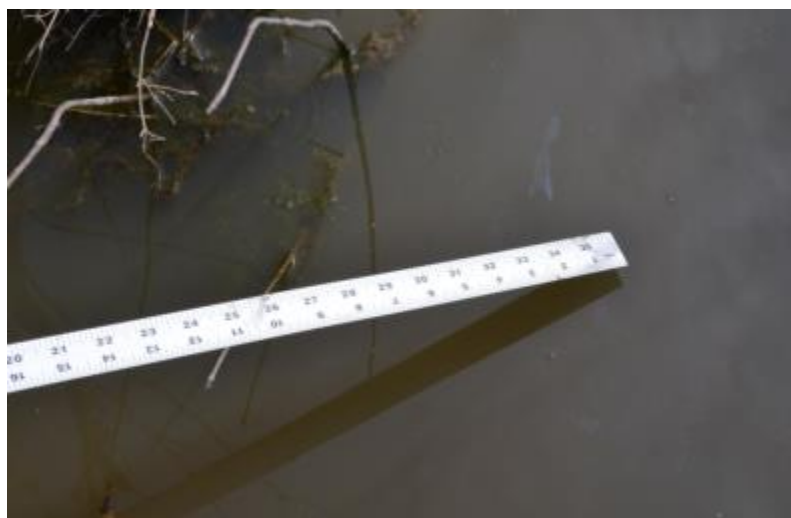
Probing Observation:

0-6 inches : Streamer (< 6") of non-brittle silver gray sheen
6-12 inches : Streamer (< 6") of non-brittle silver gray sheen (light sheen)

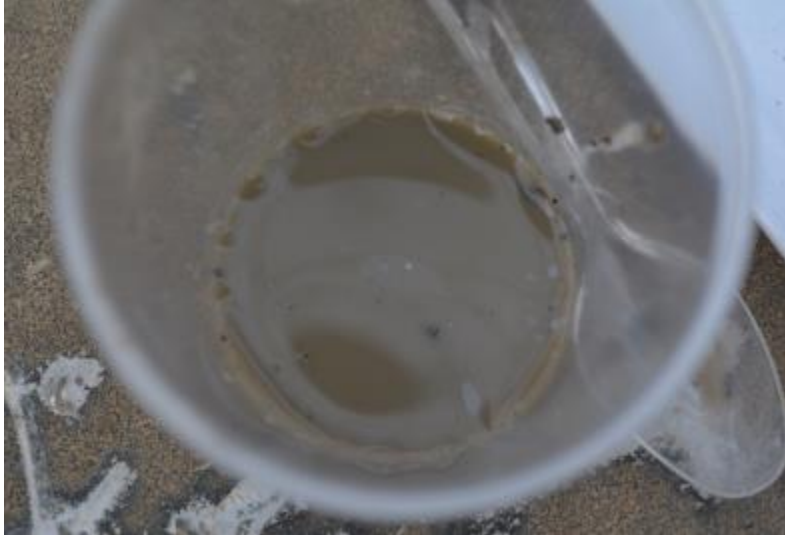
Sheen Stir-Test:

0-0.1 inches : Patches of silver gray sheen (Lighter)

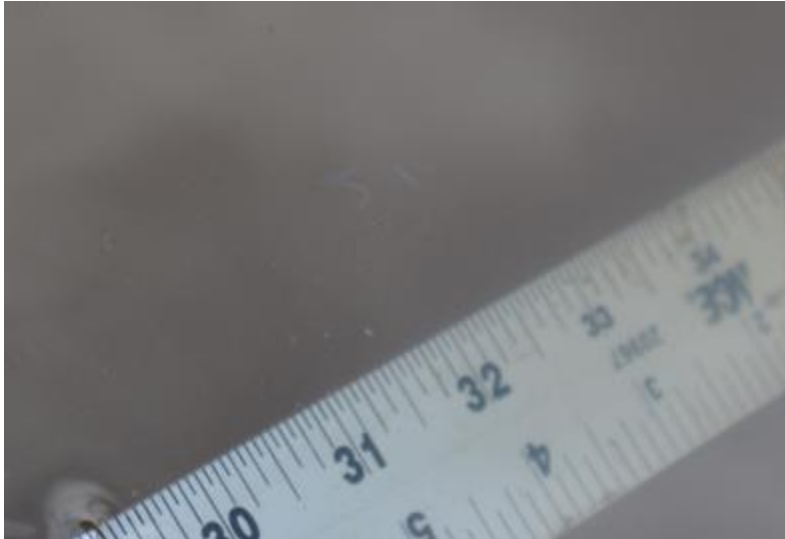
Probing Description:

6-12 inches : Patch (< 1") of non-brittle silver gray sheen

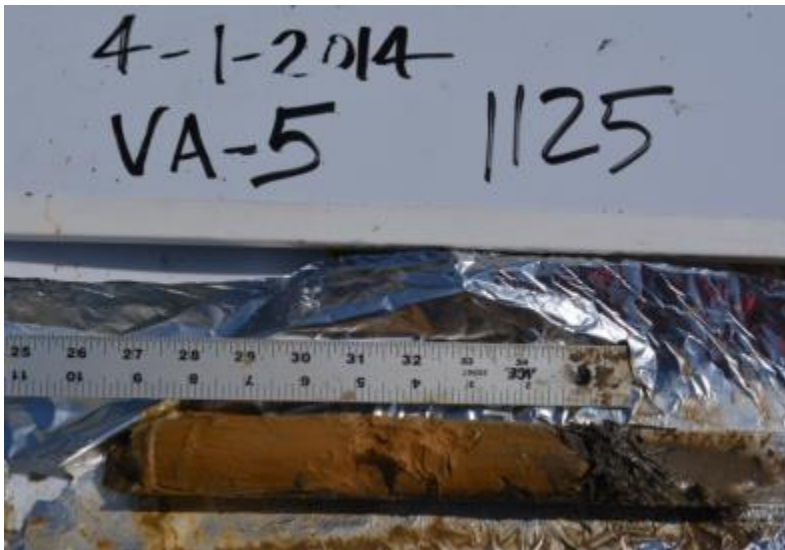
Core Description:

0-0.1 inches : Humic material with twigs
0.1-6 inches : Reddish brown clay, soft

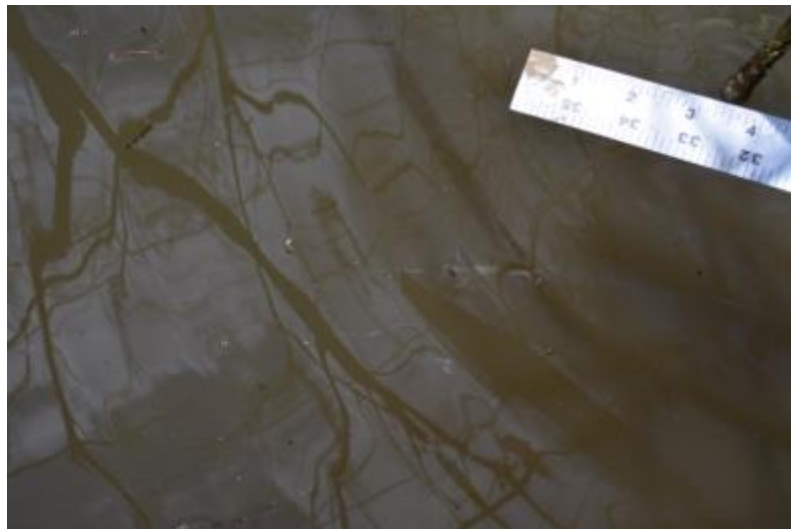
Initial Observation:

Streamer of non-brittle silver gray sheen with four oil spots (<0.1-inch)

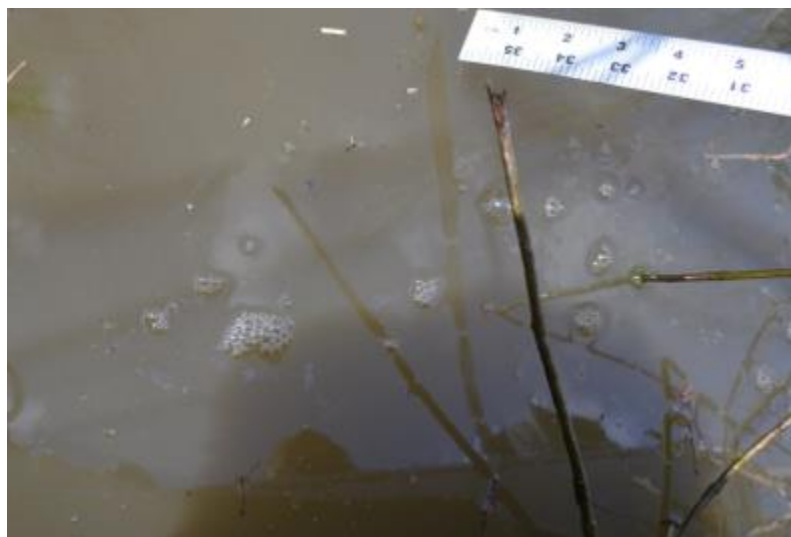
Probing Observation:

Surface : Patches/streamers of non-brittle silver gray sheen
0-6 inches : Patches/streamers of non-brittle silver gray sheen
6-12 inches : Patches/streamers of non-brittle silver gray sheen

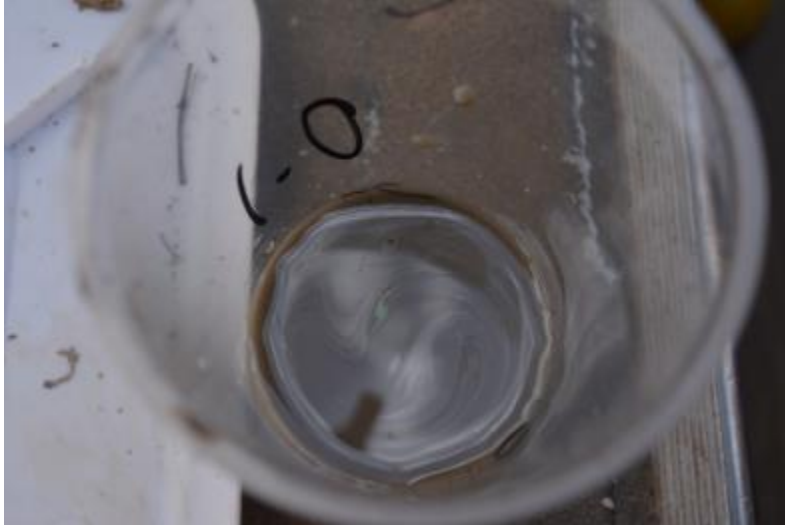
Sheen Stir-Test:

0-0.1 inches : Streamers of rainbow/silver gray sheen (Heavier)

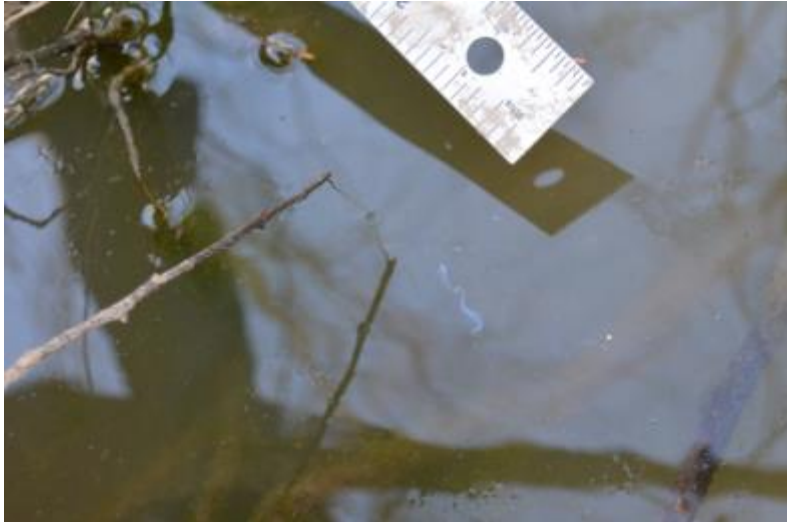
Initial Observation:

Patches/streamers of non-brittle silver gray sheen

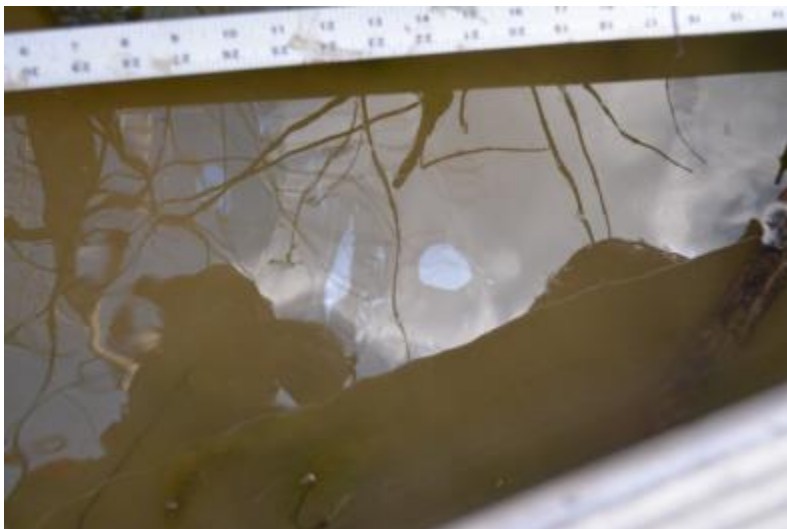
Probing Observation:

Surface : Patches/streamers of non-brittle silver gray sheen
0-6 inches : Patches/streamers of non-brittle silver gray sheen (light sheen)
6-12 inches : Patches/streamers of non-brittle silver gray sheen

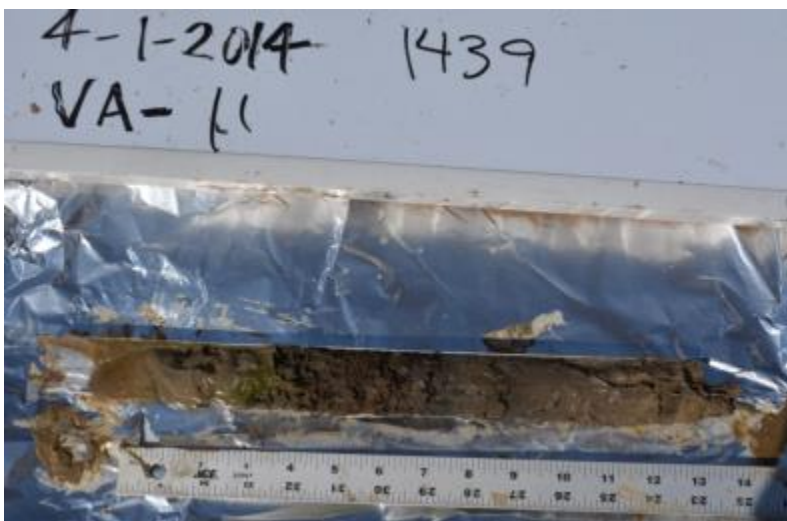
Core Description:

0-0.1 inches : Brown silt, very little visible sheen
0.1-6 inches : Silt, humic material, roots, very little sheen in 0.1-4"

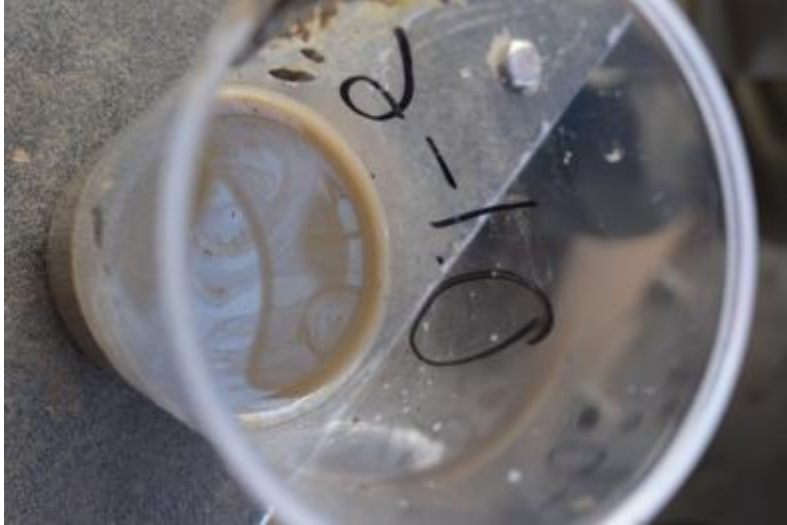
Sheen Stir-Test:

0.1-6 inches : Streamers of silver gray sheen (Medium)

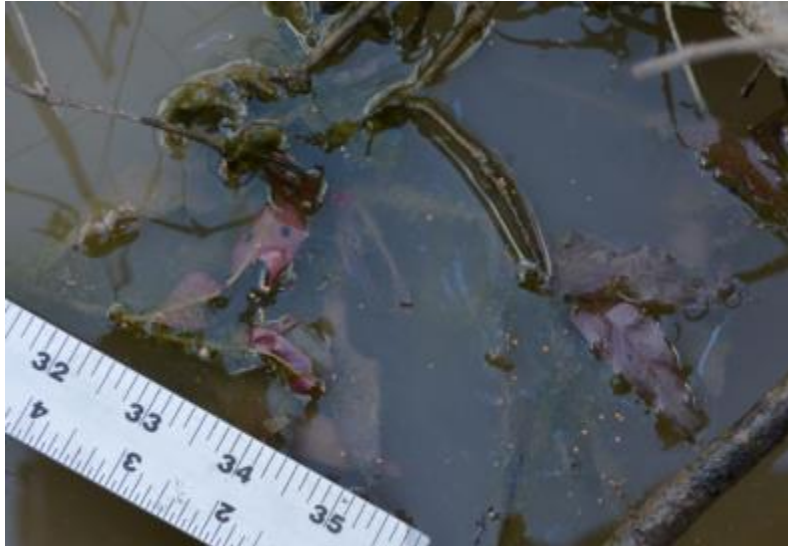
Initial Observation:

Patches/streamers of non-brittle silver gray sheen

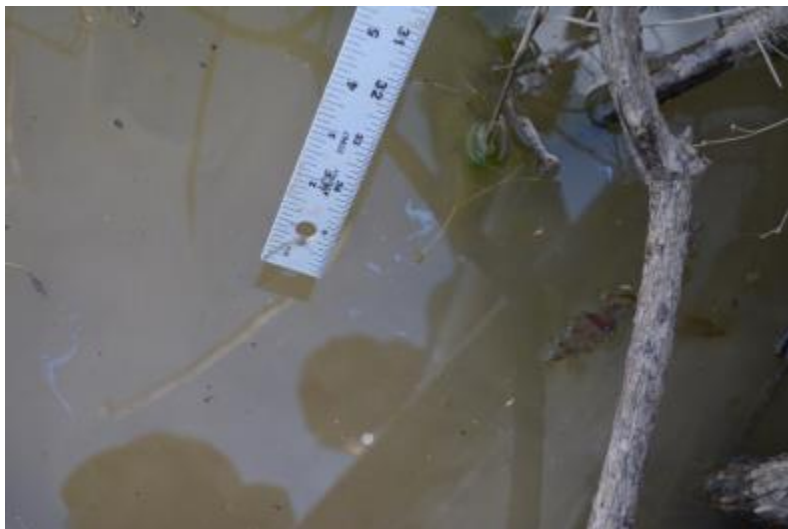
Probing Observation:

Surface : Patches/streamers of non-brittle silver gray sheen

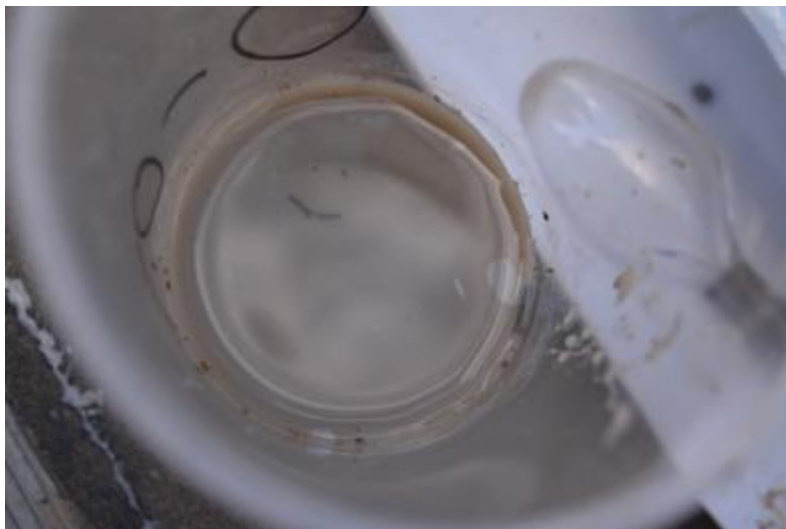
Sheen Stir-Test:

0-0.1 inches : Patches of silver gray sheen (Lighter)

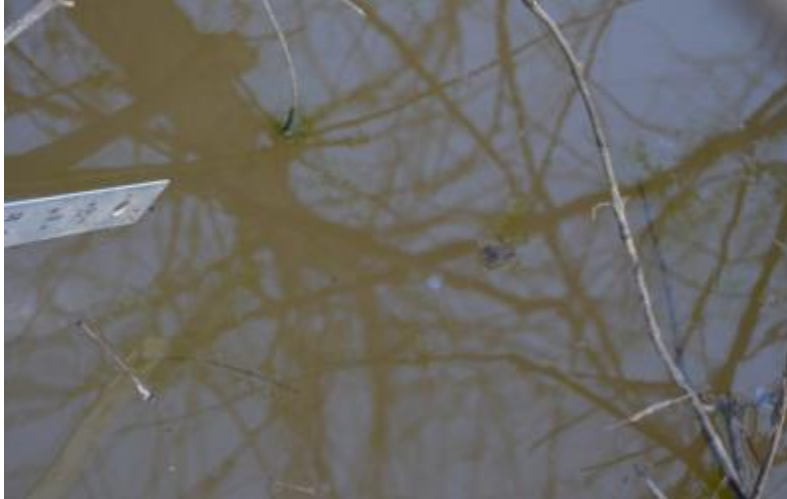
Initial Observation:

Patches of non-brittle silver gray sheen

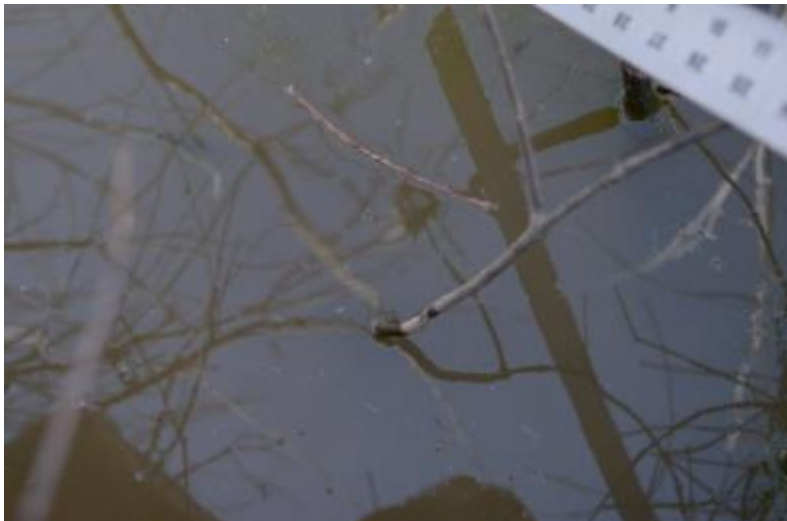
Probing Observation:

Surface : Patches of non-brittle silver gray sheen
0-6 inches : Patches of non-brittle silver gray sheen
6-12 inches : Patches/streamers of non-brittle silver gray sheen

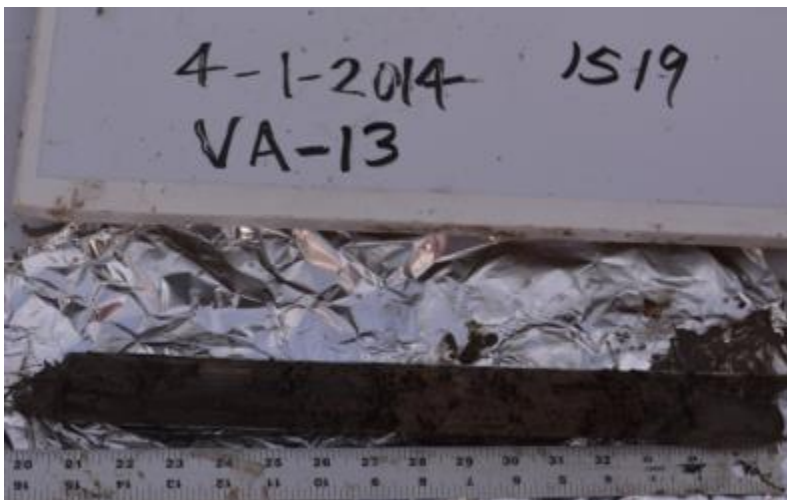
Core Description:

0-0.1 inches : Humic material with organics
0.1-6 inches : Clayey silt with roots

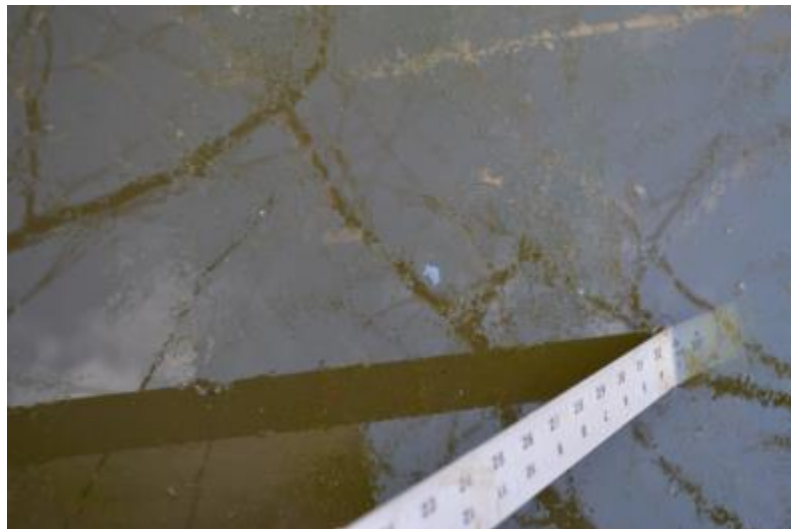
Overall Qualitative Sheening Amount:

0-0.1 inches : Lighter
0.1-6 inches : Lighter

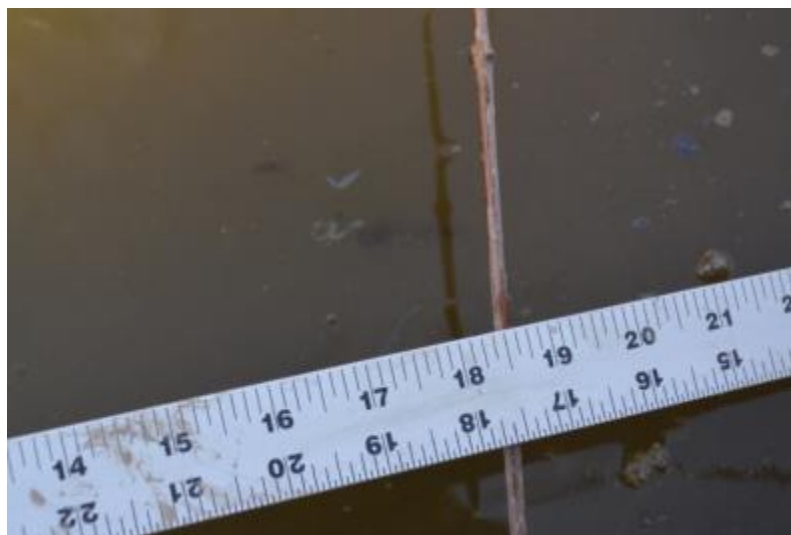
Initial Observation:

Patches/streamers of non-brittle silver gray sheen (three to four patches, one streamer)

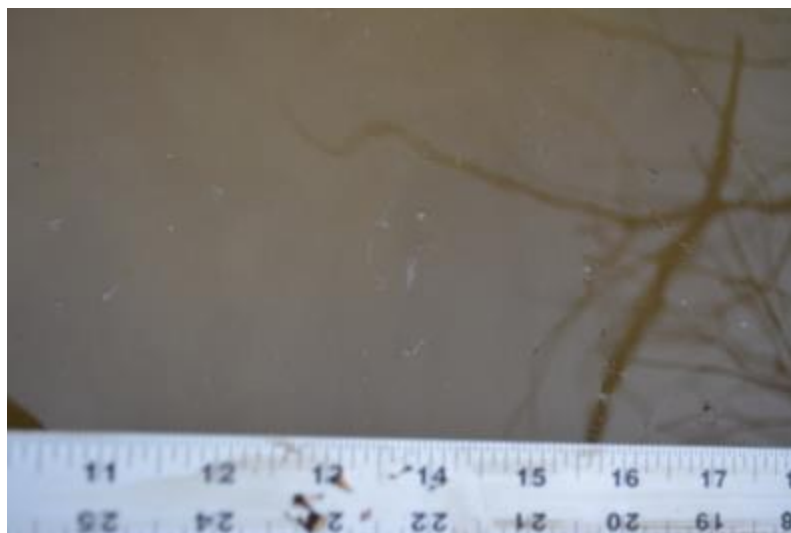
Initial Observation:

Streamers of non-brittle silver gray sheen
