**Downstream Areas Pre-Design
Study**

**Pre-Design Study
Mayflower Pipeline Incident Response, Mayflower, Arkansas**

Downstream Areas Pre-Design Study
ExxonMobil Environmental Services Company
Mayflower Pipeline Incident Response, Mayflower, Arkansas

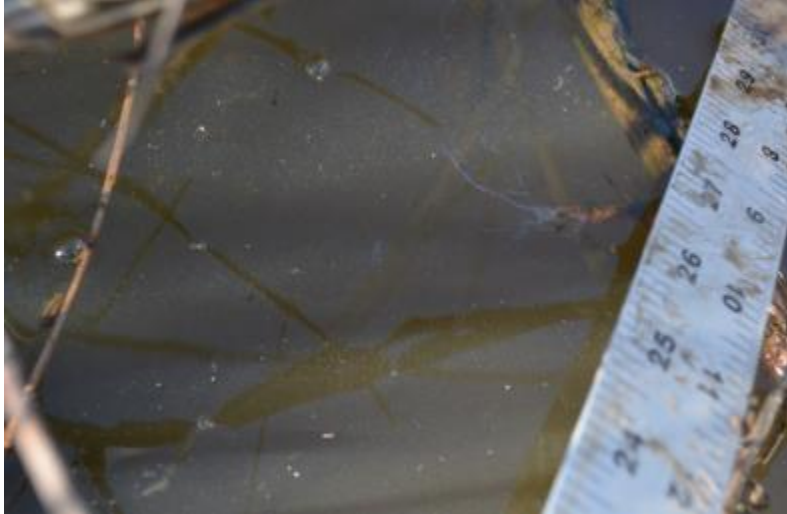
Overall Qualitative Sheening Amount:

0-0.1 inches : No Sheen
0.1-6 inches : No Sheen

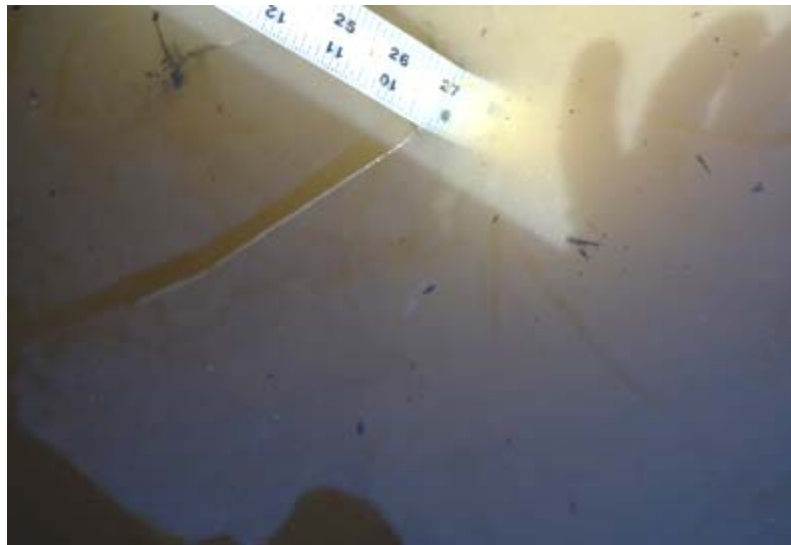
Overall Qualitative Sheening Amount:

0-0.1 inches : Lighter
0.1-6 inches : Lighter

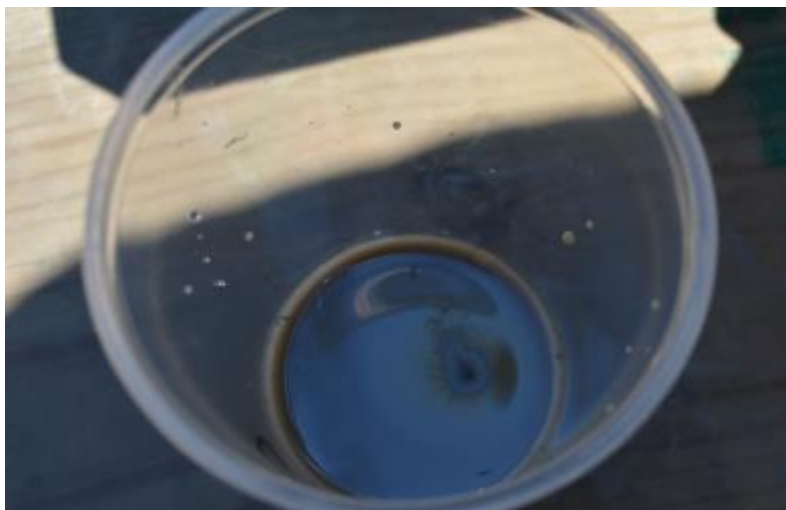
Sheen Stir-Test:

0-0.1 inches : Patches/streamers of silver gray sheen with oil spots (0.25-inch wide; Medium)

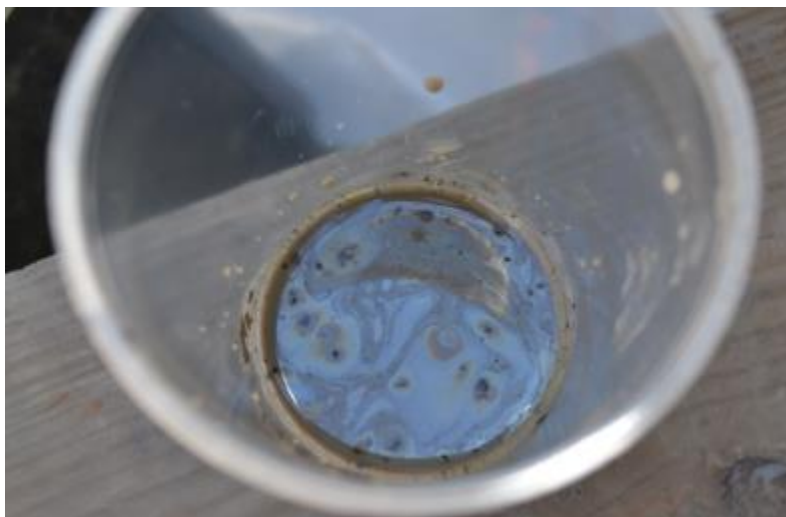
Core Description:

0-0.1 inches : Brown silt, soft, light sheen at 0-0.1"
0.1-6 inches : Brown silt, roots, light sheen at 0.1-3"

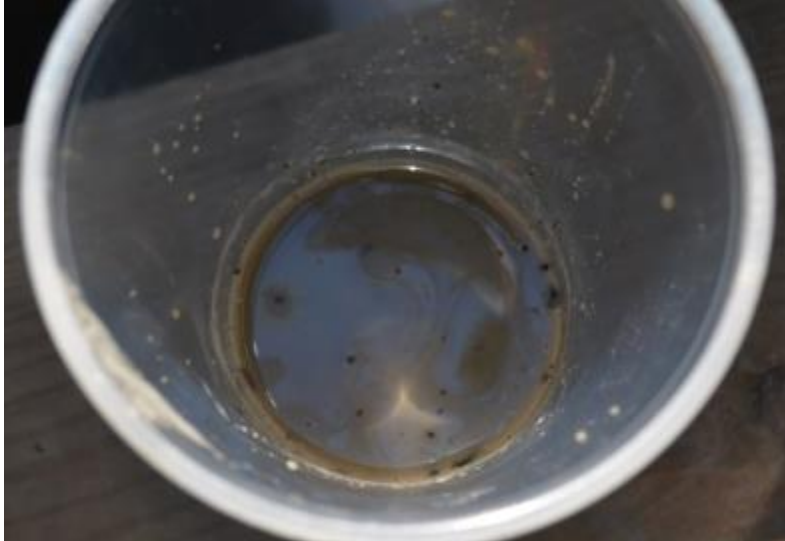
Sheen Stir-Test:

0-0.1 inches : Patches/Streamers of rainbow sheen with 10 oil spots (Heavier)

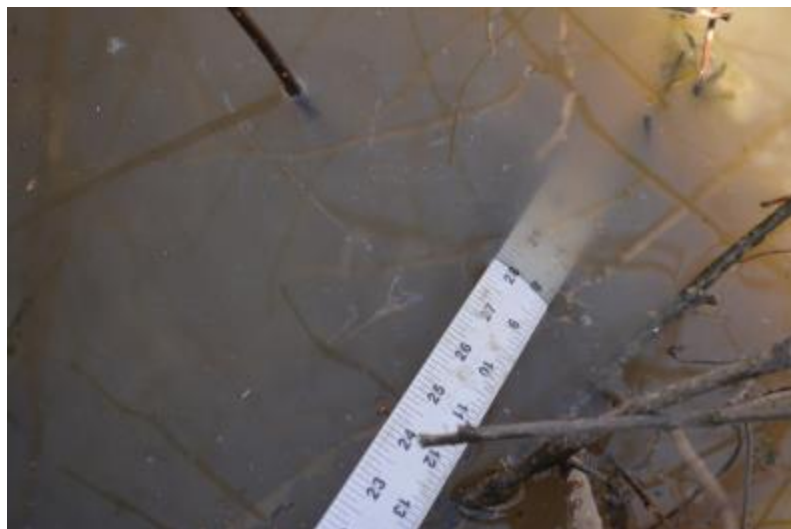
Probing Observation:

Surface : Patches of non-brittle silver gray sheen

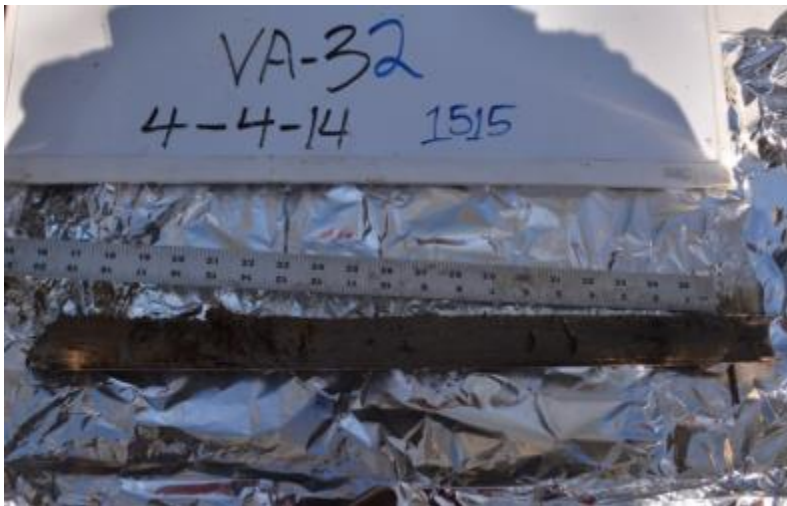
Probing Description:

6-12 inches : Streamers of non-brittle silver gray sheen
