**Downstream Areas Pre-Design
Study**

**Pre-Design Study – Revision 1
Mayflower Pipeline Incident Response, Mayflower, Arkansas**

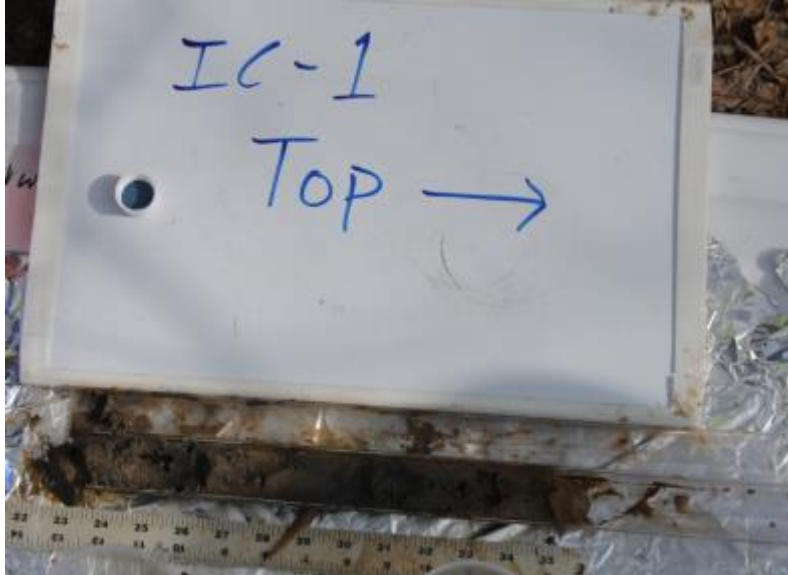
Overall Qualitative Sheening Amount:

0-6 inches : No Sheen
6-12 inches : No Sheen

Core Description:

0-3 inches : Light reddish brown silt with clay (MH)
3-12 inches : Gray silt with clay (MH)

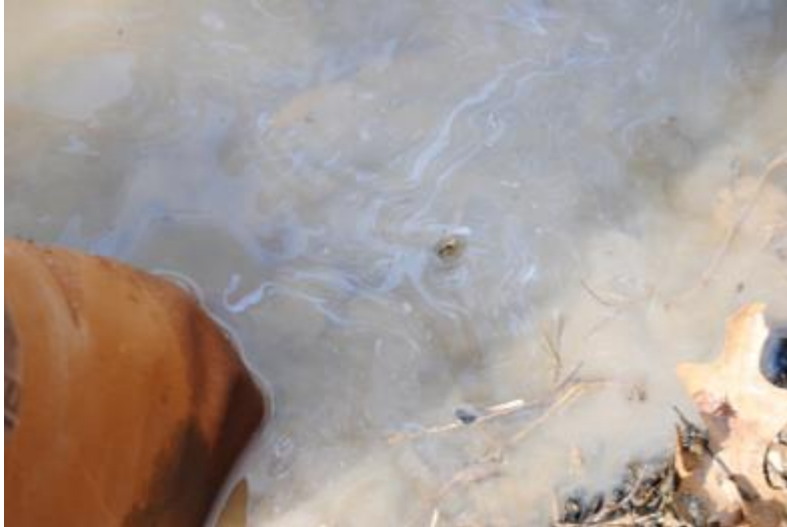
Probing Observation:

Surface : Patches/streamers of non-brittle silver gray sheen
0-6 inches : Patches/streamers of non-brittle silver gray sheen

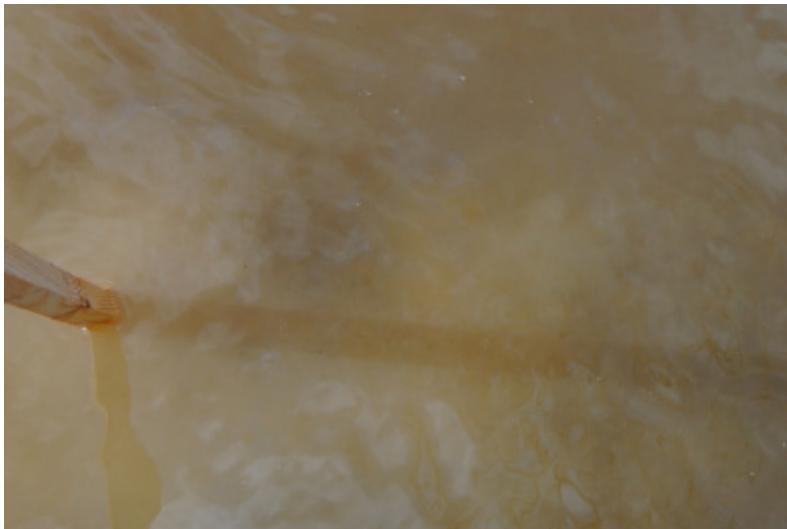
Probing Observation:

6-12 inches : Patches/streamers of non-brittle silver gray sheen with oil spots (<0.25-inch wide)

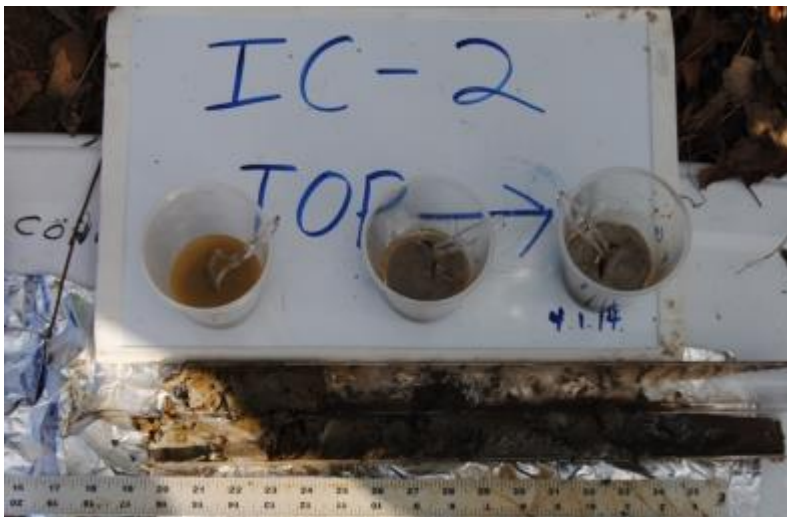
Core Description:

0-10 inches : Gray silty humic material
10-18 inches : Gray and reddish brown clayey sand (SC)

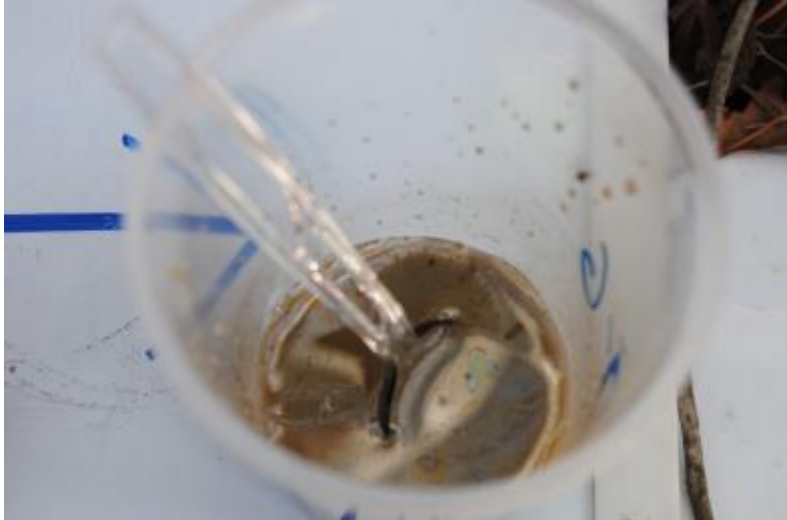
Sheen Stir-Test:

0-6 inches : Cover of rainbow sheen
(Heavier)

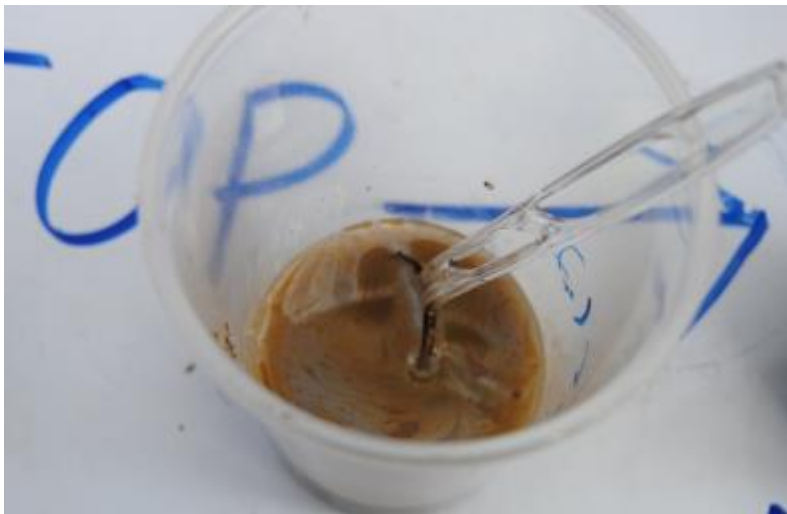
Sheen Stir-Test:

6-12 inches : Cover of rainbow sheen
(Heavier)

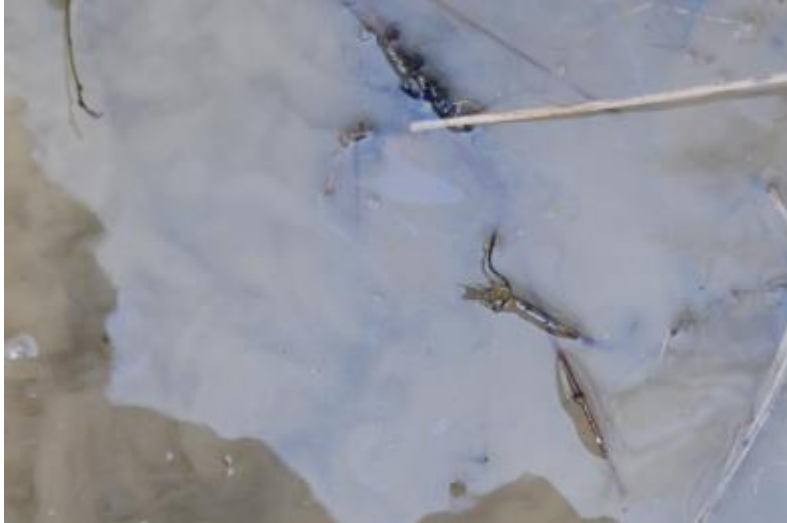
Probing Observation:

0-6 inches : Patches/streamers of non-brittle silver gray sheen

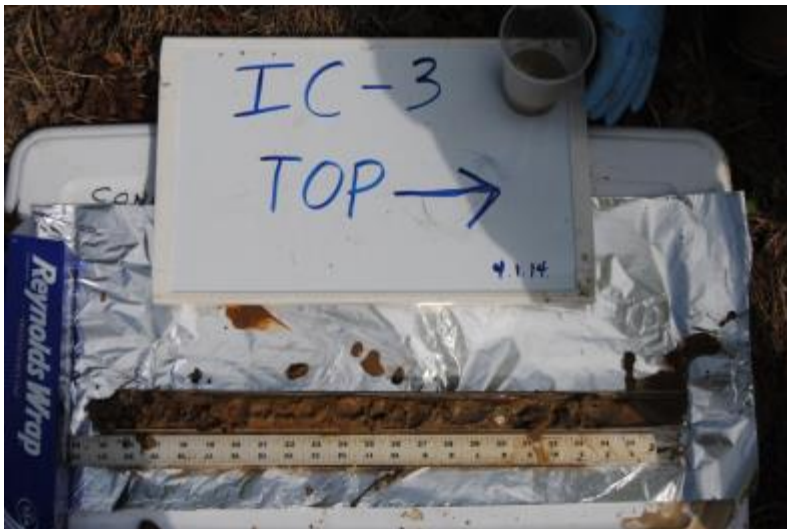
Core Description:

0-8 inches : Light brown silt (ML)
8-18 inches : Light brown silt with clay

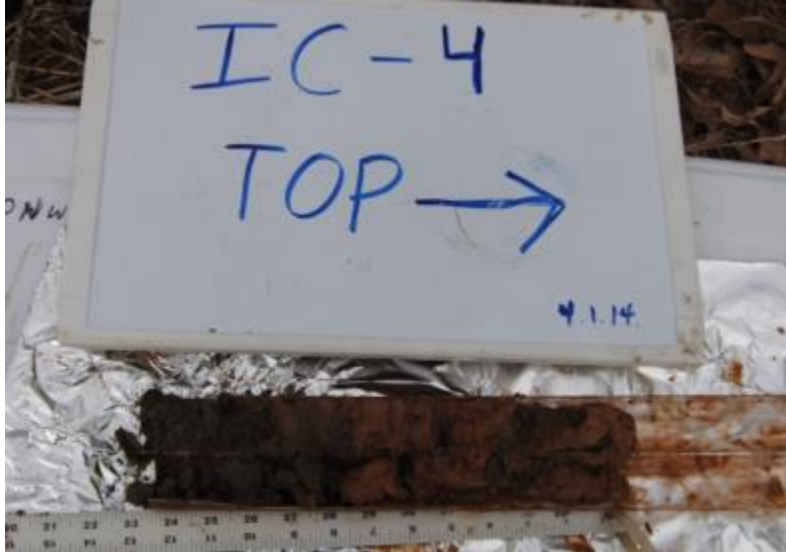
Core Description:

0-8 inches : Reddish brown silty clay (CL), soft
8-12 inches : Gray clayey sand (SC)

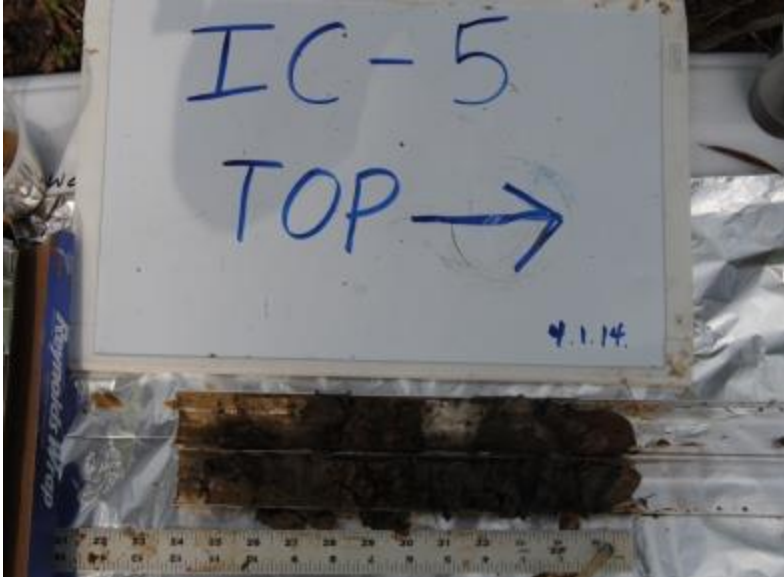
Core Description:

0-6 inches : Gray humic material with clay, soft
6-9 inches : Coarse sand (SW)
9-12 inches : Gray clayey sand

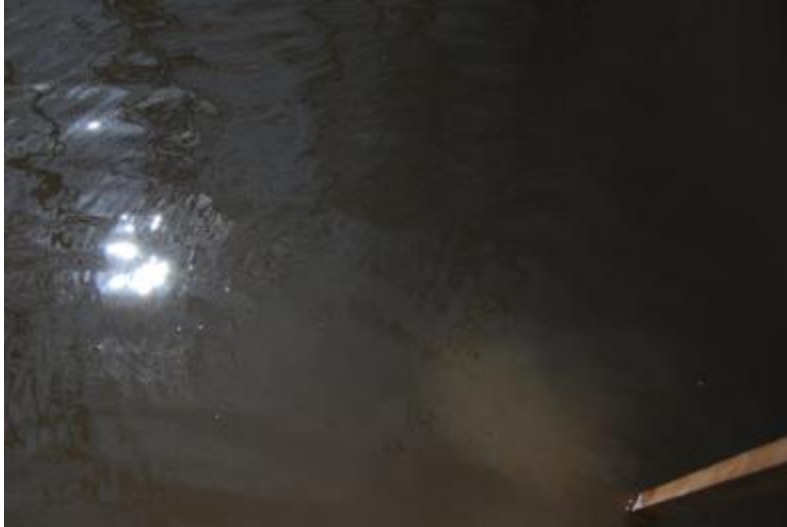
Probing Observation:

0-6 inches : Patches of non-brittle silver gray sheen
6-12 inches : Patches of non-brittle silver gray sheen

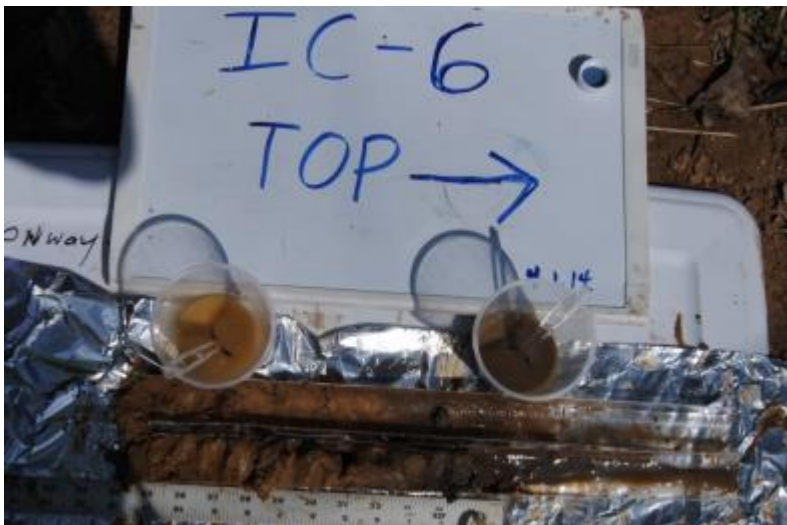
Core Description:

0-3 inches : Gray silt with humic material
3-12 inches : Light reddish brown and gray mottled silty sand (SM), very firm sand

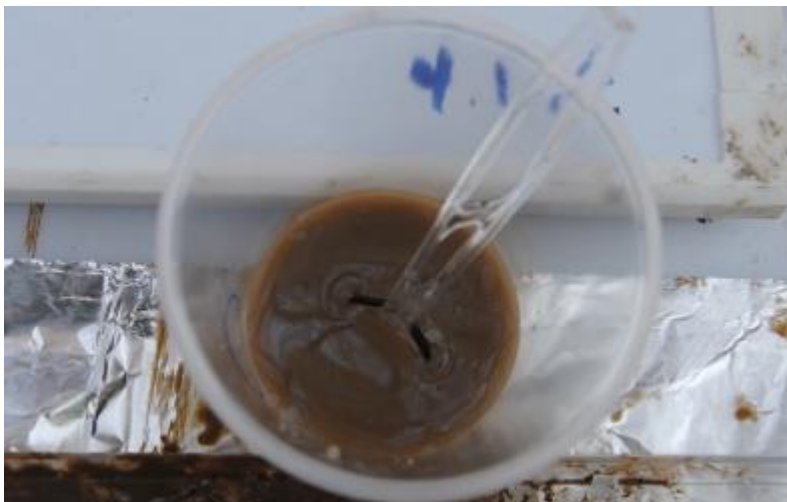
Sheen Stir-Test:

0-6 inches : Streamers of silver gray sheen (Medium)

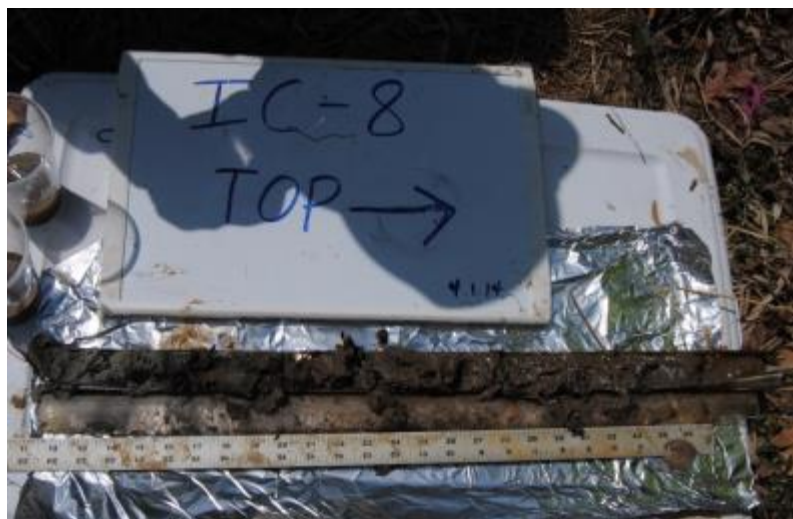
Core Description:

0-20 inches : Gray silty clay (CL) with humic material, soft
20-24 inches : Gray clayey silt (MH)

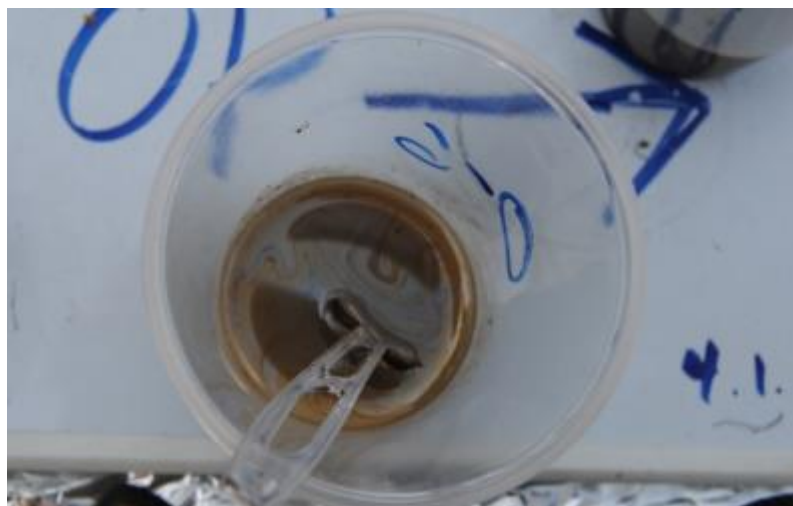
Sheen Stir-Test:

0-6 inches : Cover of rainbow sheen (Heavier)

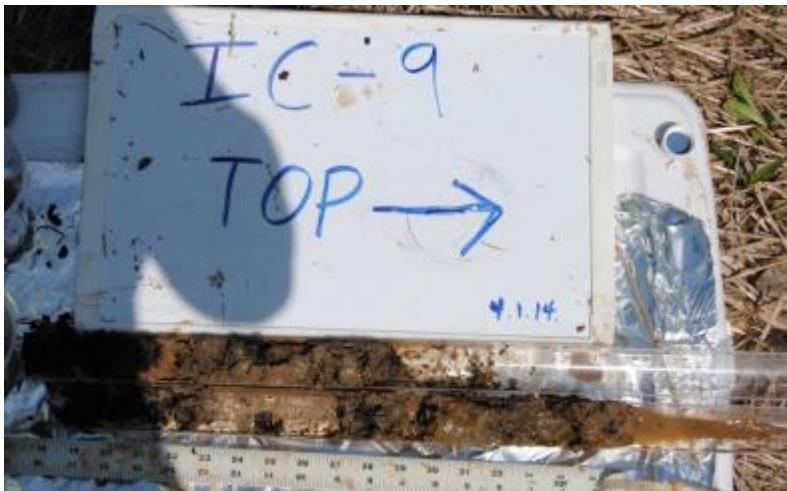
Core Description:

0-14 inches : Coarse sand (SW) with humic material
14-18 inches : Black wood

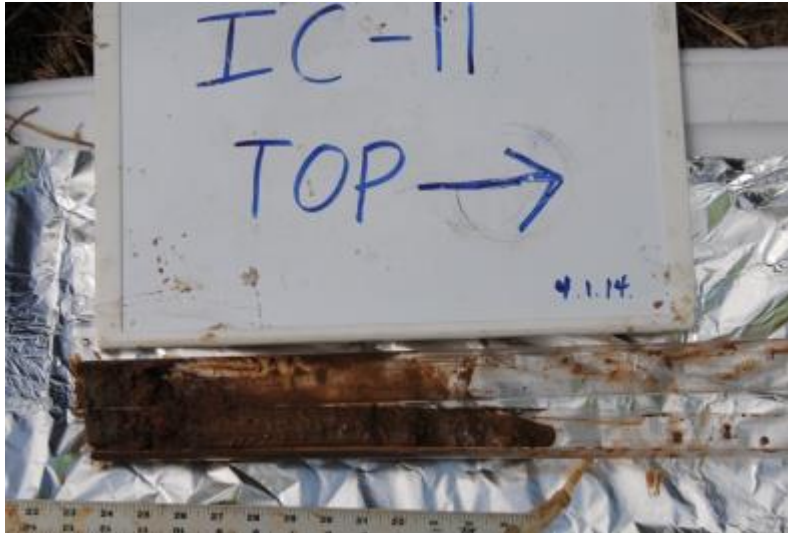
Core Description:

0-12 inches : Reddish brown silty clay (CL), soft
12-15 inches : Silty clay with woody material

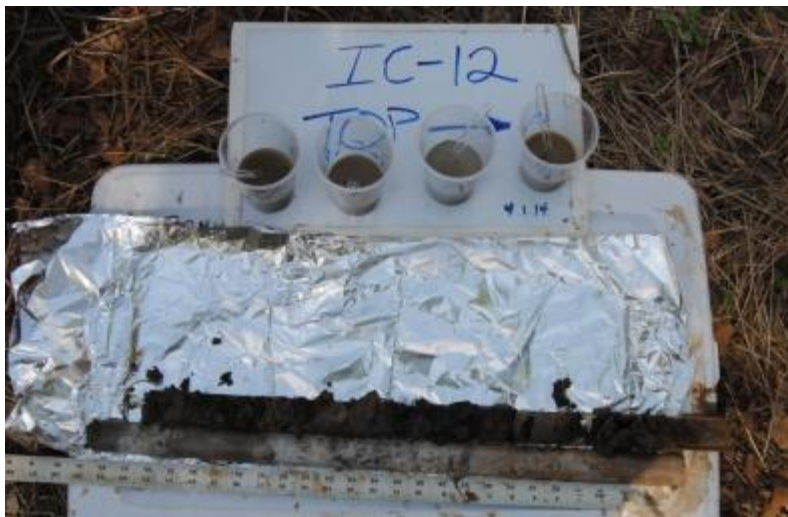
Core Description:

0-24 inches : Gray silty clay with humic material

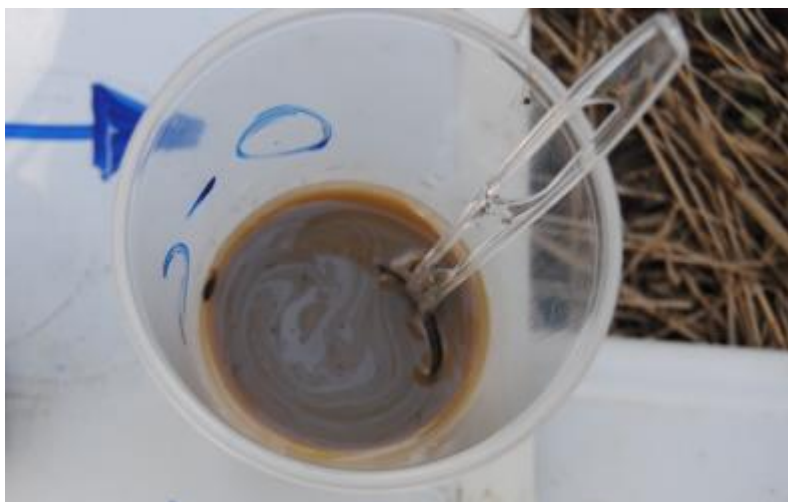
Sheen Stir-Test:

0-6 inches : Streamers of silver gray sheen (Medium)

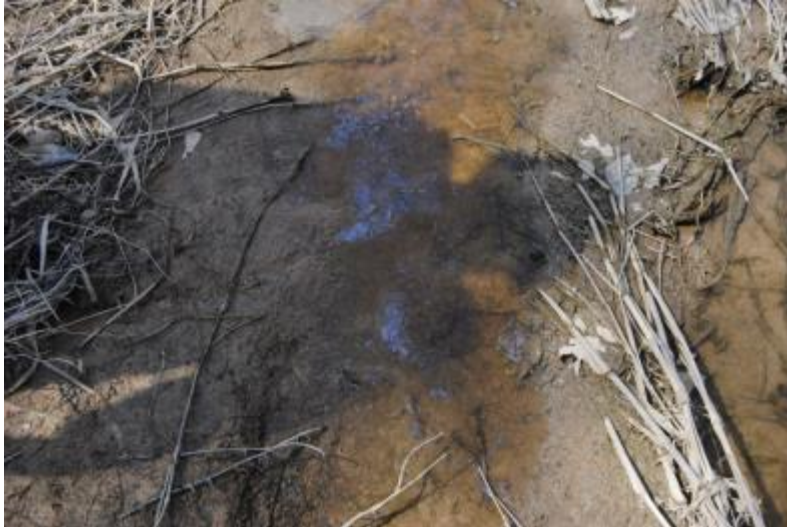
Initial Observation:

Patches of brittle silver gray sheen

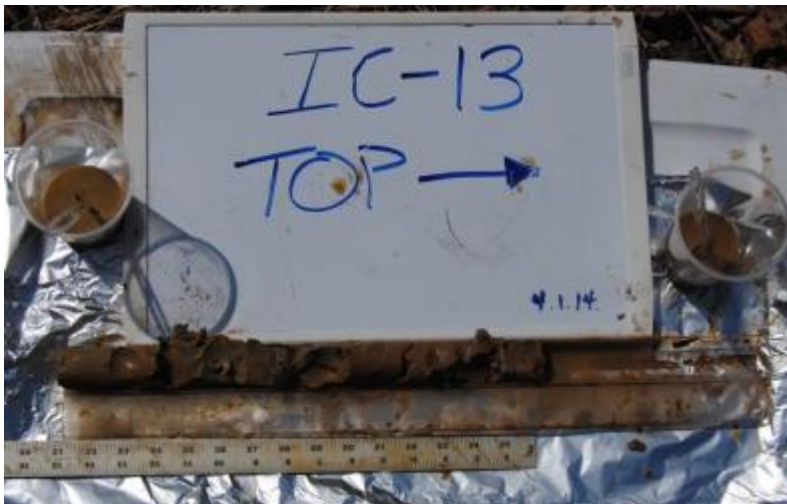
Core Description:

0-12 inches : Gray clayey silt (MH) with humic material at 0-5"

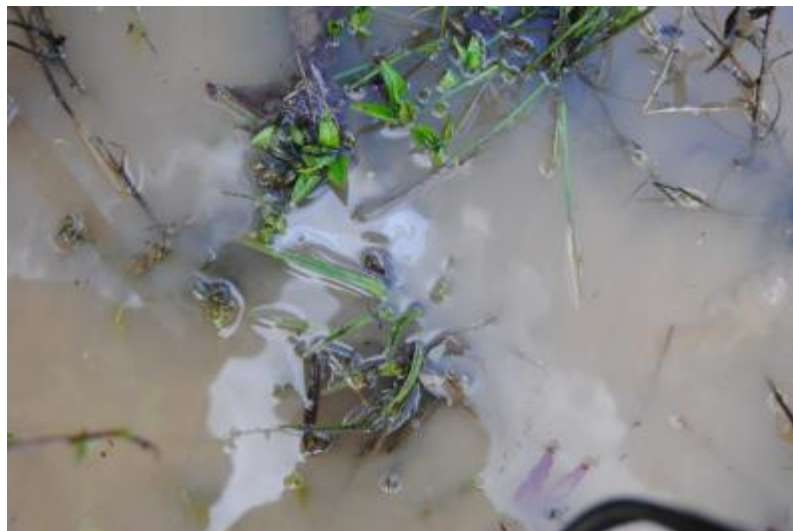
Probing Observation:

0-6 inches : Patches/streamers of non-brittle silver gray sheen (quickly dissipated)
6-12 inches : Patches/streamers of non-brittle silver gray sheen (quickly dissipated)

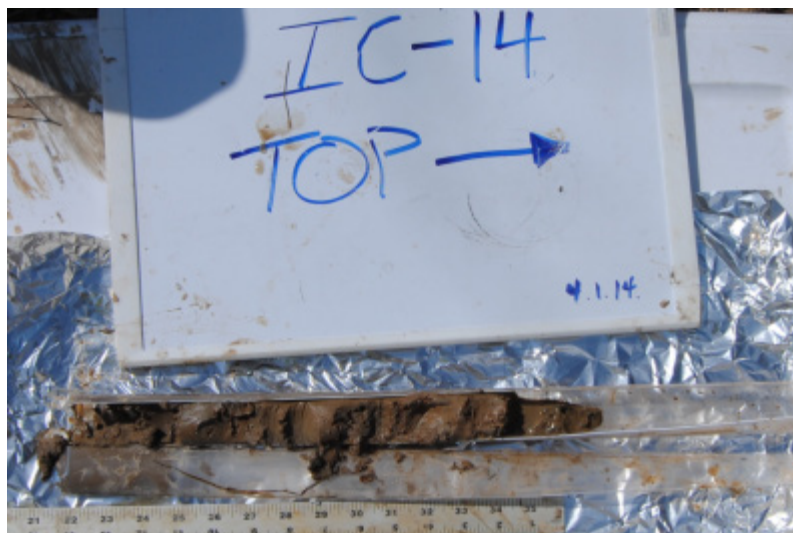
Core Description:

0-14 inches : Gray and reddish brown silty clay (CL), soft

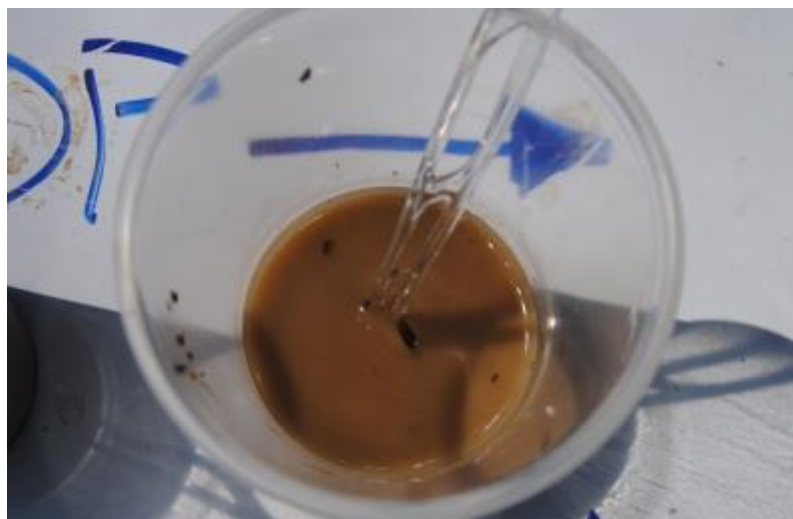
Sheen Stir-Test:

0-6 inches : Streamer of silver gray sheen (Lighter)

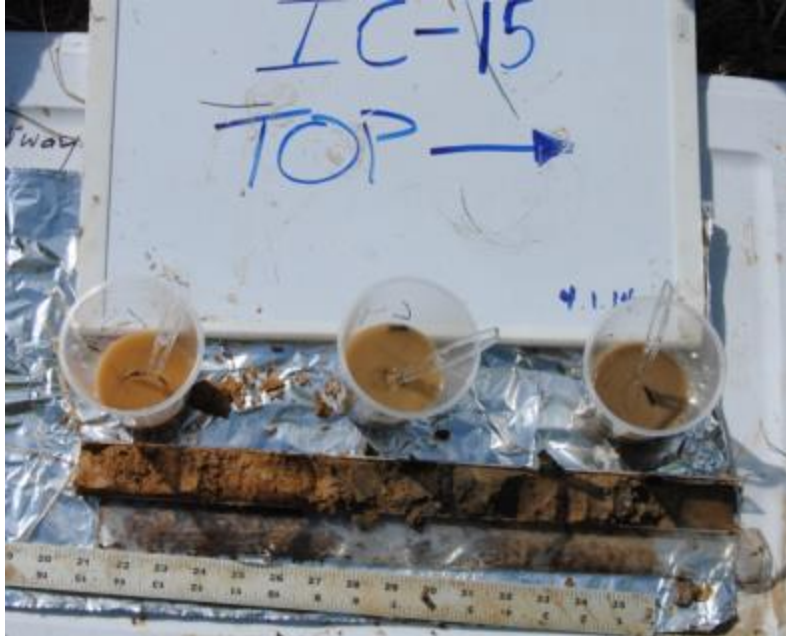
Core Description:

0-10 inches : Gray silty clay with humic material
10-15 inches : Light brown silt with clay (MH)

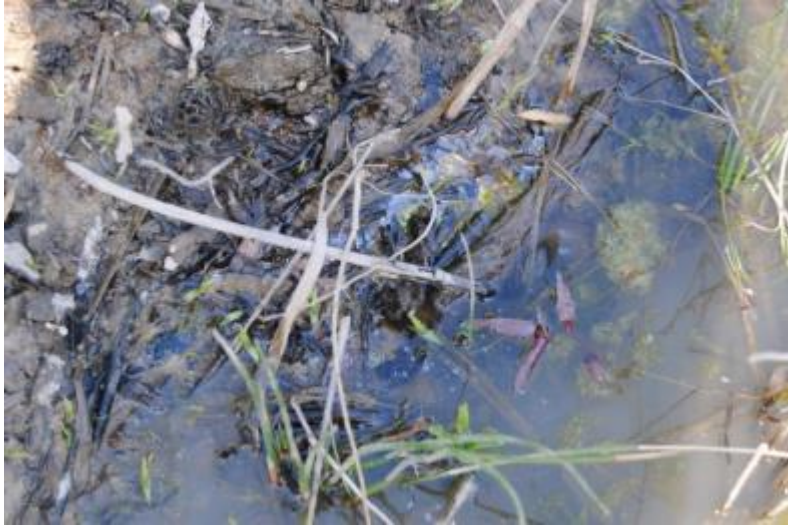
Initial Observation:

Cover of brittle silver gray sheen

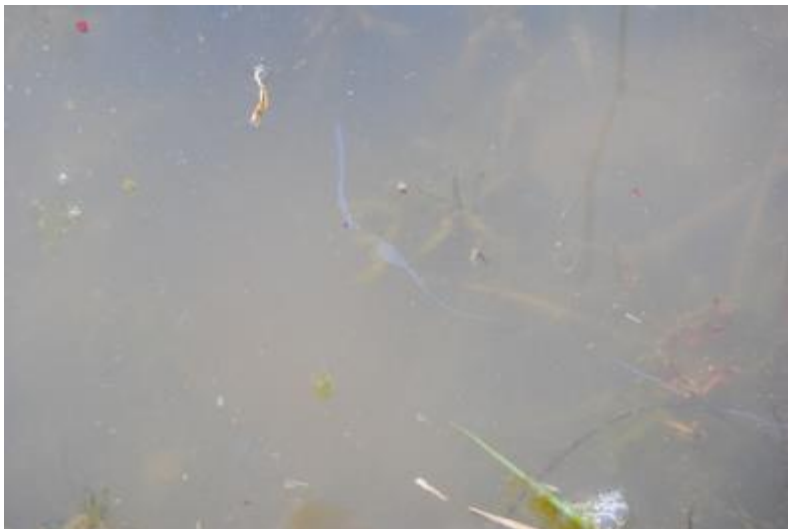
Probing Observation:

0-6 inches : Streamers (< 2 inches) of non-brittle silver gray sheen
6-12 inches : Streamers (< 2 inches) of non-brittle silver gray sheen

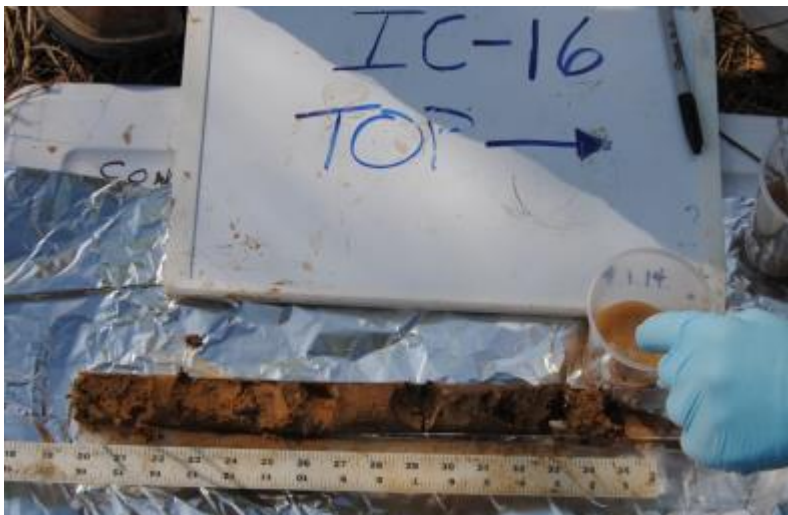
Core Description:

0-16 inches : Gray and reddish brown silt with clay

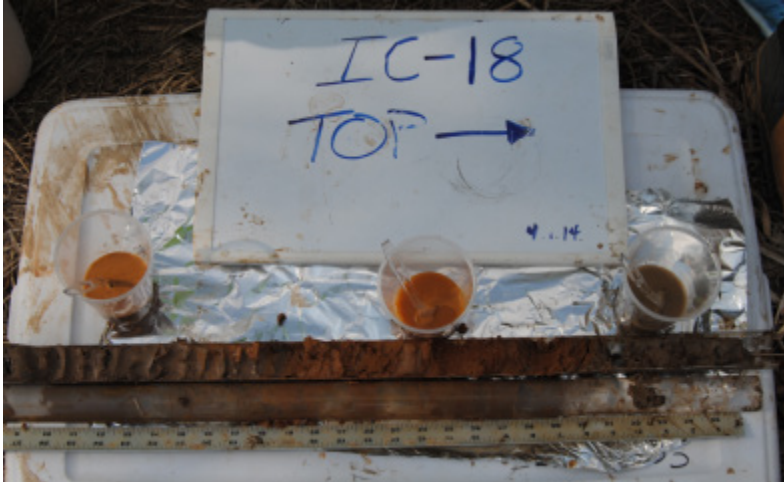
Core Description:

0-6 inches : Gray silty clay with humic material, soft
6-17 inches : Reddish brown silty sand (SM)
17-28 inches : Gray clayey silt (MH)

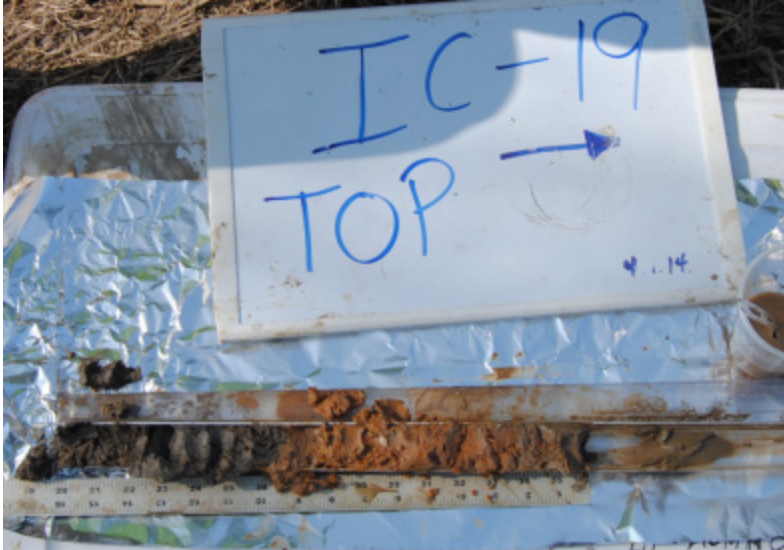
Overall Qualitative Sheening Amount:

0-6 inches : No Sheen
6-12 inches : No Sheen
12-16 inches : No Sheen

0-4 inches : Gray clayey silt (MH), soft
4-10 inches : Reddish brown silty sand (SM)
10-16 inches : Gray silt with clay (MH) and humic material, wood at 13"

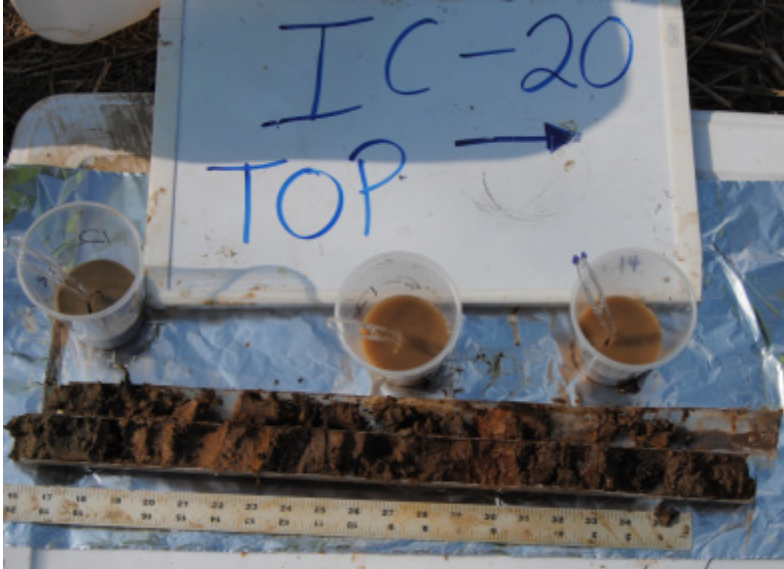
Overall Qualitative Sheening Amount:

0-6 inches : No Sheen
6-12 inches : No Sheen
12-18 inches : No Sheen

0-12 inches : Light brown and red mottled clayey silt (MH)
12-18 inches : Gray clayey sand (SC)

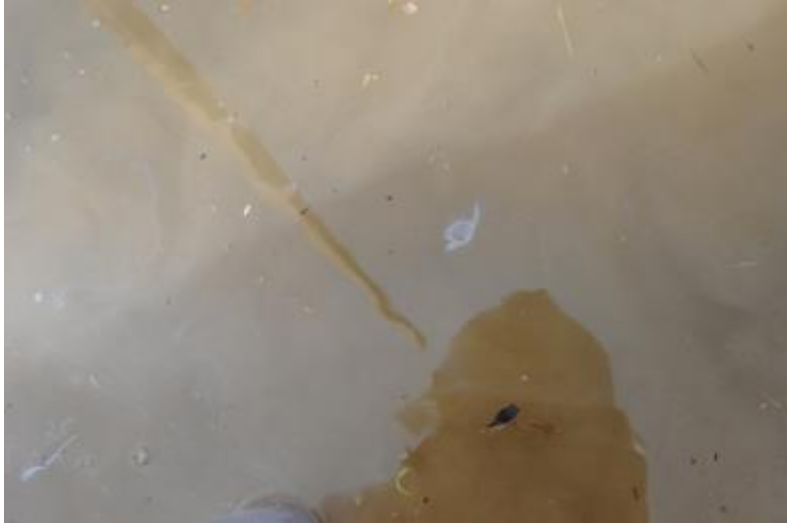
Overall Qualitative Sheening Amount:

0-6 inches : Lighter
6-12 inches : No Sheen
12-17 inches : No Sheen

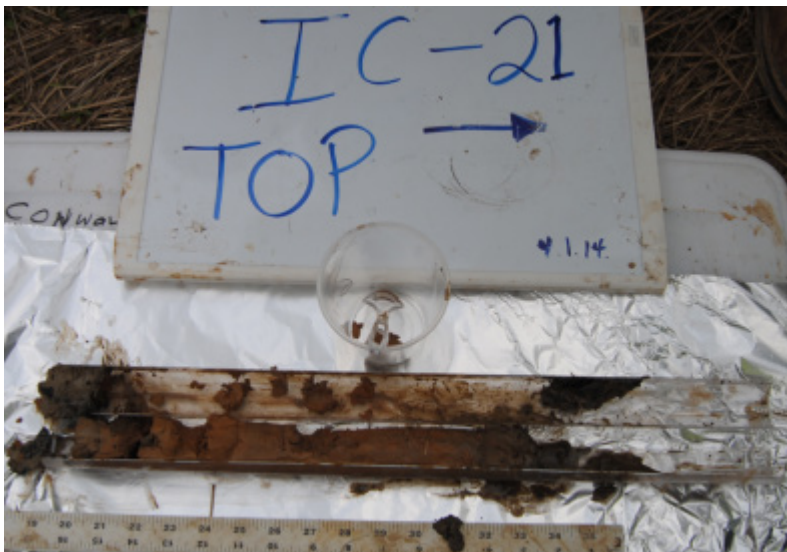
Probing Observation:

0-6 inches : Patches/streamers of non-brittle silver gray sheen (quickly dissipated)
6-12 inches : Patches/streamers of non-brittle silver gray sheen (quickly dissipated)

0-3 inches : Gray humic material with silty clay
3-15 inches : Light reddish brown clayey sand (SC)
15-17 inches : Gray silty clay with humic material

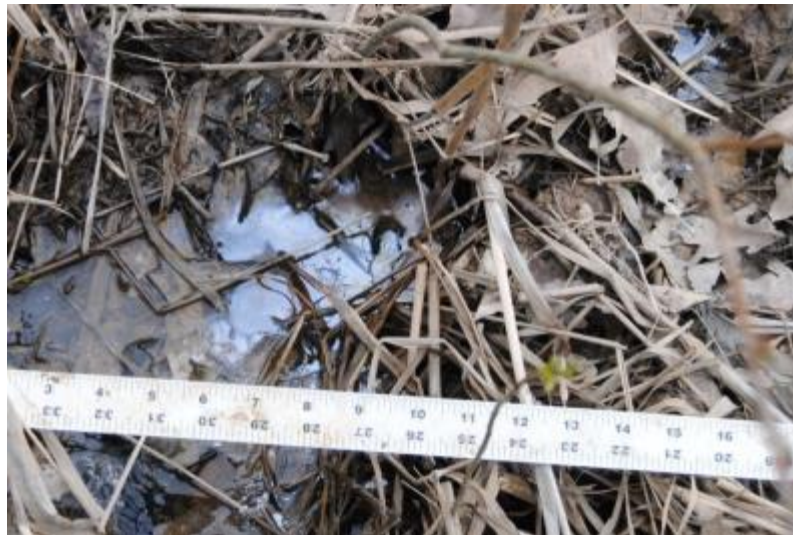
Overall Qualitative Sheening Amount:

0-6 inches : Lighter
6-12 inches : Lighter
12-15 inches : Lighter
18-24 inches : No Sheen

Cover of brittle rainbow sheen

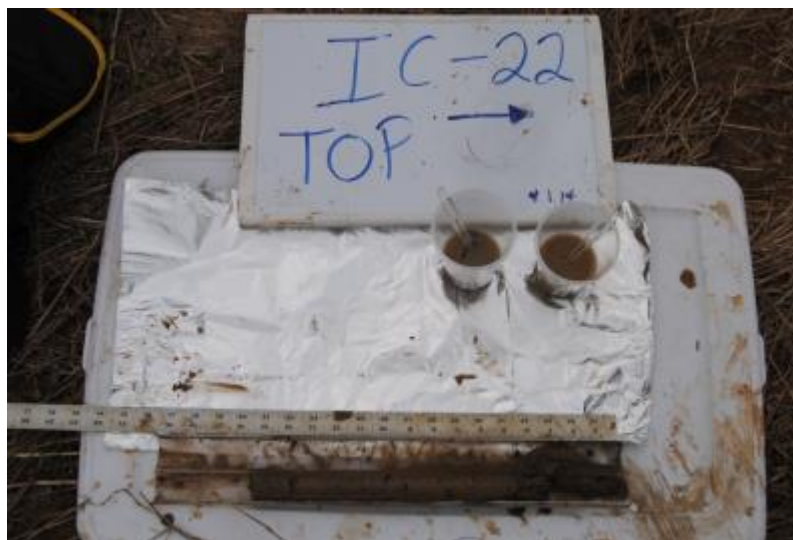
0-12 inches : Gray silty clay with humic material
12-24 inches : Light brown clayey silt

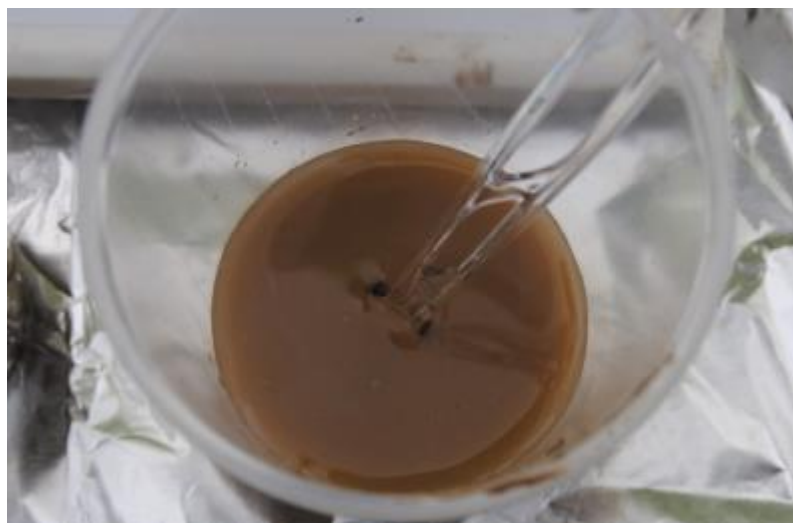
Sheen Stir-Test:

0-6 inches : Streamer of silver gray sheen (Lighter)

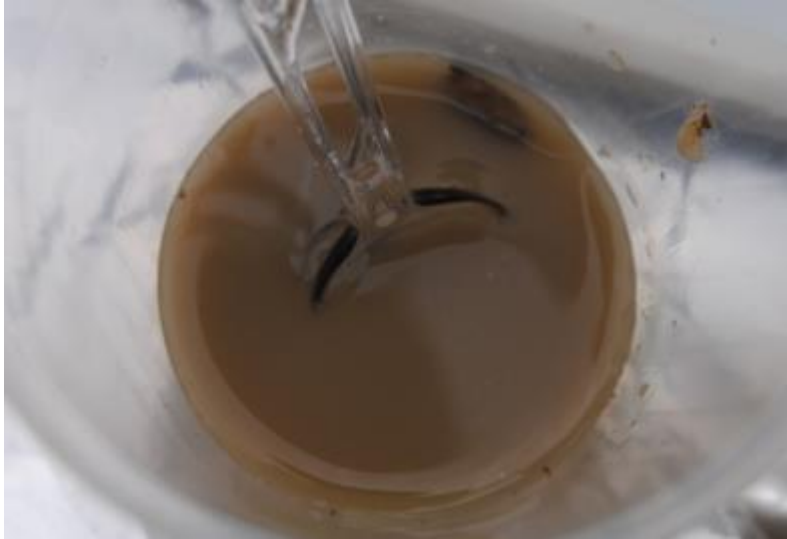
Overall Qualitative Sheening Amount:

0-6 inches : Lighter
6-12 inches : Lighter
12-15 inches : Lighter
18-24 inches : No Sheen

6-12 inches : Streamer of silver gray sheen (Lighter)

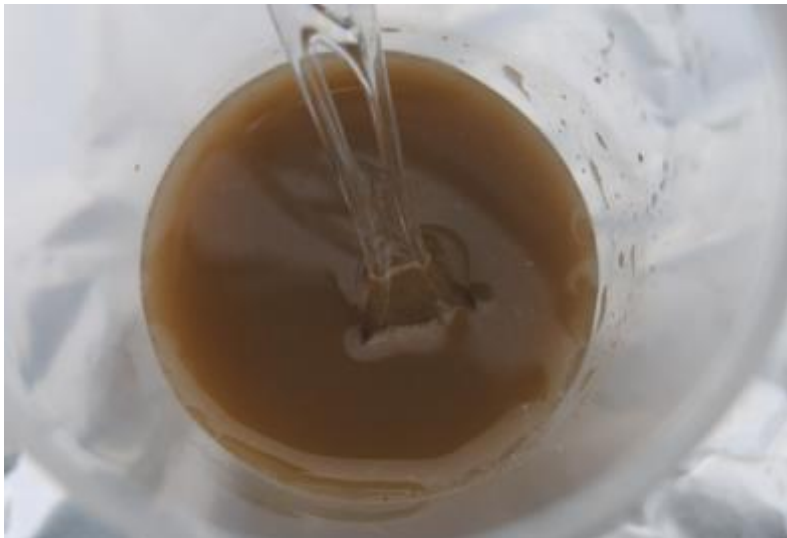
12-15 inches : Streamer of silver gray sheen (Lighter)

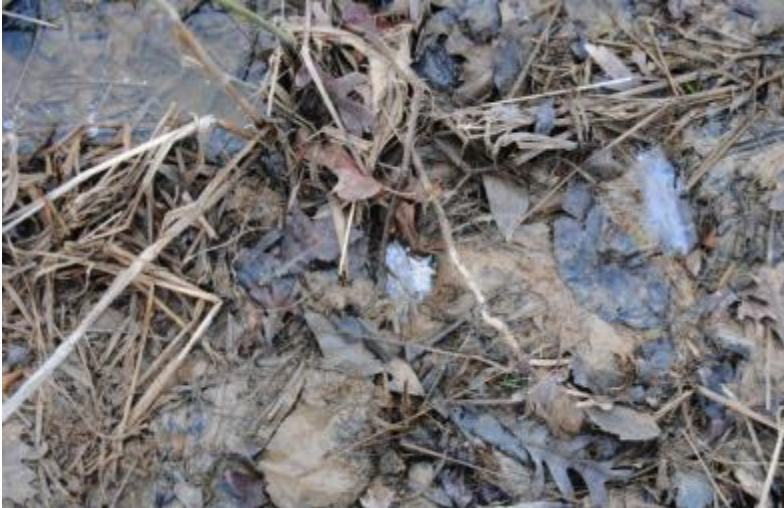
Overall Qualitative Sheening Amount:

0-6 inches : No Sheen
6-12 inches : Lighter
12-18 inches : Lighter
18-22 inches : No Sheen

Cover of non-brittle rainbow sheen

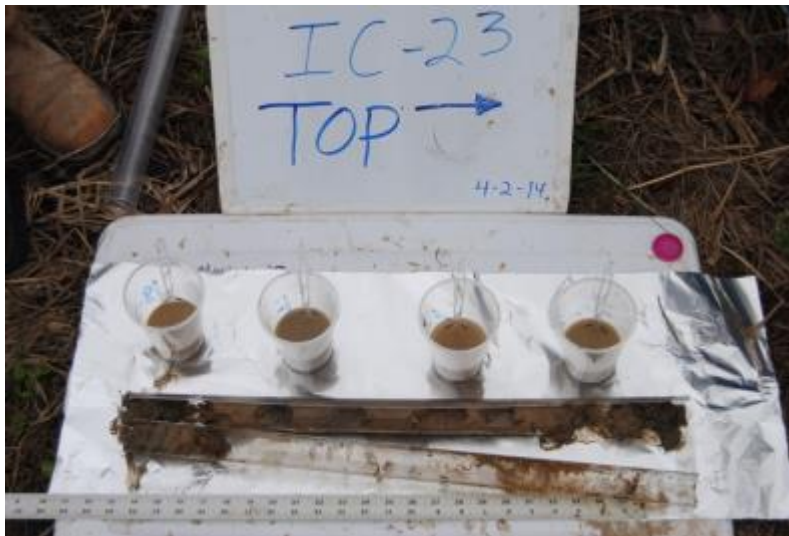
0-12 inches : Gray silty clay with humic material, soft
12-22 inches : Light brown silt with clay

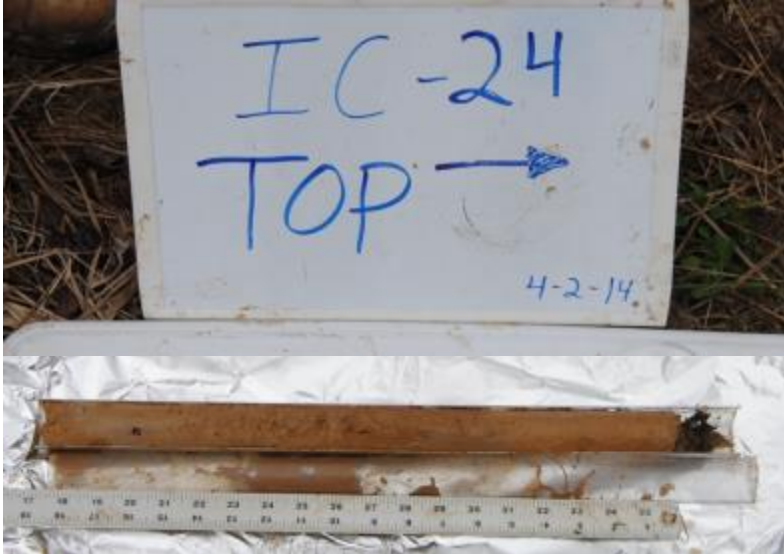
Overall Qualitative Sheening Amount:

0-6 inches : No Sheen
6-12 inches : No Sheen
12-18 inches : No Sheen

0-12 inches : Light brown clayey silt (MH)
12-18 inches : Light brown clayey sand (SC)

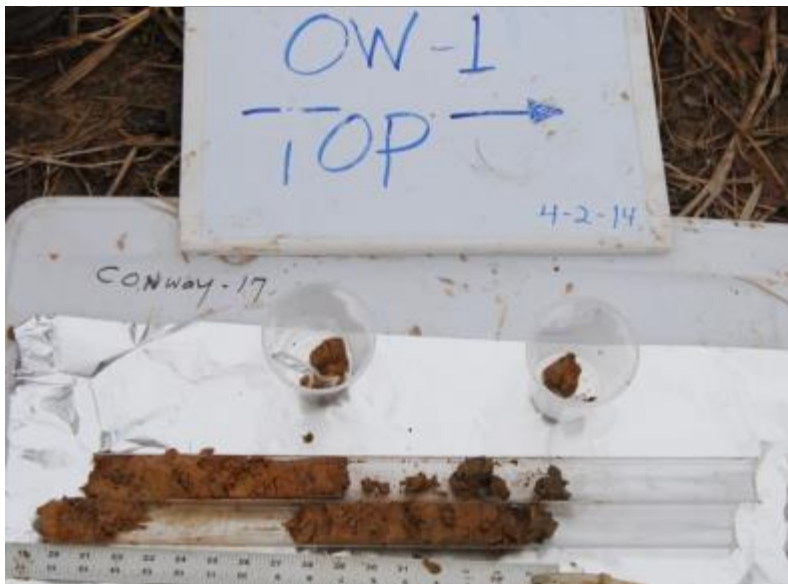
0-12 inches : Light brown and reddish mottled silt with clay (MH), humic material at 0-2"

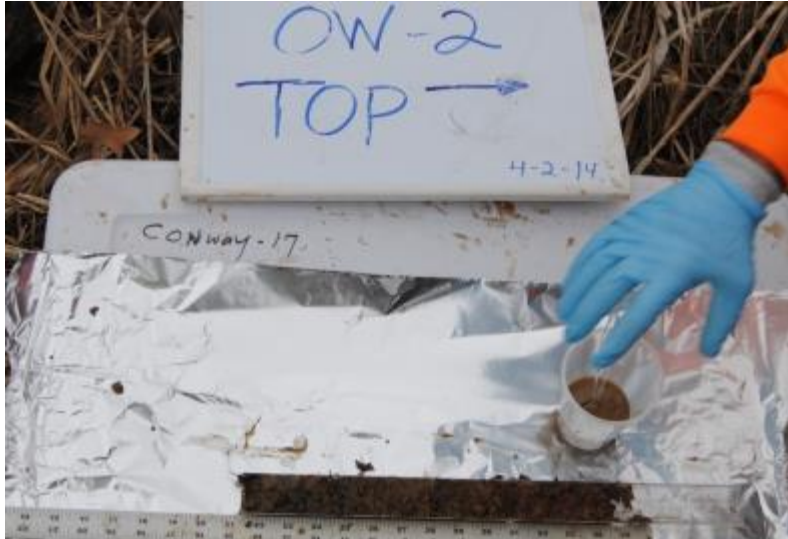
Overall Qualitative Sheening Amount:

0-6 inches : No Sheen
6-12 inches : Lighter

0-12 inches : Gray and reddish brown mottled silt with clay (MH)

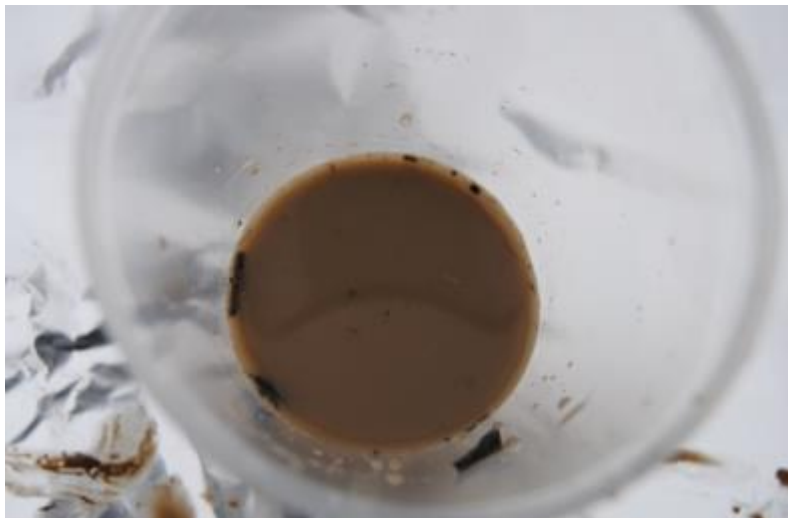
6-12 inches : Patch of silver gray sheen (Lighter)

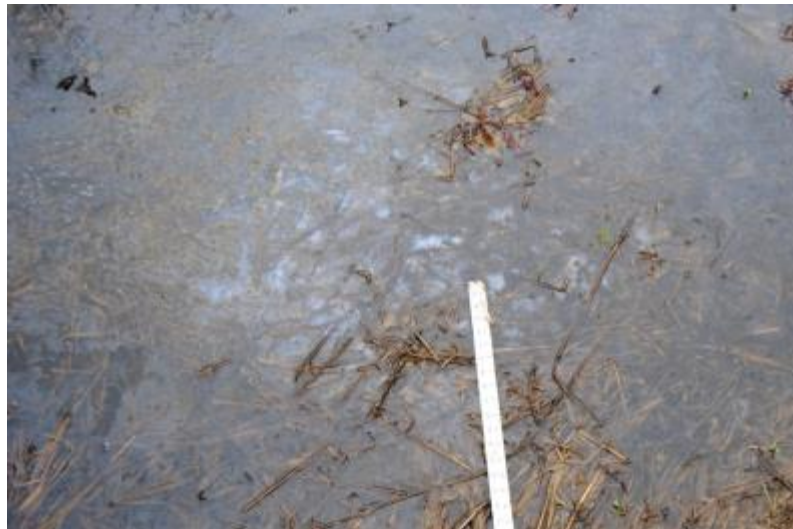
Overall Qualitative Sheening Amount:

0-6 inches : No Sheen
6-12 inches : Lighter

Cover of brittle and non-brittle silver gray sheen

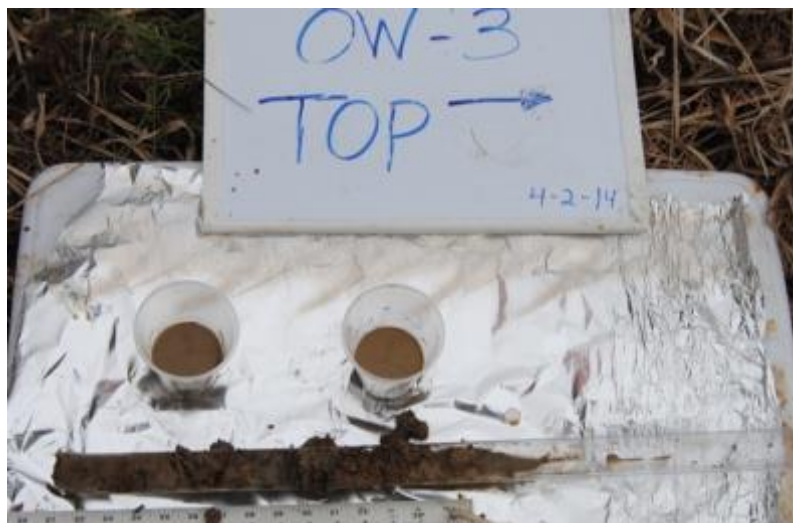
0-12 inches : Gray and reddish brown mottled clayey silt (MH)

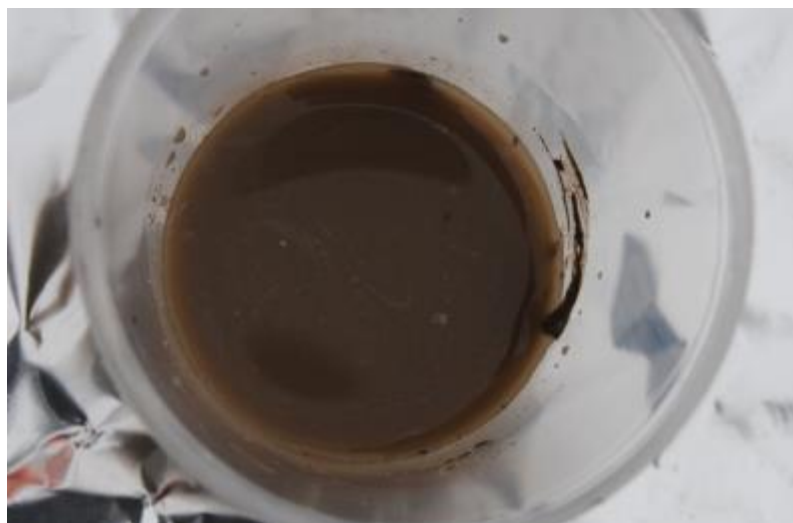
6-12 inches : Patches/streamers of silver gray sheen (Lighter)

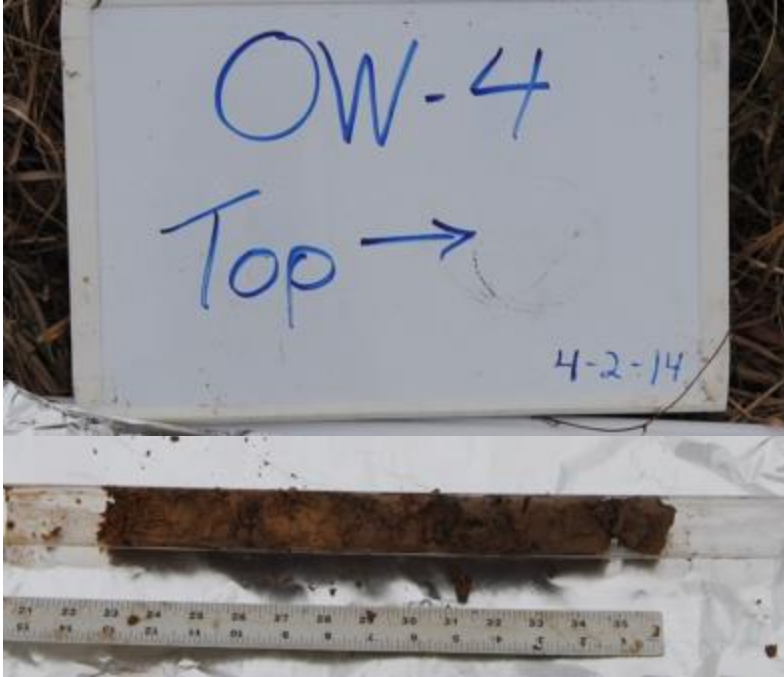
Overall Qualitative Sheening Amount:

0-6 inches : No Sheen
6-12 inches : No Sheen

0-12 inches : Light brown and reddish brown mottled silt (ML)

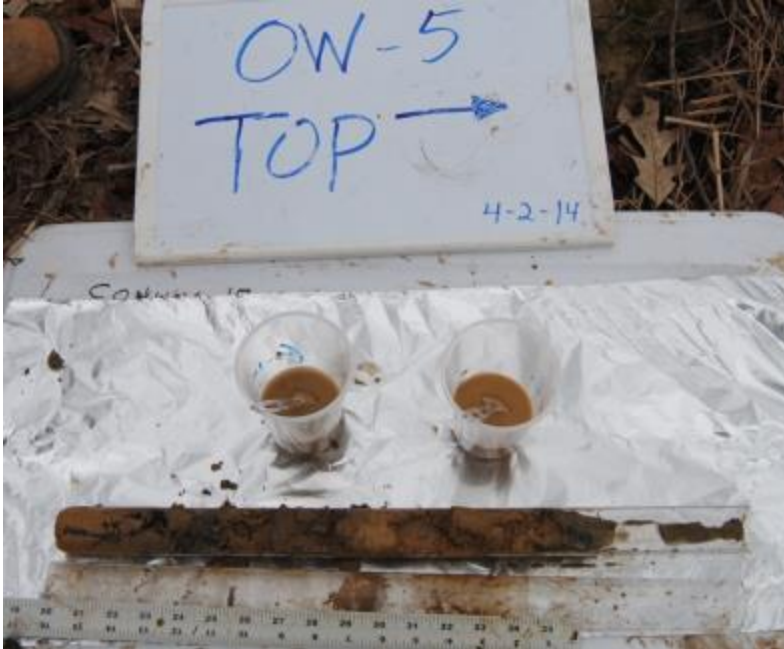
Overall Qualitative Sheening Amount:

0-6 inches : No Sheen
6-12 inches : No Sheen

0-6 inches : Light brown and reddish brown mottled silt with clay, some humic material at 0-2"
6-12 inches : Gray and light brown mottled silt with clay

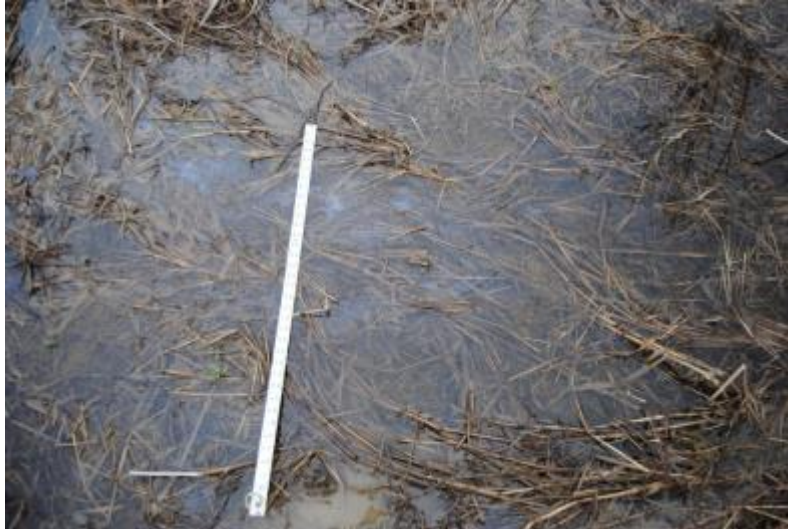
Overall Qualitative Sheening Amount:

0-6 inches : No Sheen
6-12 inches : No Sheen

Cover of brittle silver gray sheen
