**Downstream Areas Pre-Design
Study**

**Pre-Design Study – Revision 1
Mayflower Pipeline Incident Response, Mayflower, Arkansas**

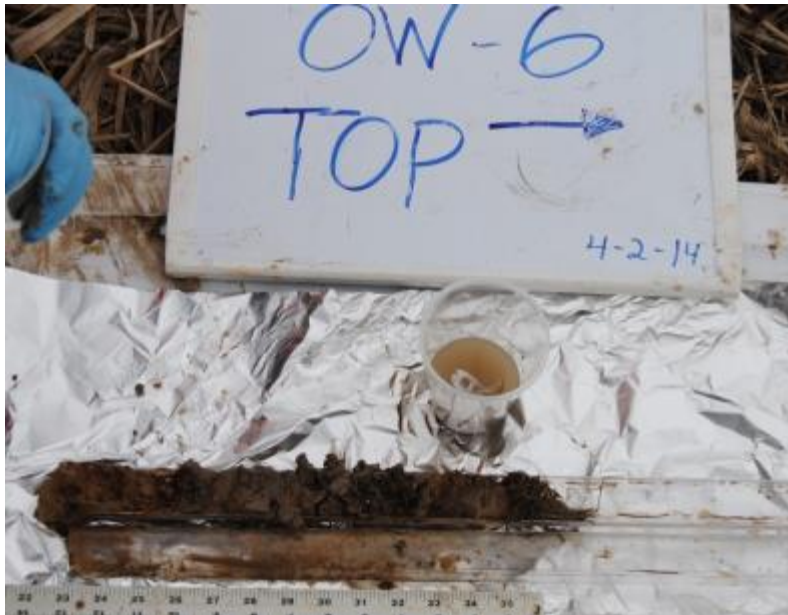
0-10 inches : Gray and reddish brown clayey silt (MH), humic material at 0-2"
10-12 inches : Light brown and reddish brown mottled clayey silt (MH)

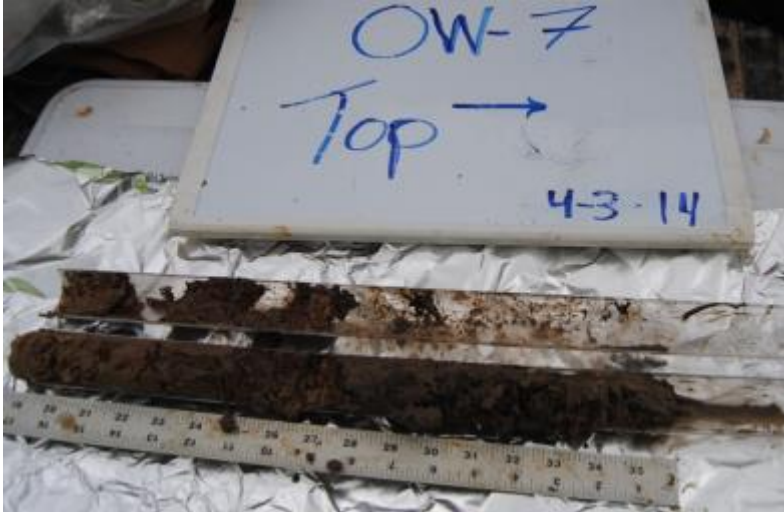
Overall Qualitative Sheening Amount:

0-6 inches : No Sheen
6-12 inches : No Sheen

0-8 inches : Gray silty clay (CL) with roots and organic material
8-12 inches : Gray and reddish brown mottled clayey silt (MH)

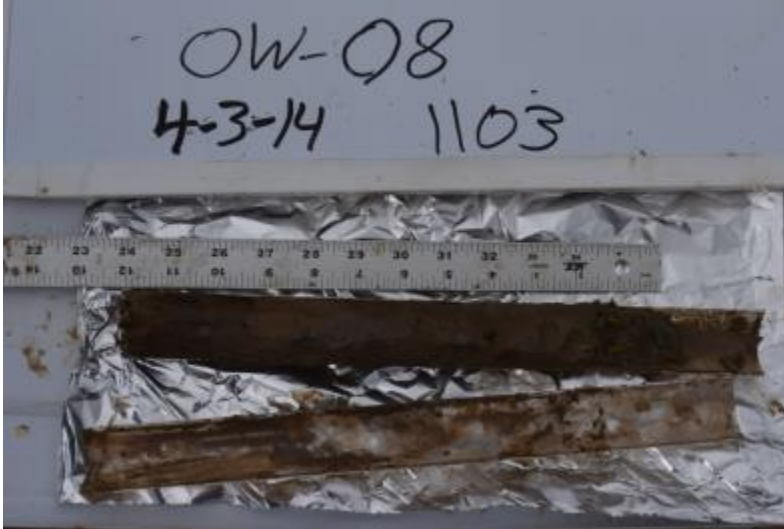
Overall Qualitative Sheening Amount:

0-6 inches : No Sheen
6-12 inches : No Sheen

0-6 inches : Brown clayey silt with roots
6-12 inches : Brown clay, medium stiff

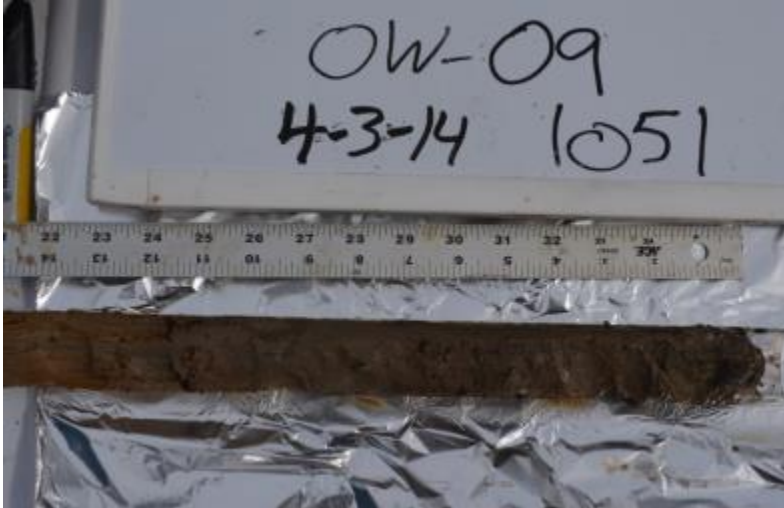
Overall Qualitative Sheening Amount:

0-6 inches : No Sheen
6-12 inches : No Sheen

0-8 inches : Brown clay, some silt, soft
8-12 inches : Brown clay, stiff

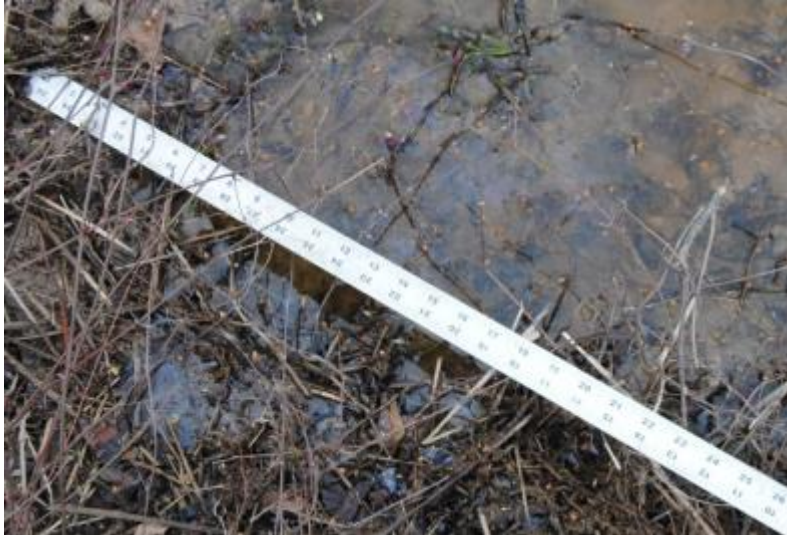
Overall Qualitative Sheening Amount:

0-6 inches : No Sheen
6-12 inches : No Sheen

Cover of brittle silver gray sheen

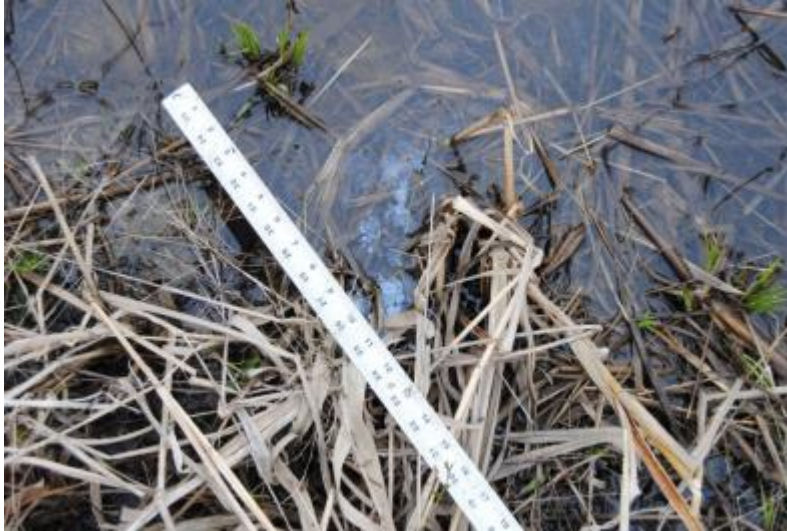
Overall Qualitative Sheening Amount:

0-6 inches : No Sheen
6-12 inches : No Sheen

Cover of brittle silver gray sheen

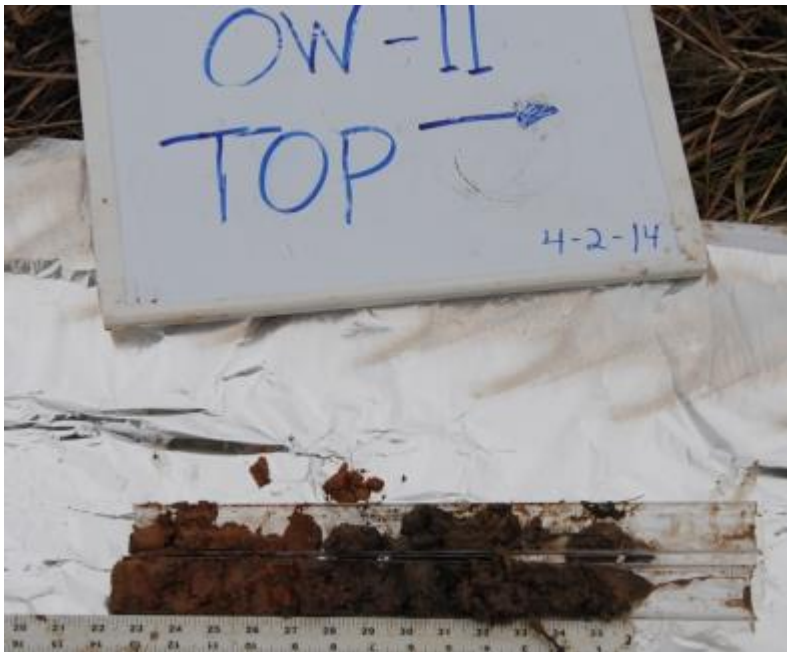
0-6 inches : Gray silt with clay (MH), roots, humic material
6-12 inches : Light brown and reddish silt (ML)

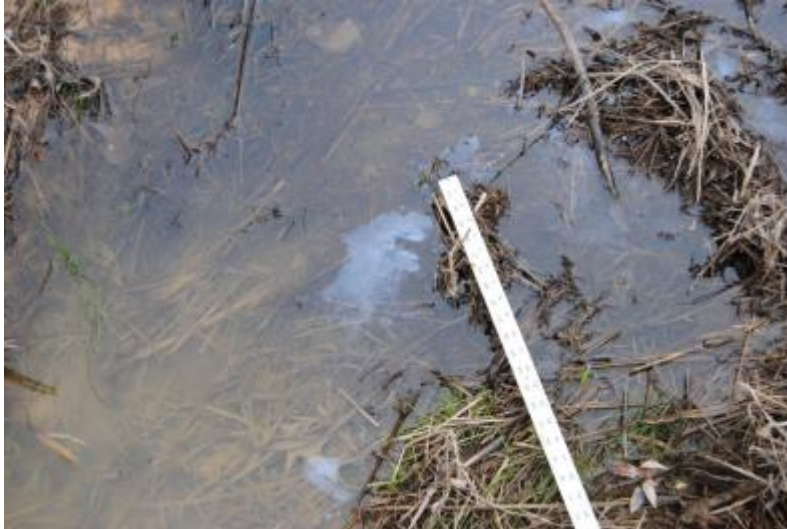
Overall Qualitative Sheening Amount:

0-6 inches : No Sheen
6-10 inches : No Sheen

Patches of brittle silver gray sheen

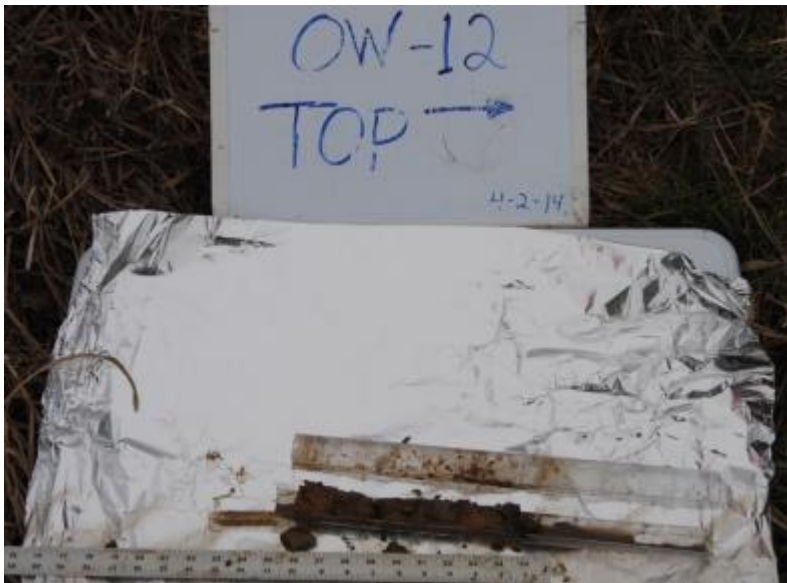
0-10 inches : Gray and reddish brown mottled silt with clay (MH); organic material (roots and grass) at 0-2"

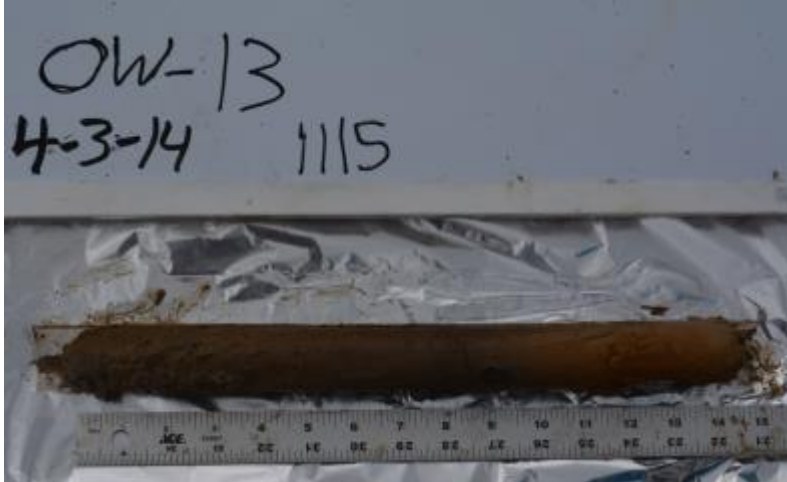
Overall Qualitative Sheening Amount:

0-6 inches : No Sheen
6-12 inches : No Sheen

0-6 inches : Brown silty clay
6-12 inches : Brown clay

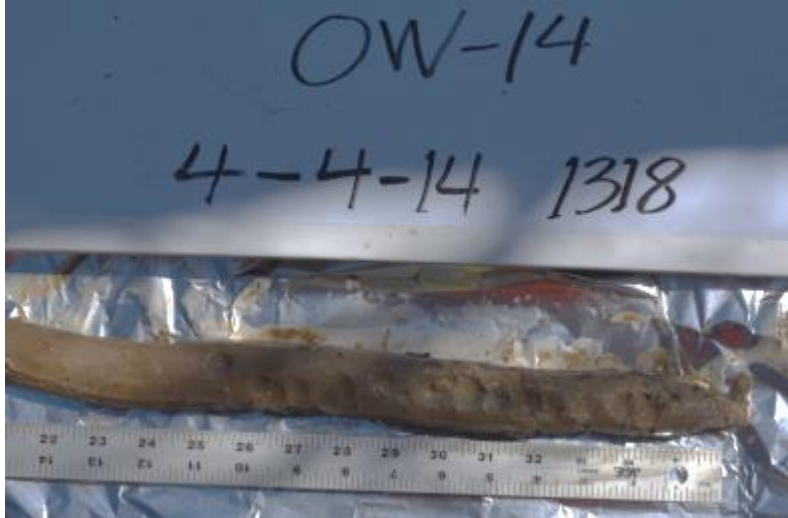
Overall Qualitative Sheening Amount:

0-6 inches : No Sheen
6-12 inches : No Sheen

0-12 inches : Brown clayey silt

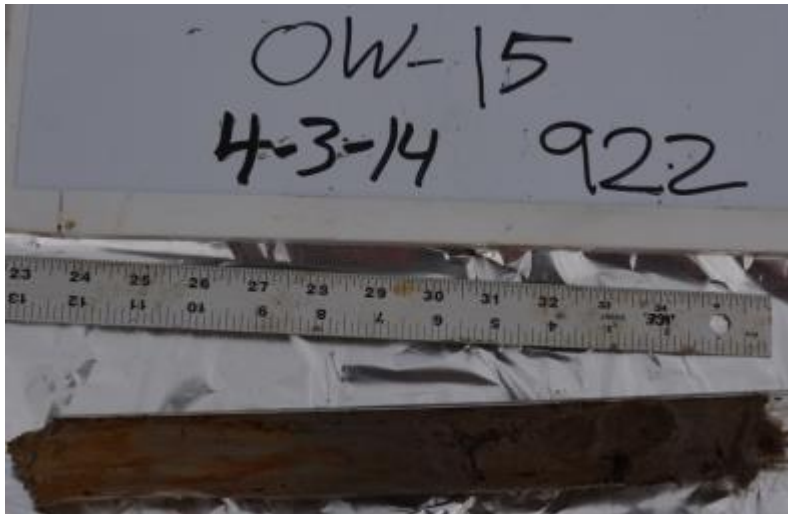
0-6 inches : Brown silty clay, soft, very light sheen at 0-5"
6-12 inches : Brown clay, medium stiff

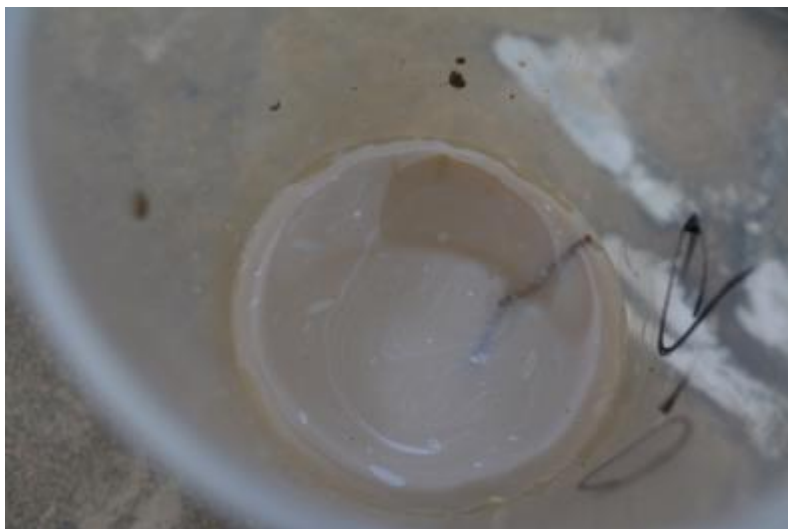
0-6 inches : Patches/streamers of silver gray sheen (Lighter)

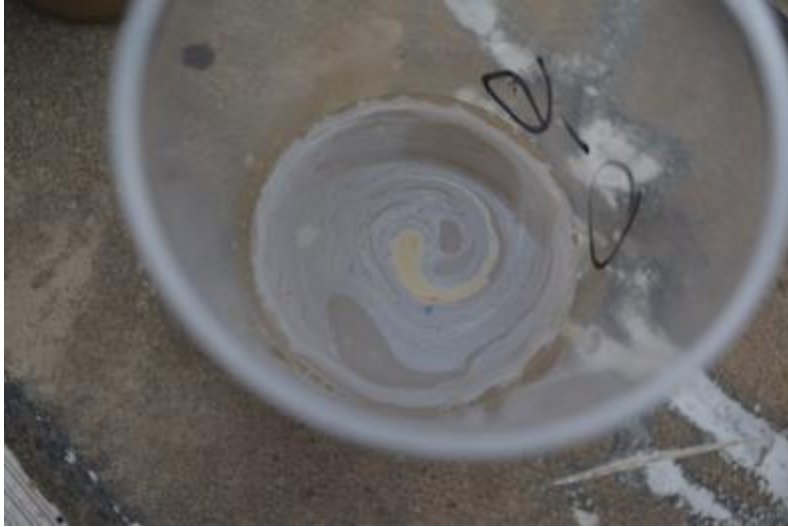
Cove Open Water
Area Location – OW-16

Overall Qualitative Sheening Amount:

0-6 inches : Medium
6-12 inches : No Sheen

0-6 inches : Patches/streamers of rainbow sheen with 10 oil spots (0.1- to 0.25-inch wide) (Medium)

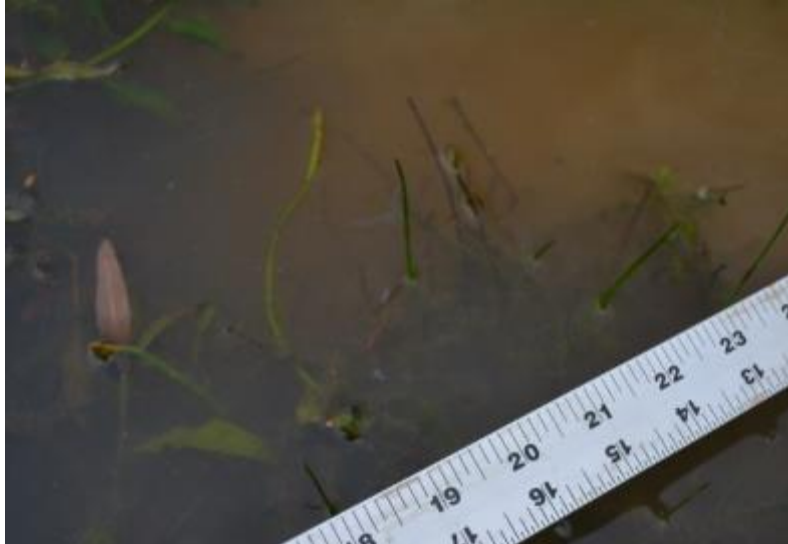
Probing Observation:

6-12 inches : Streamers of non-brittle silver gray sheen

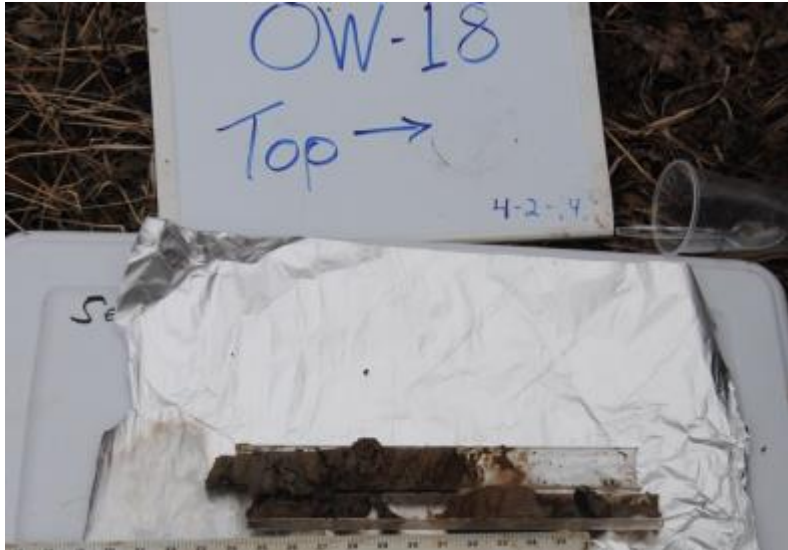
Core Description:

0-3 inches : Gray silty clay (CL), soft
3-10 inches : Gray and reddish brown clayey silt (MH)
10-12 inches : Gray silty clay (CL)

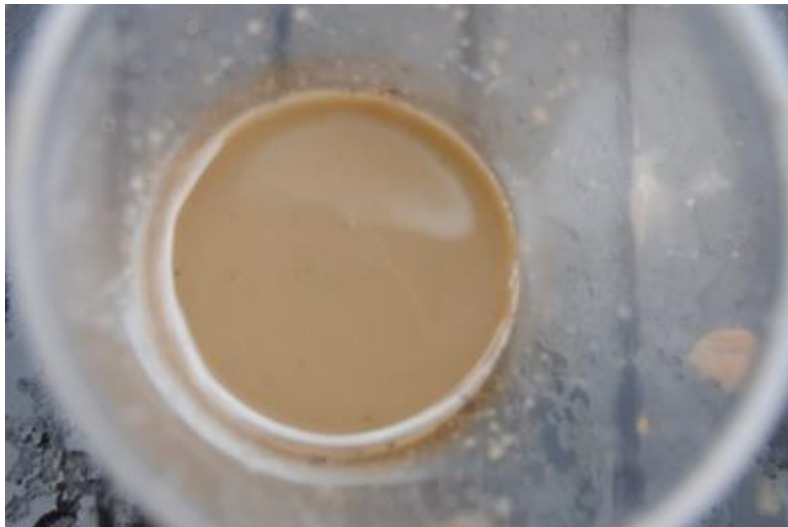
Sheen Stir-Test:

0-6 inches : Streamer of rainbow sheen (Heavier)

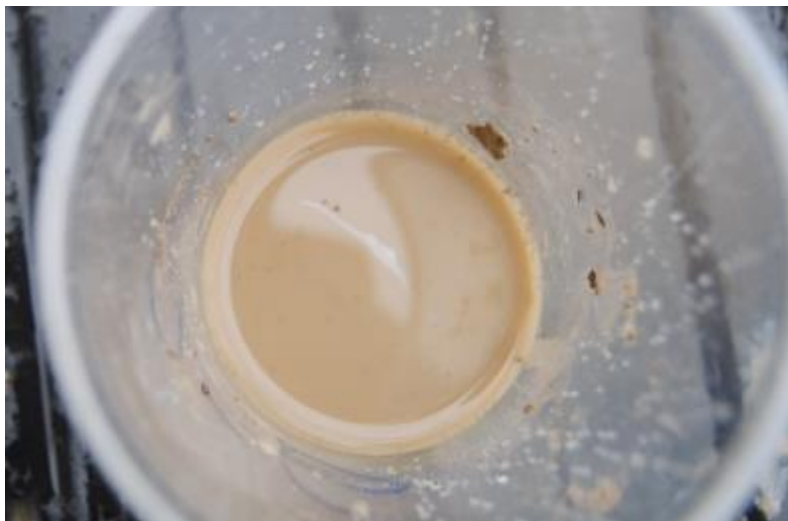
Sheen Stir-Test:

6-12 inches : Patch of silver gray sheen (Lighter)

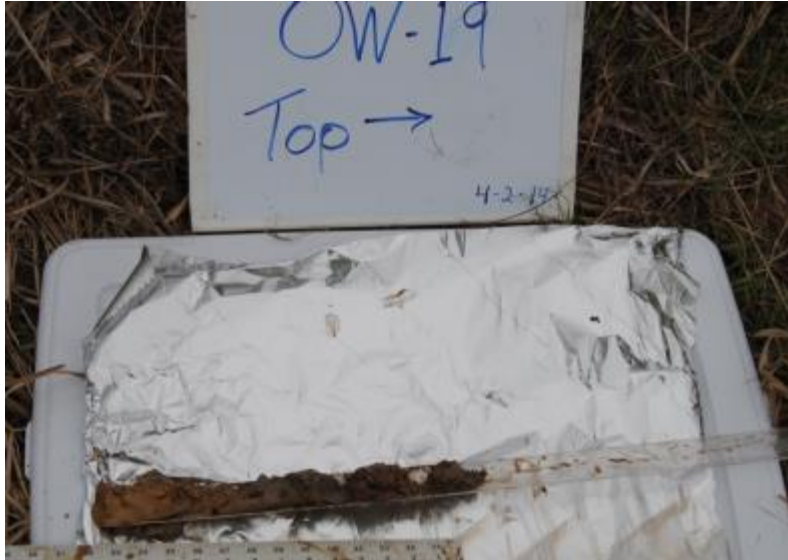
Core Description:

0-12 inches : Gray and reddish brown silt with clay (MH), roots and plant material at 0-2"

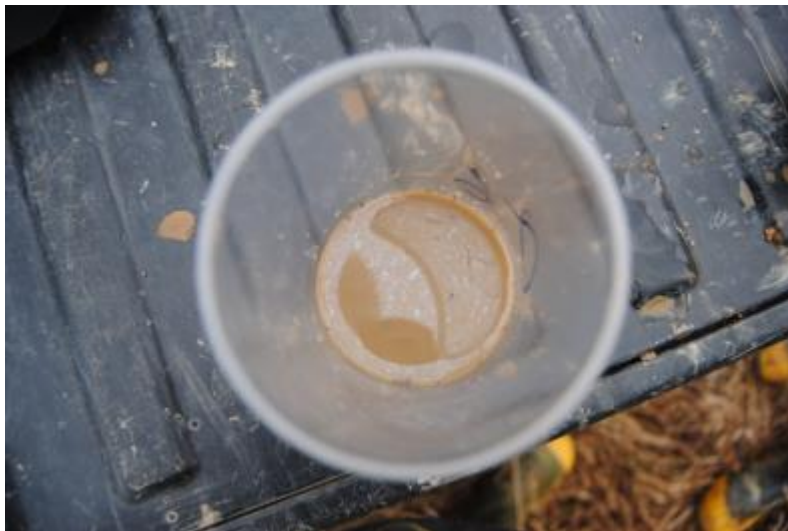
Sheen Stir-Test:

0-6 inches : Patches of silver gray sheen (Medium)

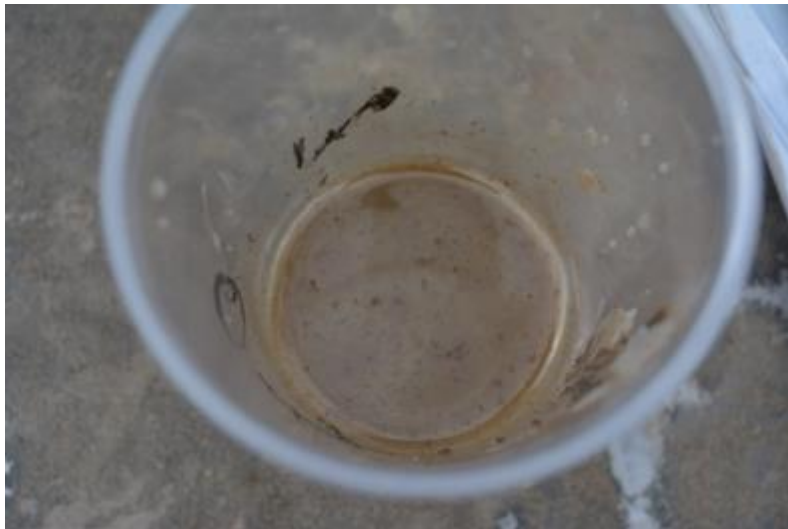
Sheen Stir-Test:

0-6 inches : Patches/streamers of rainbow sheen with oil spots (Heavier)

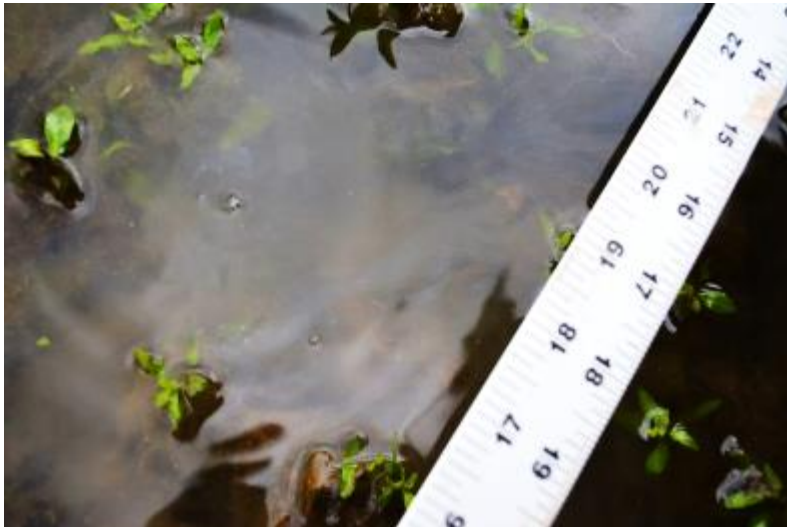
Probing Observation:

Surface : Streamers of non-brittle silver gray sheen
0-6 inches : Streamers of non-brittle silver gray sheen

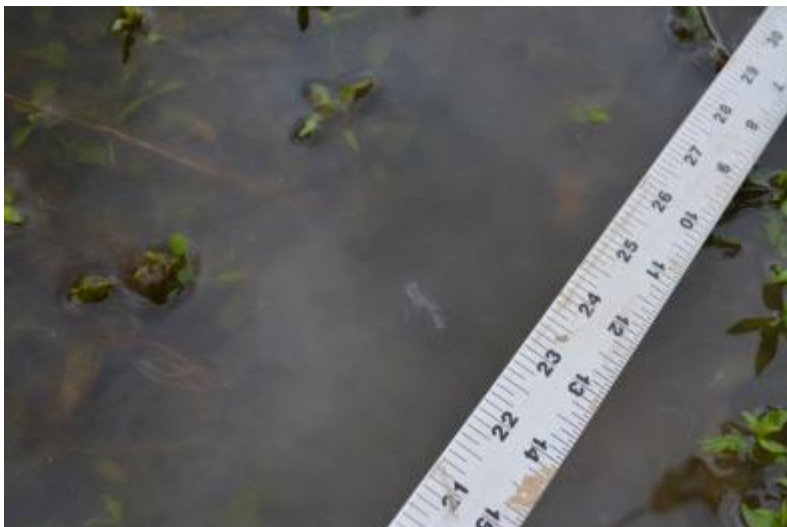
Probing Observation:

6-12 inches : Patches/streamers of non-brittle silver gray sheen with four oil spots (0.1 to 0.25-inch wide)

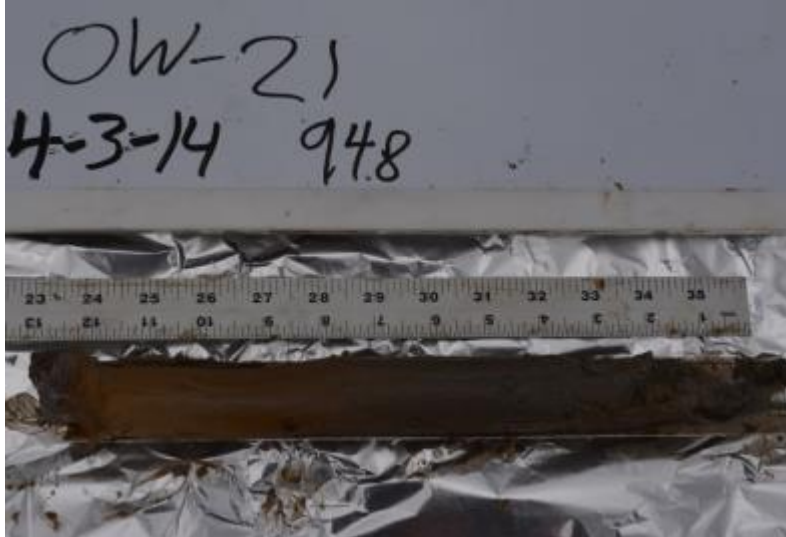
Core Description:

0-6 inches : Brown silt, light sheen 0-4"
6-12 inches : Red brown clay, soft

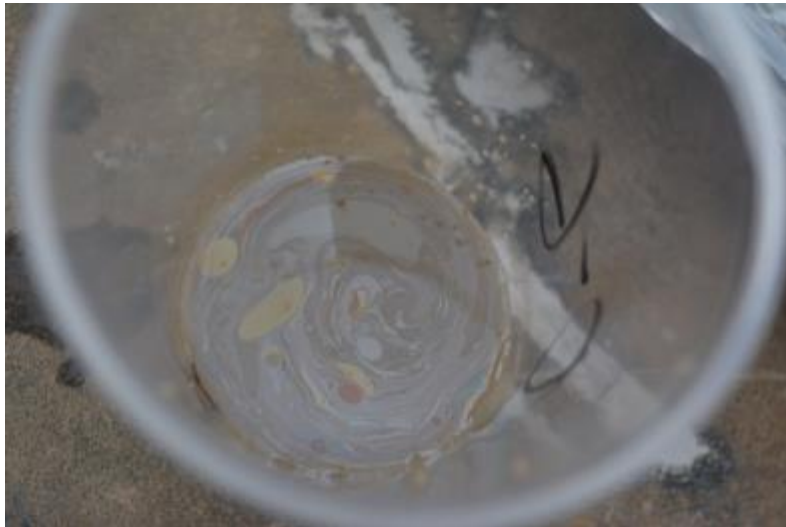
Sheen Stir-Test:

0-6 inches : Patches/streamers of rainbow sheen (Medium)

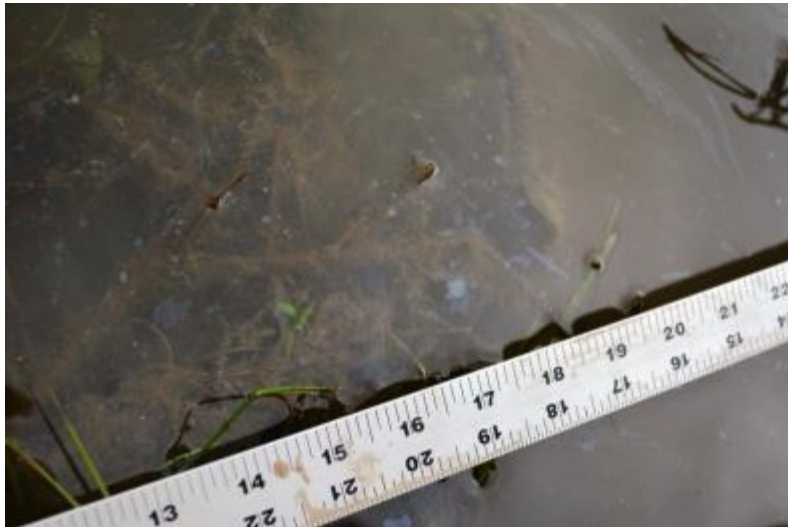
Probing Observation:

Surface : Patches/streamers of non-brittle silver gray sheen with three oil spots (0.1-inch wide)
0-6 inches : Patches/streamers of non-brittle silver gray sheen with 0.1-inch wide oil spots

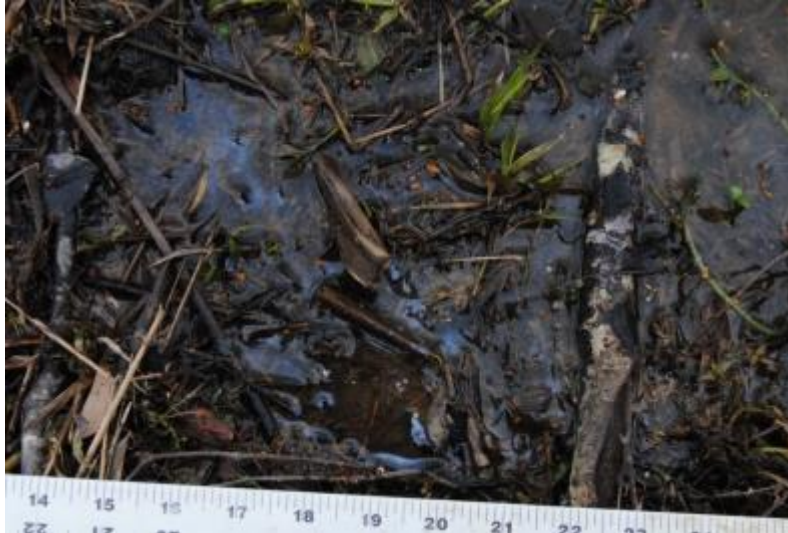
Initial Observation:

Streamers of brittle and non-brittle silver gray sheen

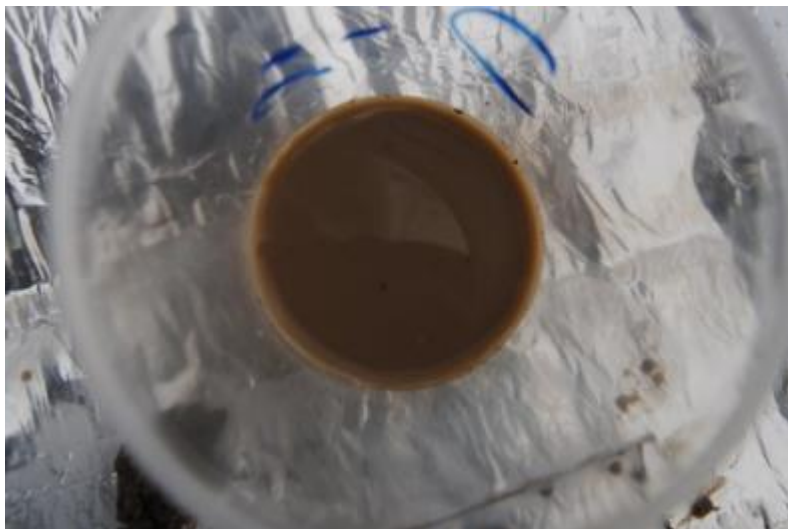
Sheen Stir-Test:

0-6 inches : Streamer of silver gray sheen (Lighter)

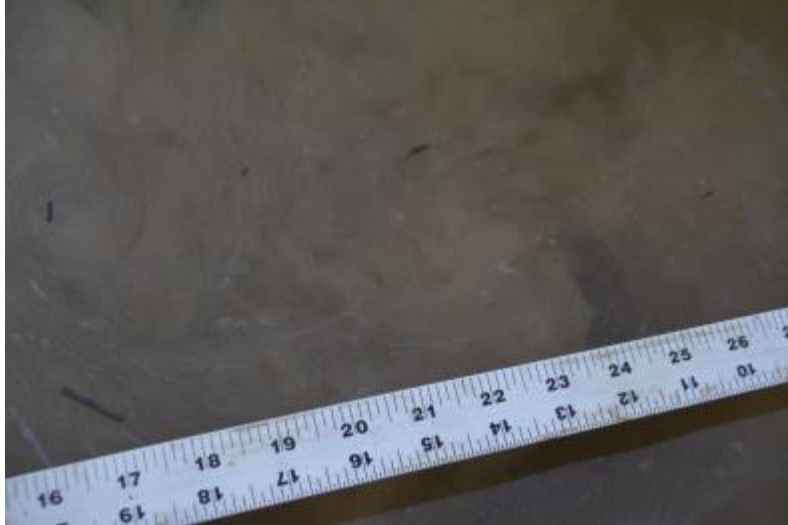
Probing Description:

Surface : Patches/streamers of non-brittle silver gray sheen with 10 oil spots (0.1-inch wide)
0-6 inches : Patches/streamers of non-brittle silver gray sheen
6-12 inches : Patches/streamers of non-brittle silver gray sheen

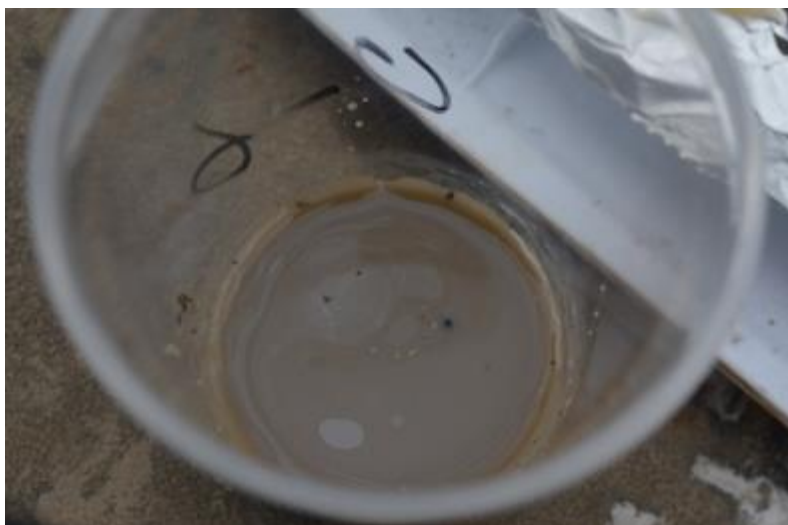
Sheen Stir-Test:

0-6 inches : Patches/streamers of silver gray sheen with 0.25-inch wide oil spot (Heavier)

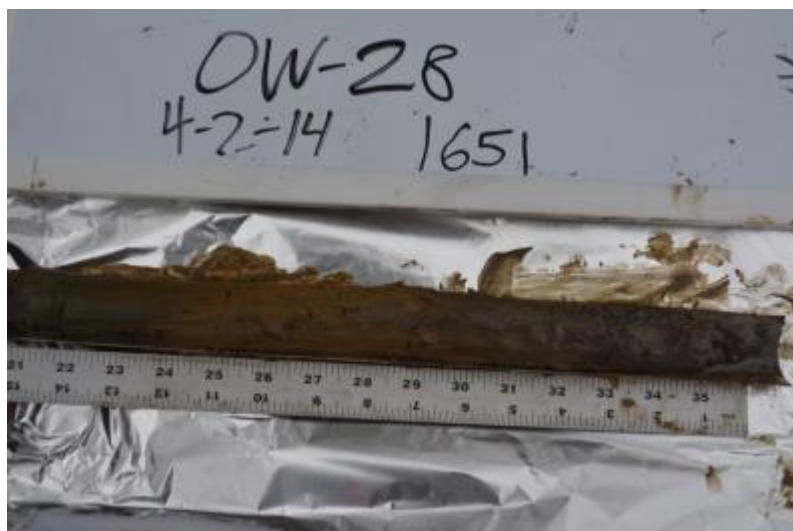
Core Description:

0-6 inches : Silty clay, light sheen at 0-2.4"
6-12 inches : Reddish brown clay, stiff

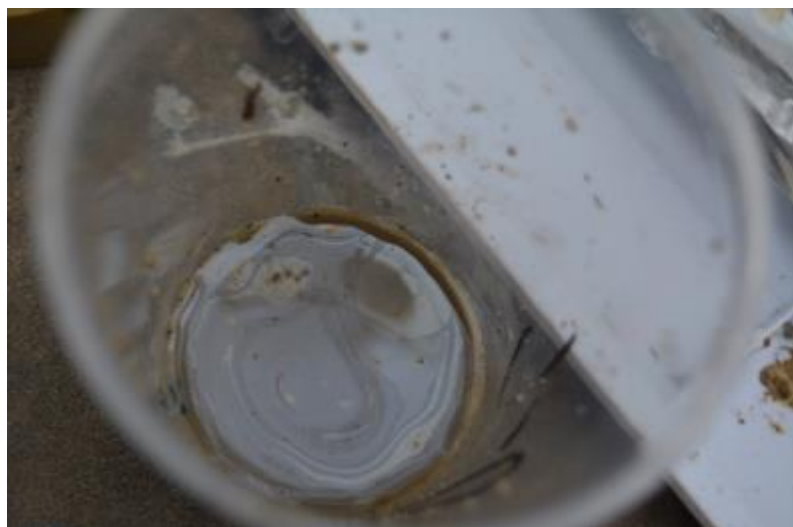
Sheen Stir-Test:

0-6 inches : Patches/streamers of silver gray sheen with three oil spots (Heavier)

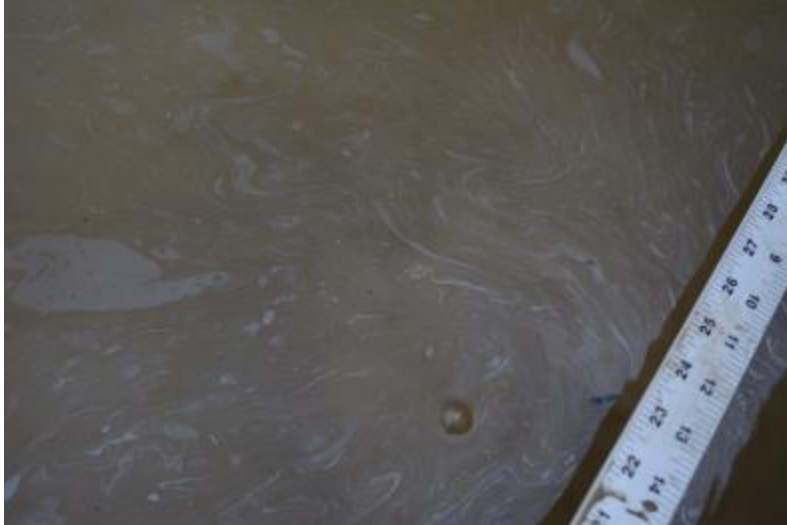
Probing Description:

Surface : Patches/streamers of silver gray sheen
0-6 inches : Patches/streamers of silver gray sheen
6-12 inches : Patches/streamers of silver gray sheen

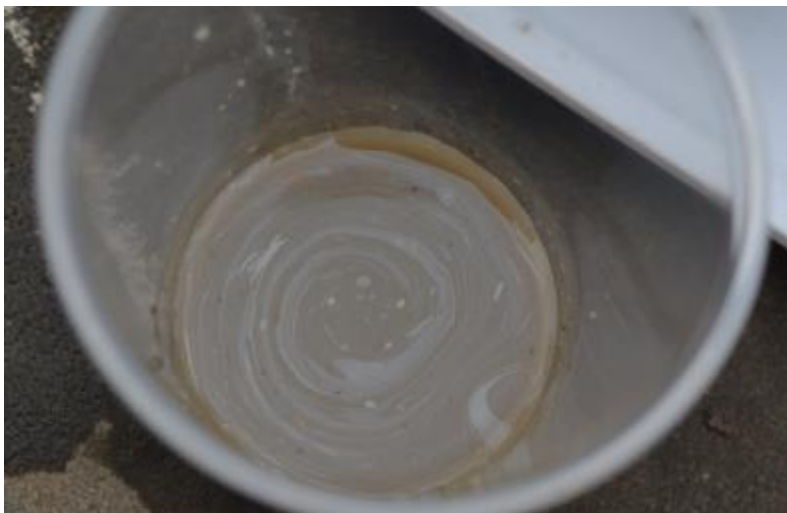
Sheen Stir-Test:

0-6 inches : Patches/streamers of silver gray sheen (Medium)

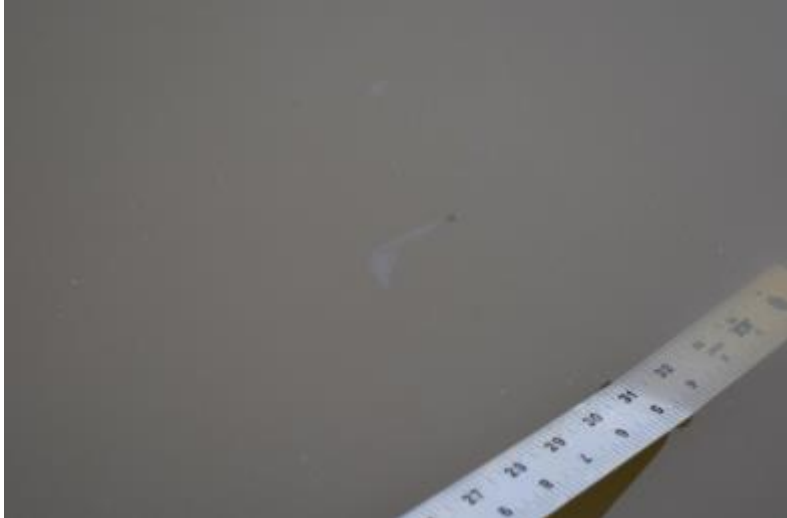
Initial Observation:

Patch/streamer of non-brittle silver gray sheen

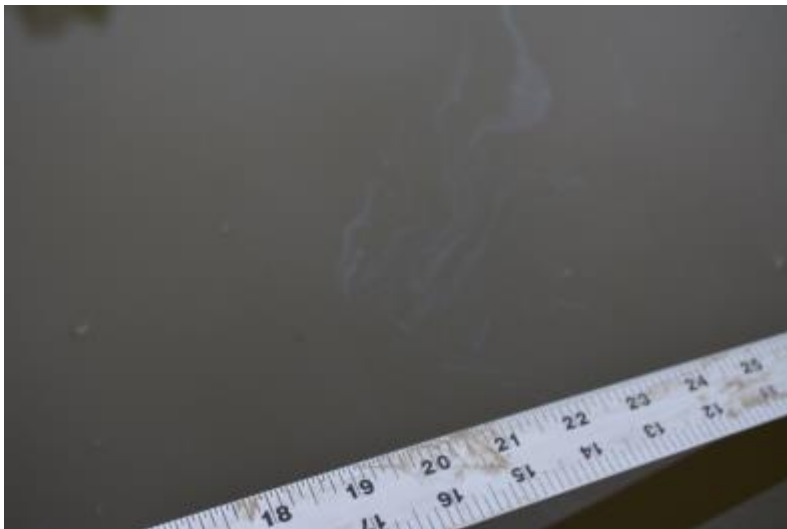
Probing Observation:

Surface : Patch/streamer of non-brittle silver gray sheen
0-6 inches : Patch/streamer of non-brittle silver gray sheen with four oil spots (0.1-inch wide)
6-12 inches : Patch/streamer of non-brittle silver gray sheen

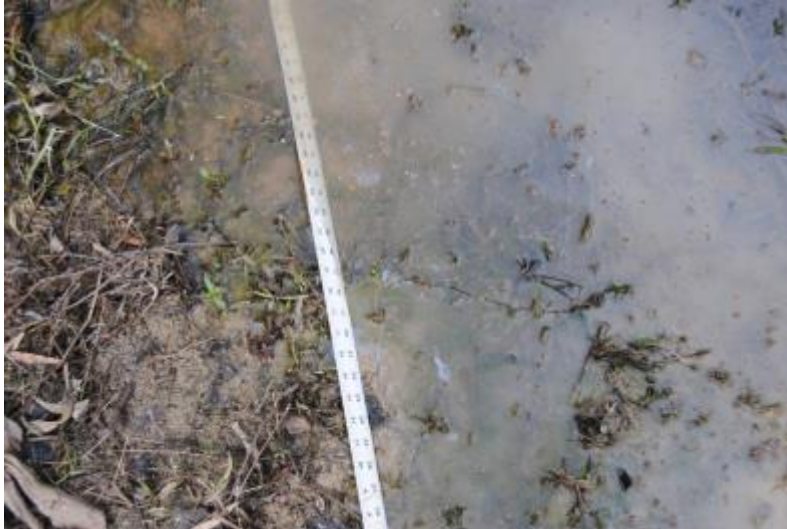
Initial Observation:

Cover/patches of brittle silver gray sheen

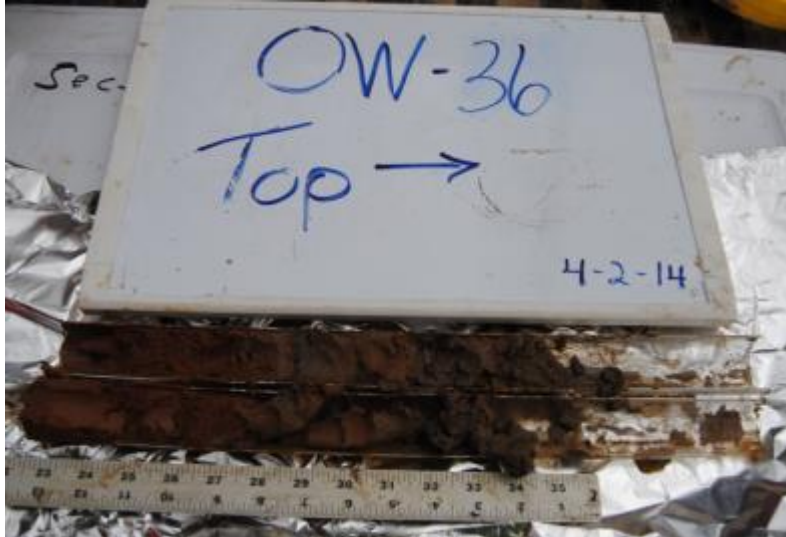
Core Description:

0-4 inches : Gray silty clay (CL) with humic material, soft
4-12 inches : Light brown and reddish brown mottled silty clay (CL)

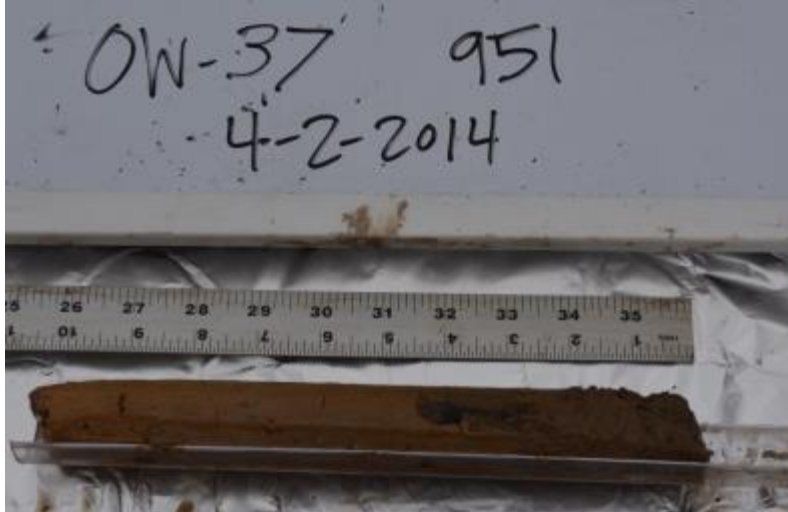
Core Description:

0-6 inches : Reddish brown silty clay
6-12 inches : Red clay

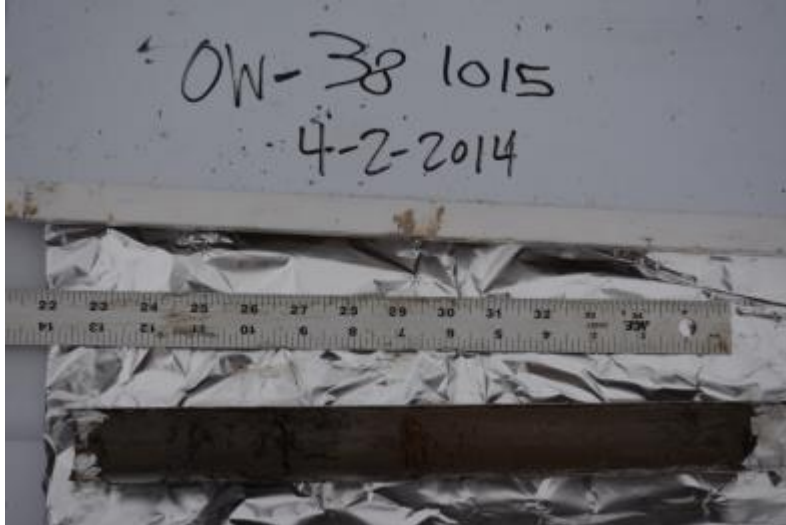
Core Description:

0-6 inches : Brown clay
6-12 inches : Brown silty clay

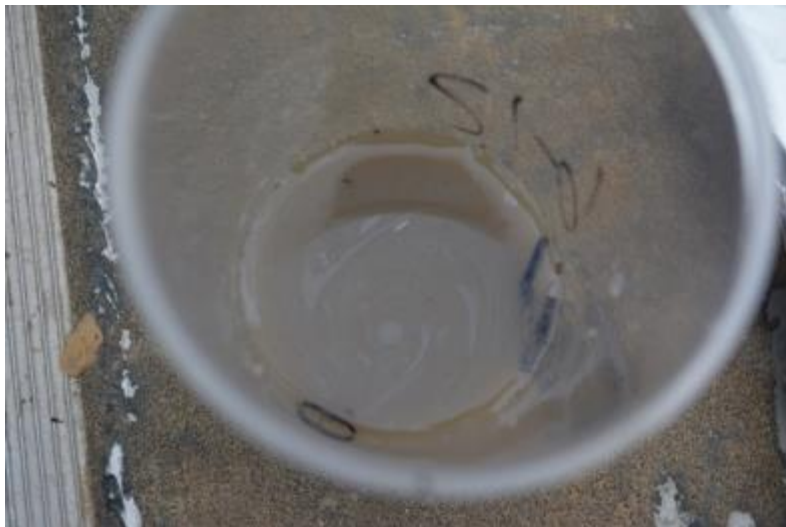
Sheen Stir-Test:

6-12 inches : Patches/streamers of silver gray sheen (Medium)

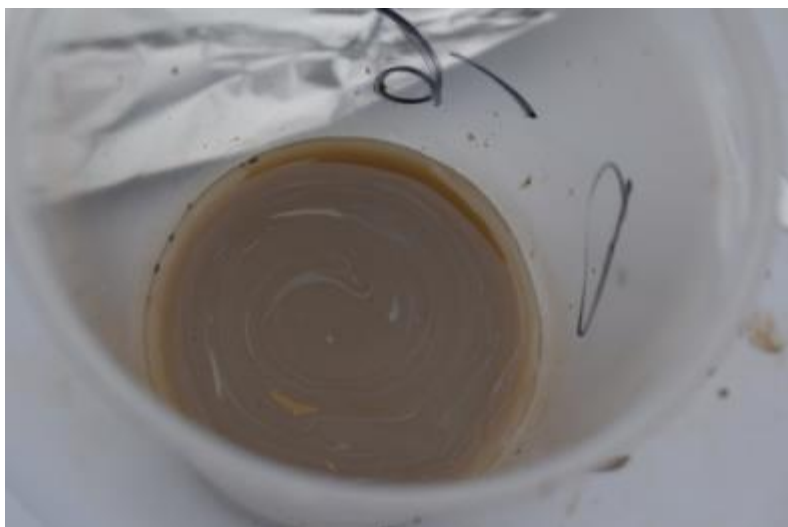
Sheen Stir-Test:

0-6 inches : Streamers of silver gray sheen (Lighter)

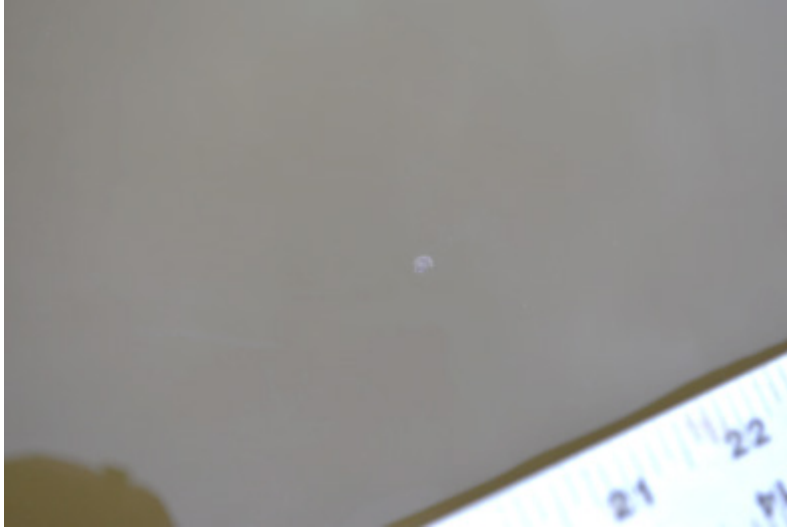
Probing Description:

0-6 inches : Patches/streamers of silver gray sheen with one oil spot (0.25-inch wide)

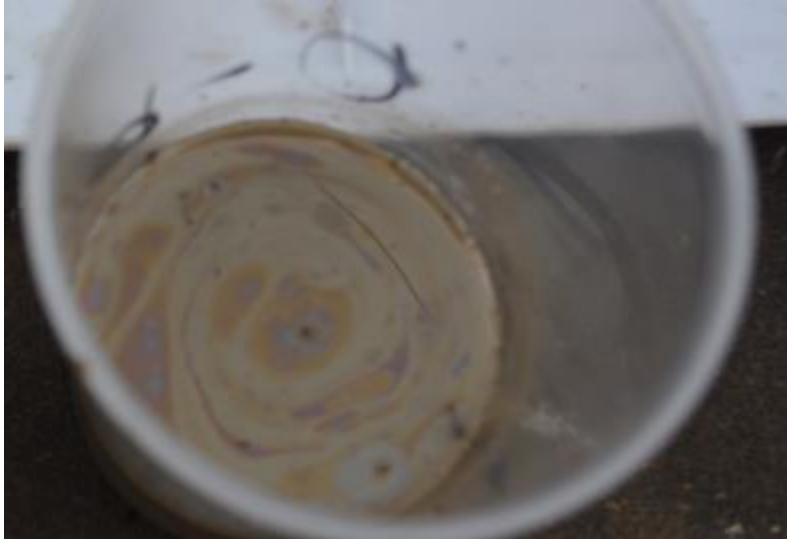
Sheen Stir-Test:

0-6 inches : Patches/streamers of rainbow sheen with 20 oil spots (Heavier)

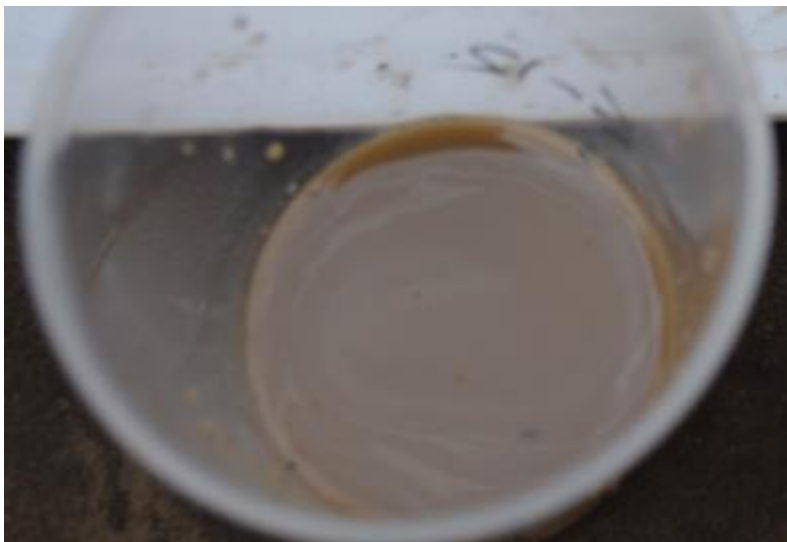
Sheen Stir-Test:

6-12 inches : Streamers of silver gray sheen with oil spot (Medium)

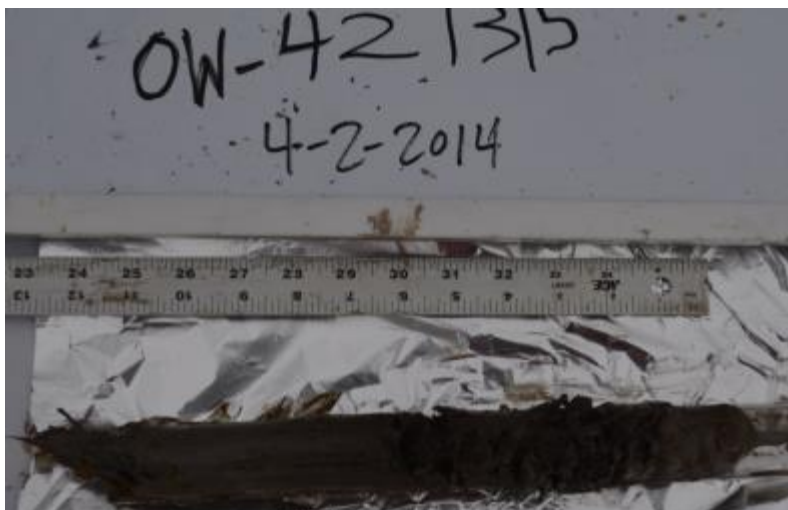
Core Description:

0-6 inches : Brown silt, humic material at 3", light sheen at 0-6"
6-12 inches : Brown clay

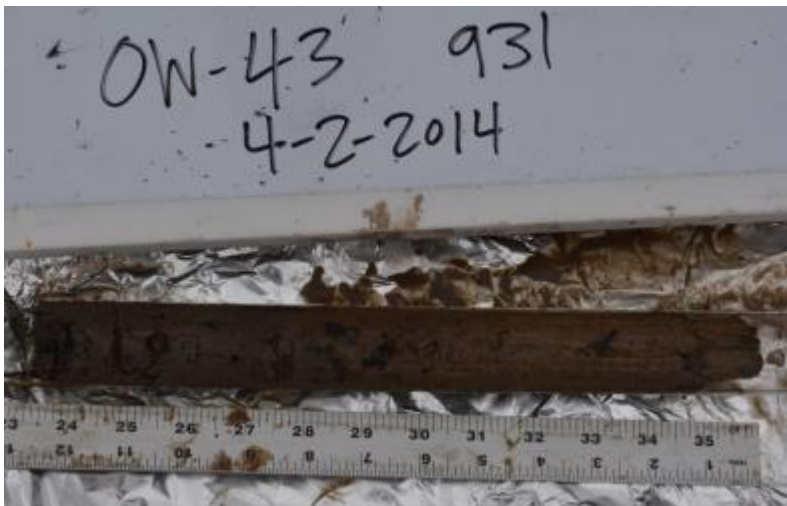
Core Description:

0-6 inches : Gray brown clayey silt with rootlets
6-12 inches : Dark brown clayey silt with rootlets

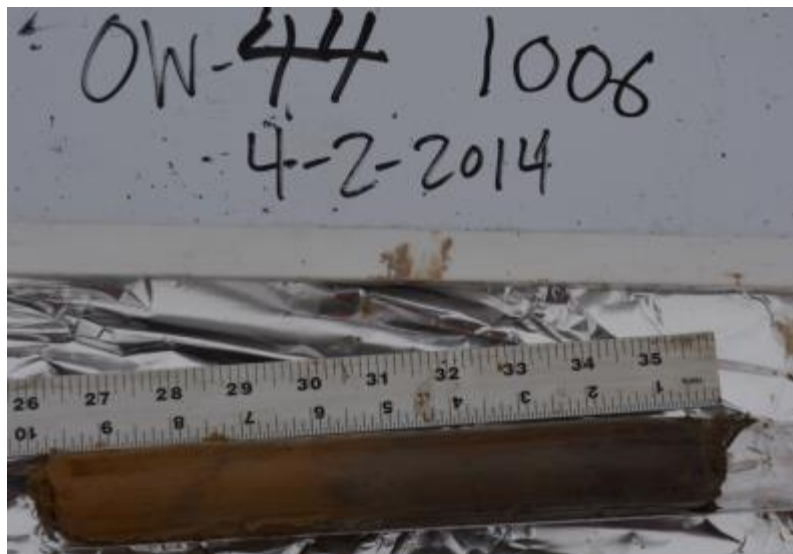
Core Description:

0-6 inches : Brown clay
6-11 inches : Red brown clay

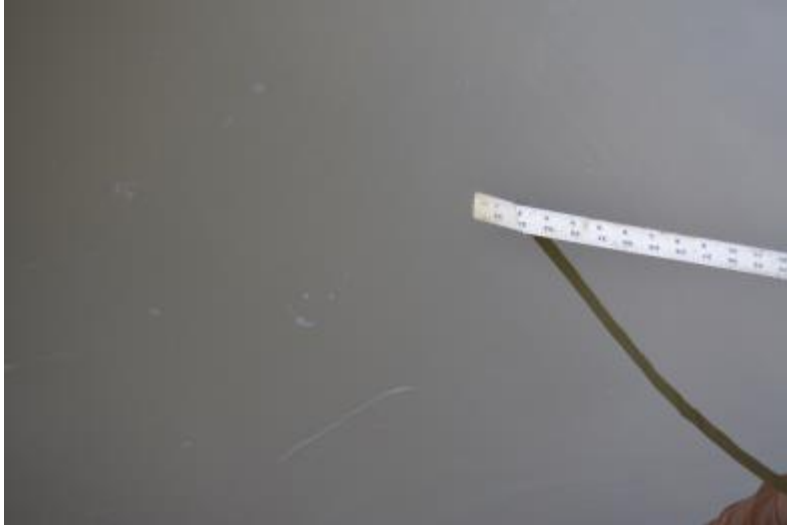
Initial Observation:

Patches/streamers of non-brittle silver gray sheen

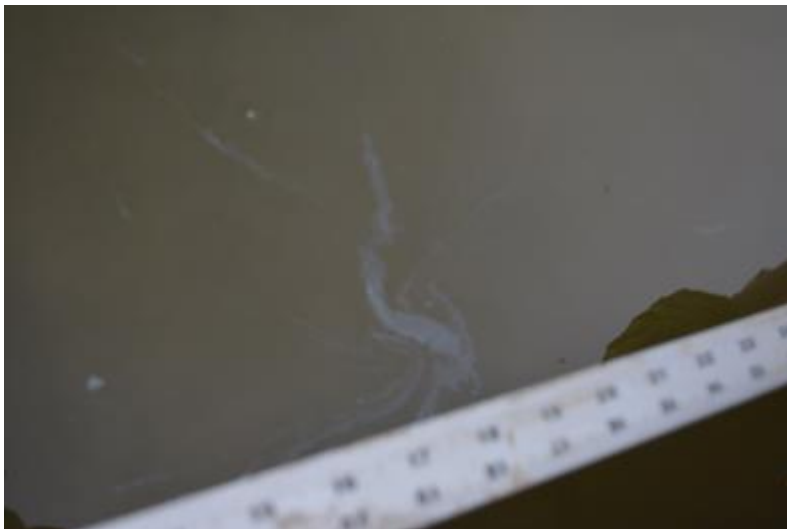
Probing Observation:

Surface : Patches/streamers of non-brittle silver gray sheen
0-6 inches : Patches/streamers of non-brittle silver gray sheen
6-12 inches : Patches/streamers of non-brittle rainbow sheen (heavy sheen)

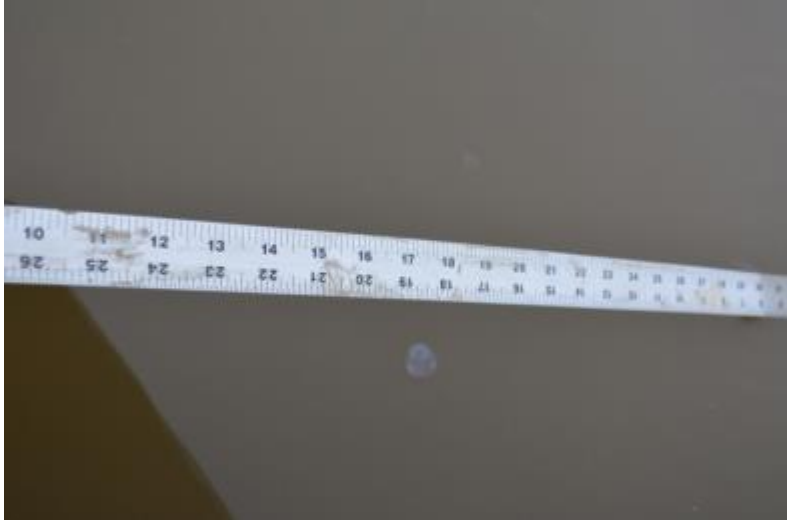
Initial Observation:

Patches (four to five) of non-brittle silver gray sheen
