**Downstream Areas Pre-Design
Study**

**Pre-Design Study – Revision 1
Mayflower Pipeline Incident Response, Mayflower, Arkansas**

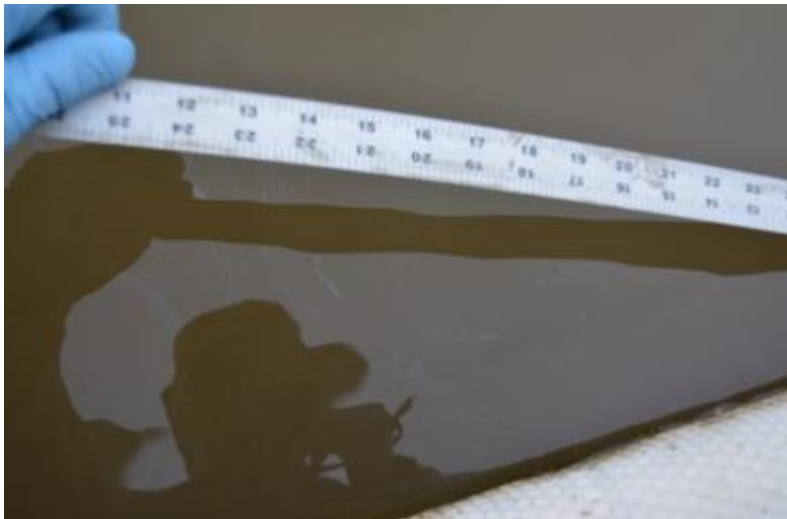
Probing Observation:

Surface : Streamers of non-brittle silver gray sheen
0-6 inches : Streamers of non-brittle silver gray sheen
6-12 inches : Streamers of non-brittle silver gray sheen

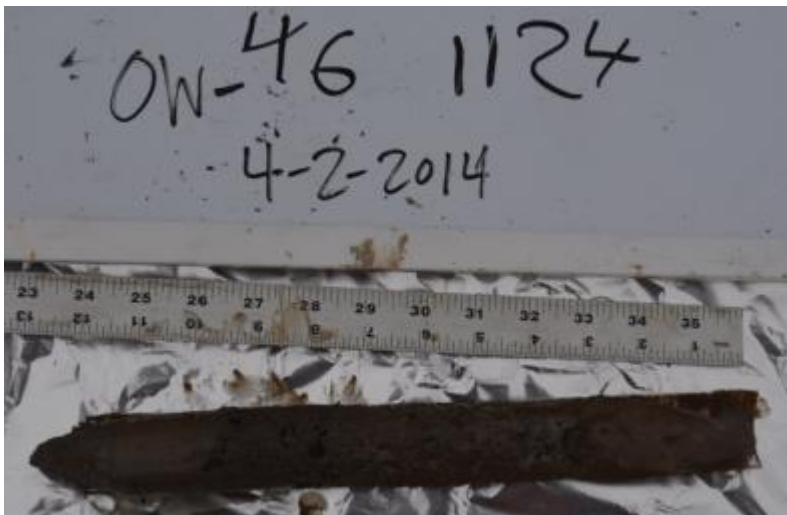
Core Description:

0-6 inches : Brown silt, medium sheen at 0-5"
6-12 inches : Brown silty clay

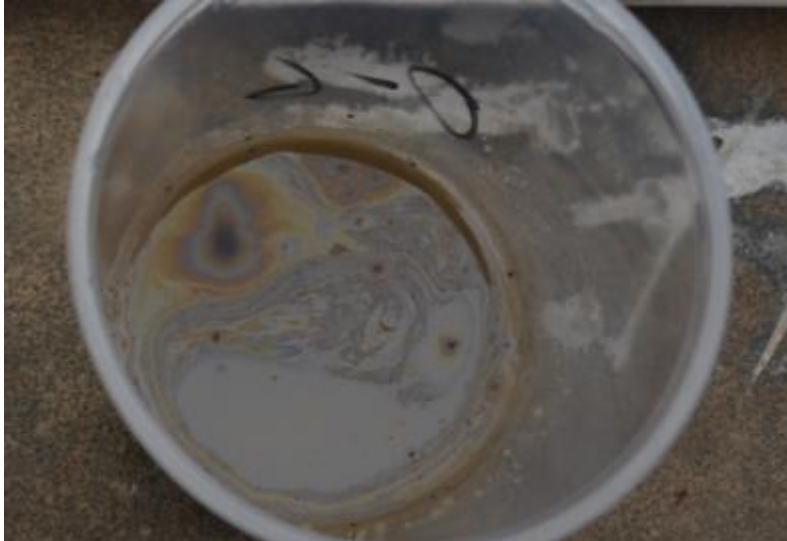
Sheen Stir-Test:

0-6 inches : Patches/streamers of rainbow sheen with oil spots (Heavier)

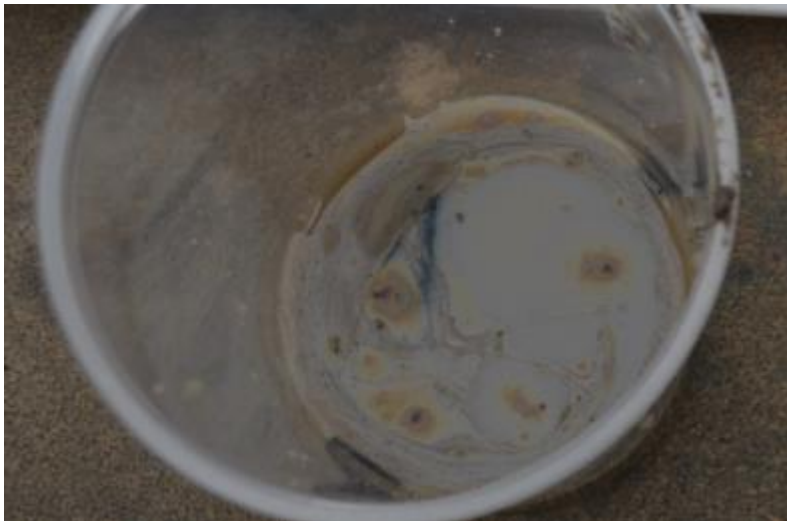
Sheen Stir-Test:

6-12 inches : Patches/streamers of rainbow sheen with oil spots (Heavier)

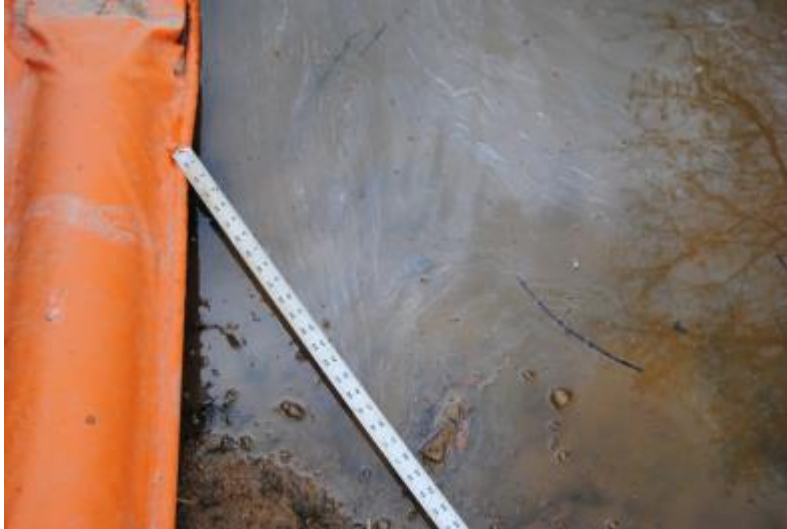
Initial Observation:

Streamers of non-brittle rainbow sheen

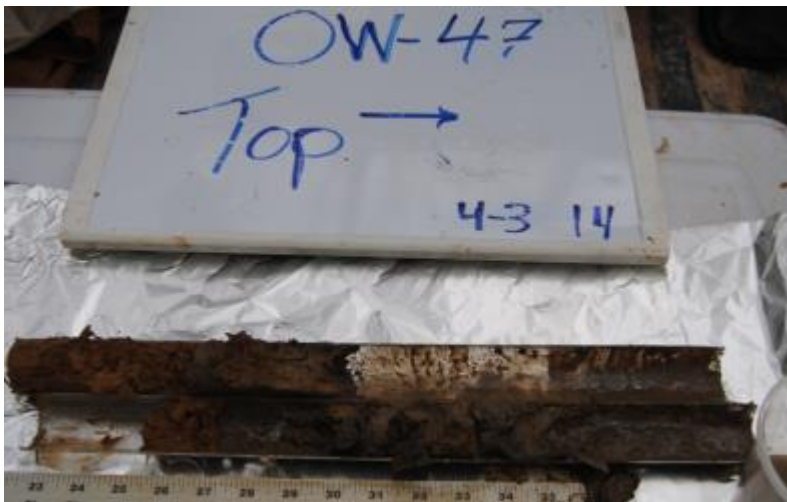
Probing Observation:

Surface : Patches of non-brittle silver gray sheen
0-6 inches : Patches of non-brittle silver gray sheen
6-12 inches : Patches of non-brittle silver gray sheen

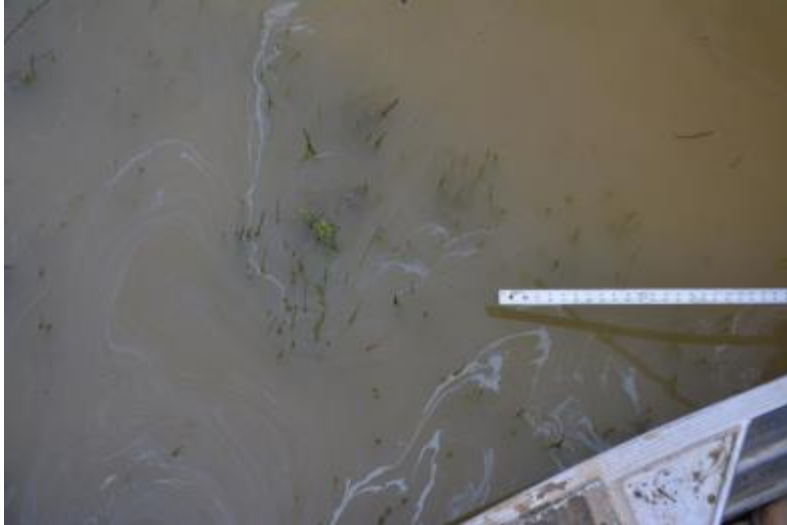
Initial Observation:

Streamers of non-brittle rainbow sheen with eight oil spots (<0.25-inch wide)

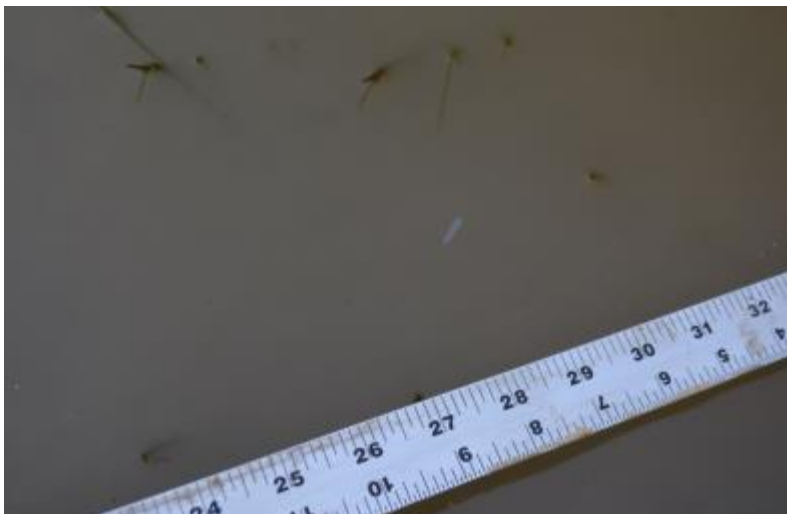
Probing Observation:

Surface : Patches of non-brittle silver gray sheen
0-6 inches : Patches of non-brittle silver gray sheen

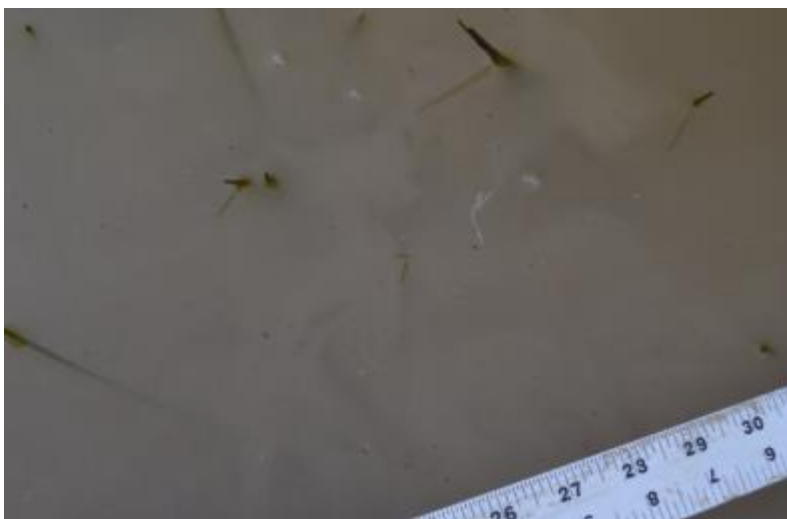
Probing Observation:

6-12 inches : Streamers of non-brittle silver gray sheen

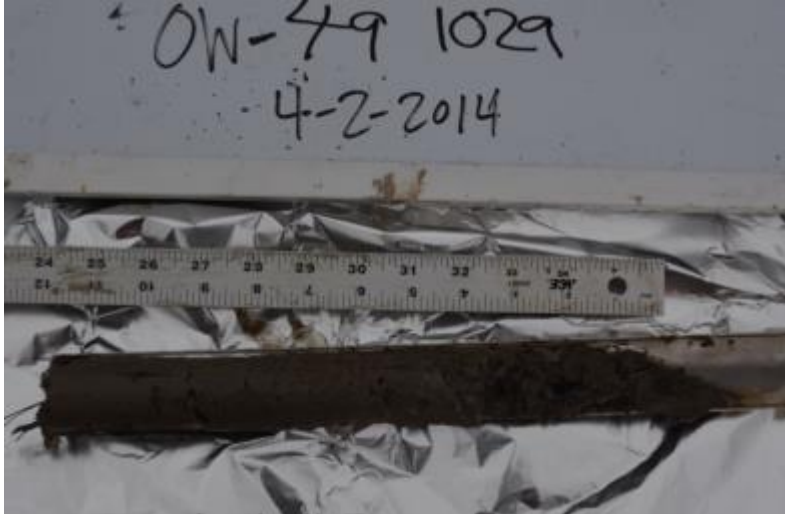
Core Description:

0-6 inches : Humic material, visible sheen at 0-5"
6-12 inches : Brown silty clay, roots

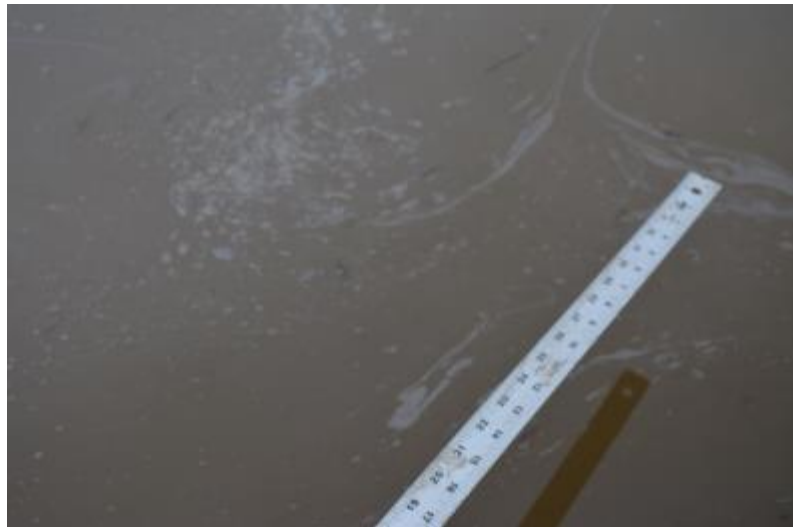
Initial Observation:

Patch/streamer of non-brittle rainbow sheen with about 100 oil spots

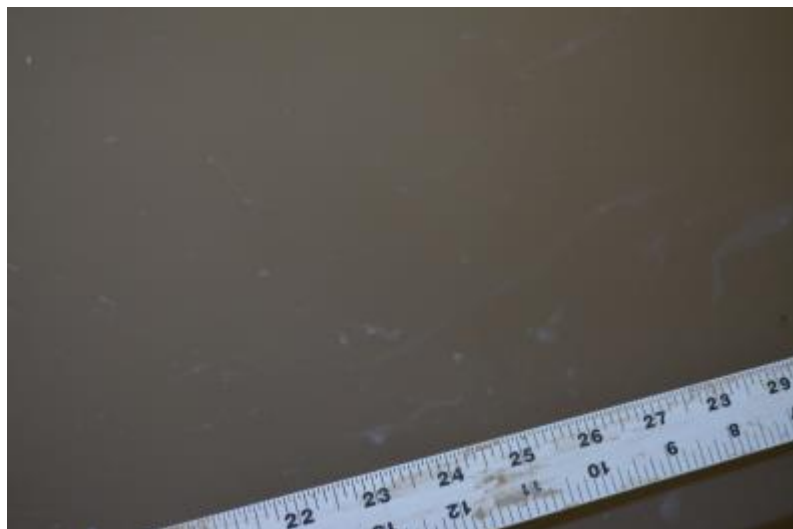
Probing Observation:

Surface : Patches/streamers of non-brittle silver gray sheen with two oil spots (<0.25-inch wide)
0-6 inches : Patches/streamers of non-brittle silver gray sheen with four oil spots (<0.25-inch wide)
6-12 inches : Patches/streamers of non-brittle silver gray sheen with five oil spots (0.1-inch wide)

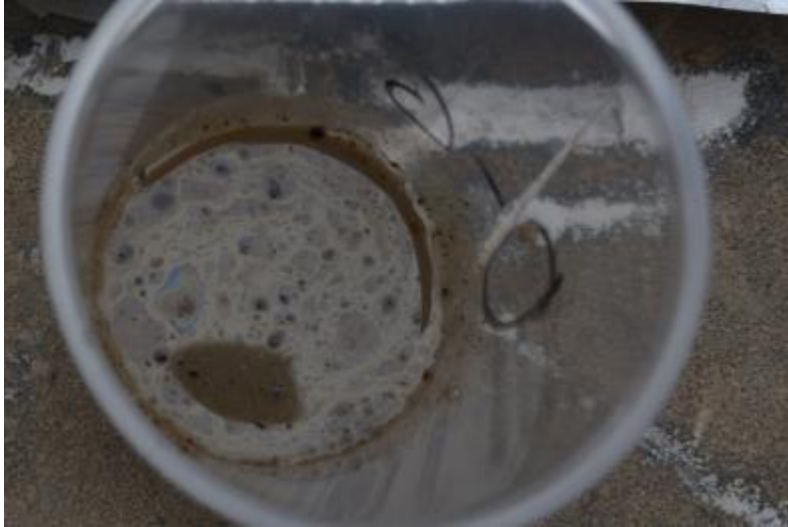
Sheen Stir-Test:

0-6 inches : Patches/streamers of rainbow sheen with oil spots (Heavier)

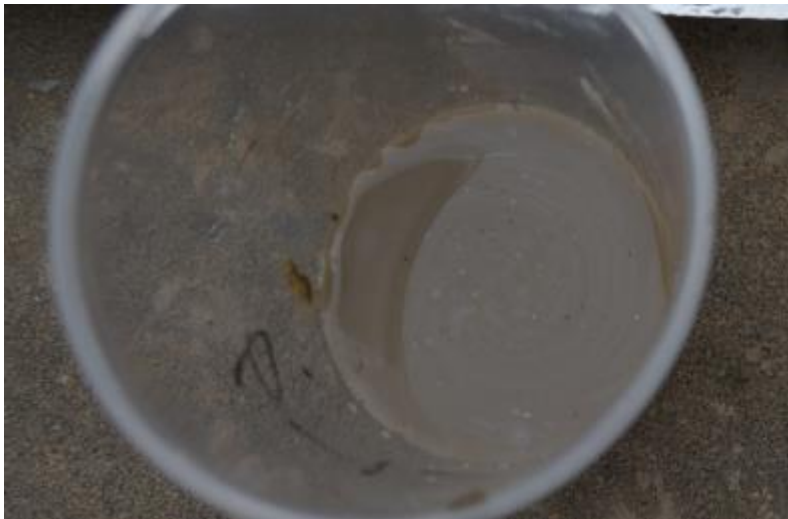
Sheen Stir-Test:

6-12 inches : Streamers of silver gray sheen (Lighter)

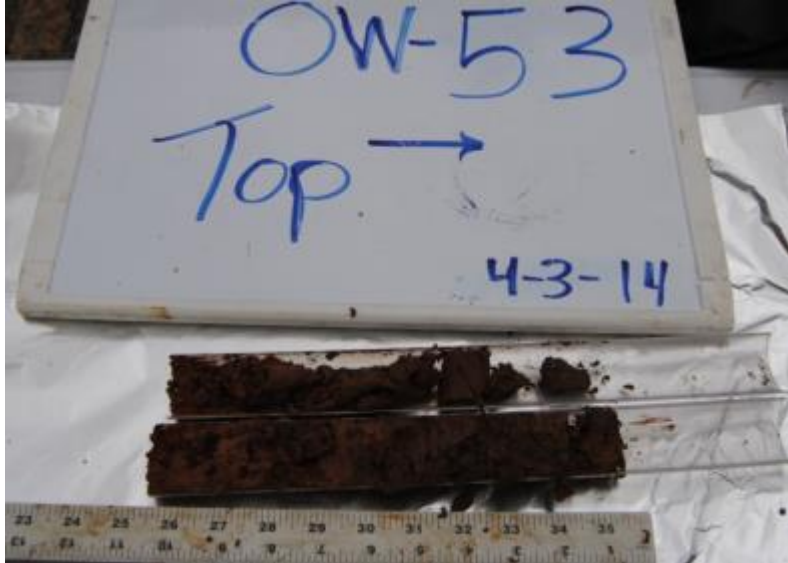
Core Description:

0-10 inches : Gray and reddish brown mottled clayey silt (MH)

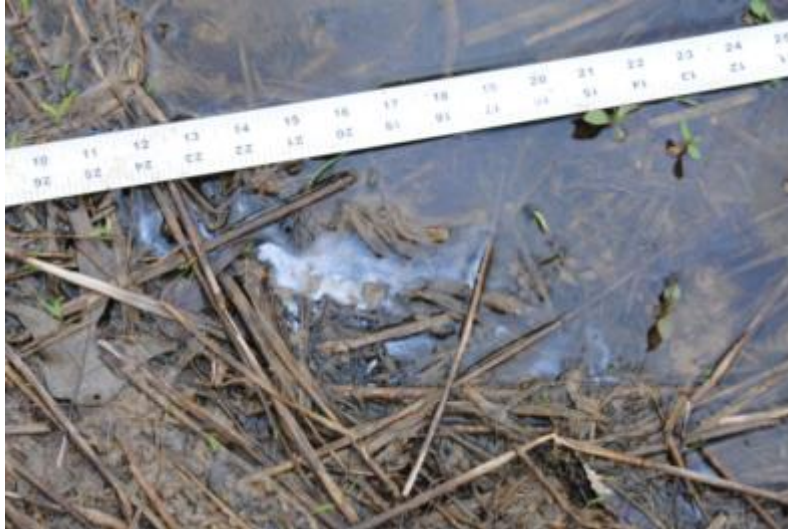
Cover of brittle rainbow sheen

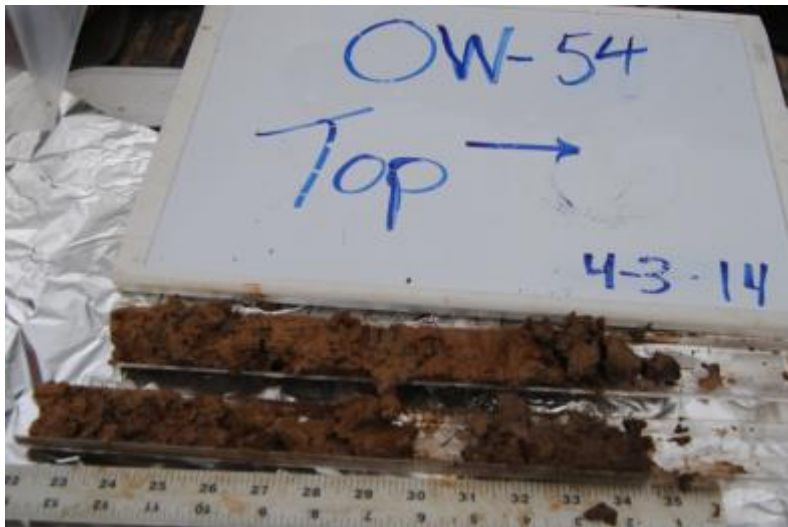
No description

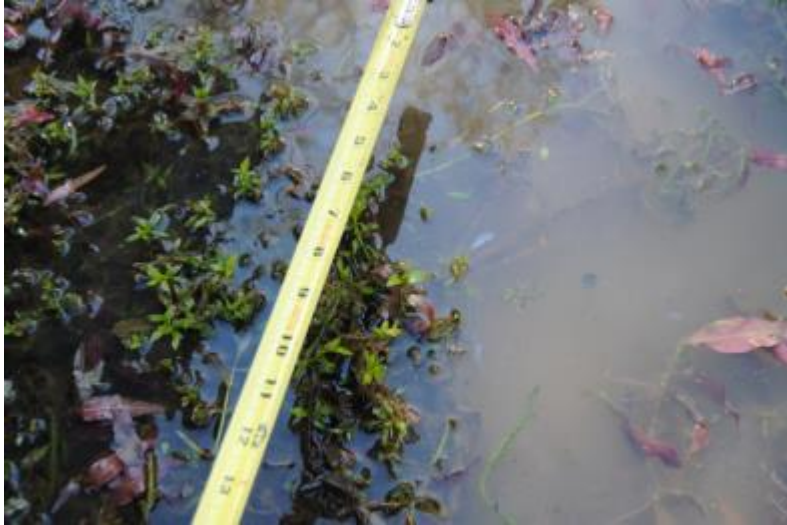
0-6 inches : Streamers of non-brittle silver gray sheen
6-12 inches : Streamers of non-brittle silver gray sheen

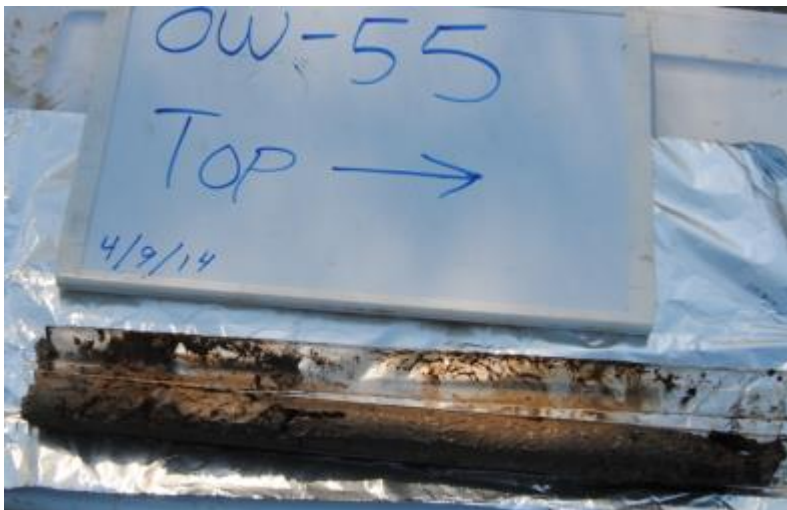
0-6 inches : Gray clayey silt with organic material
6-12 inches : Gray and reddish brown mottled clayey silt (MH)

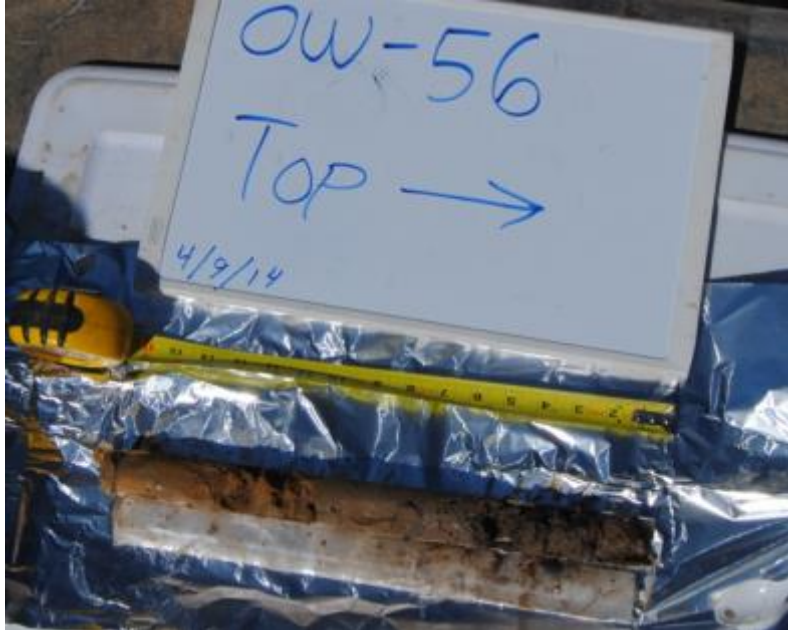
0-5 inches : Gray silty clay with organic material
5-12 inches : Gray and reddish brown mottled clayey silt (MH)

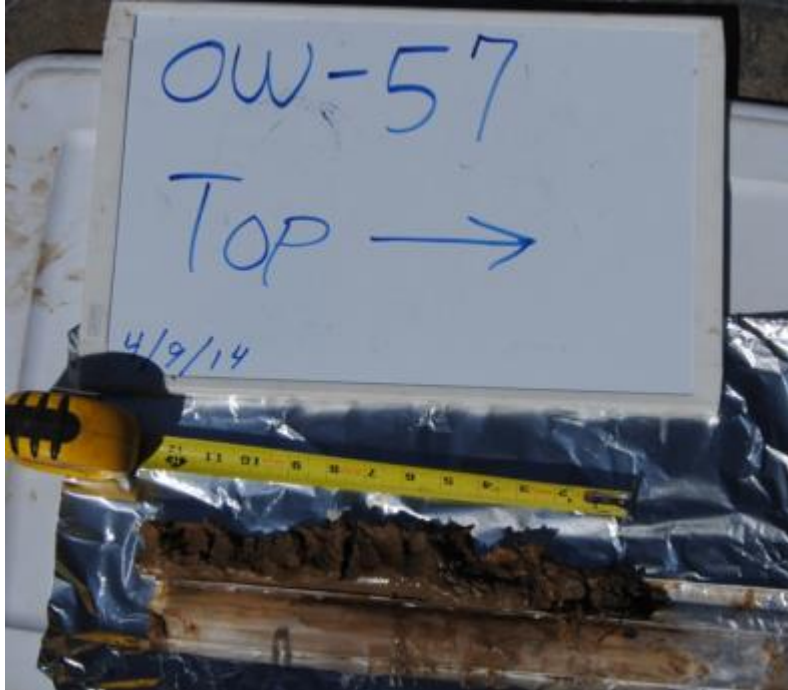
0-4 inches : Gray silty clay with organic material
4-12 inches : Gray and reddish brown clayey silt (MH)

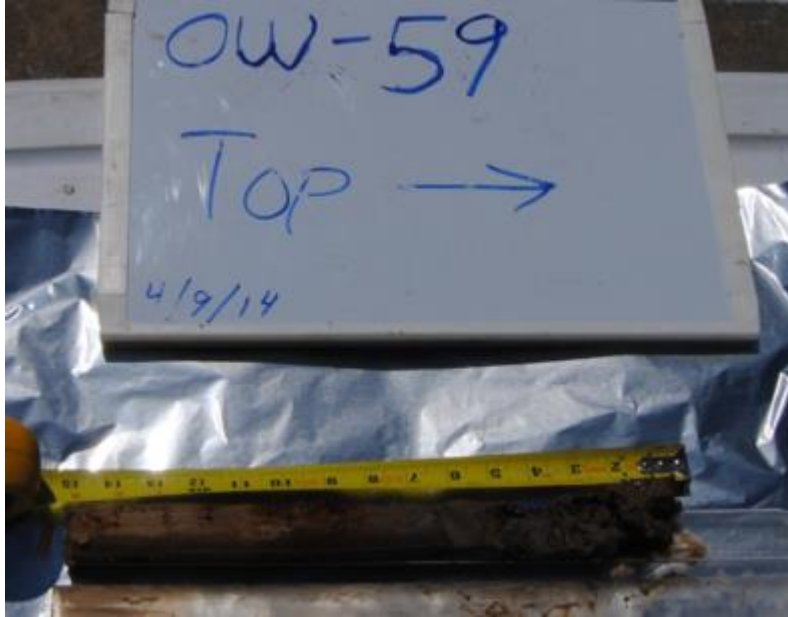
0-4 inches : Gray silty clay (CL) with organic material, soft
4-12 inches : Gray and reddish brown clayey silt (MH)

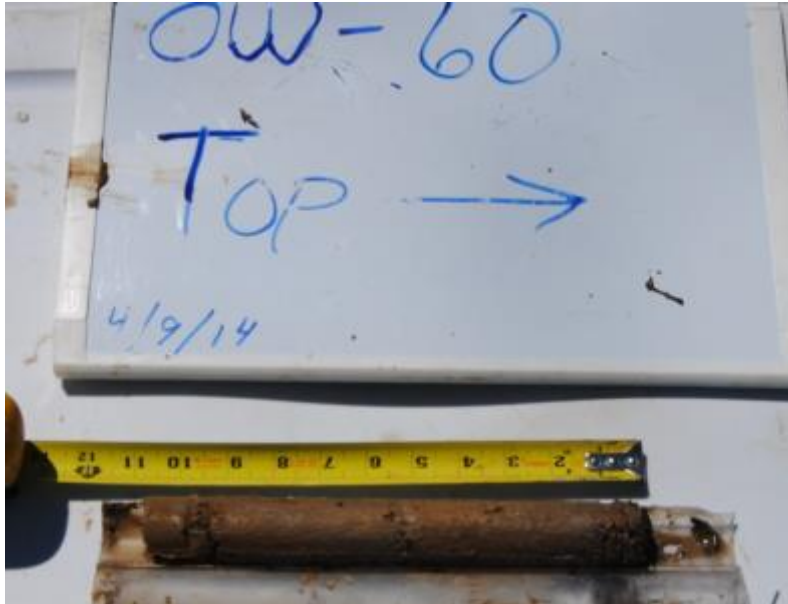
0-2 inches : Gray silty clay (CL) with organic material
2-10.5 inches : Gray and reddish brown clayey silt (MH)

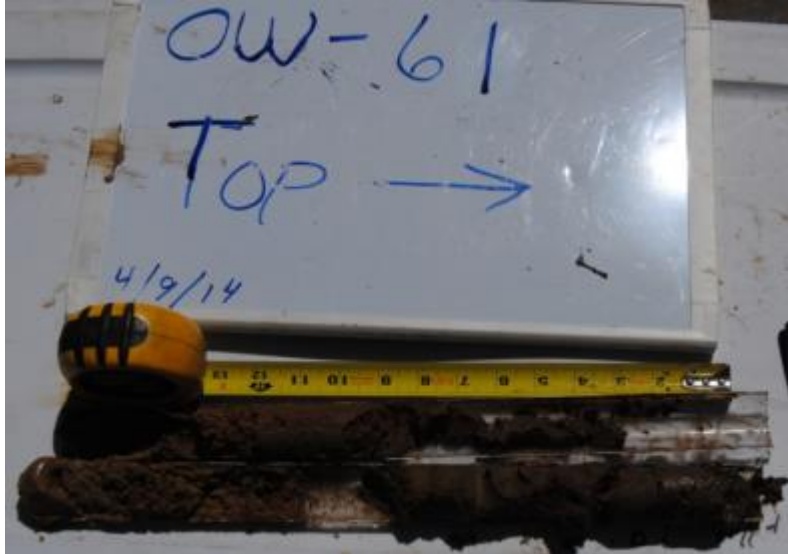
0-12 inches : Gray and reddish brown mottled silt with clay

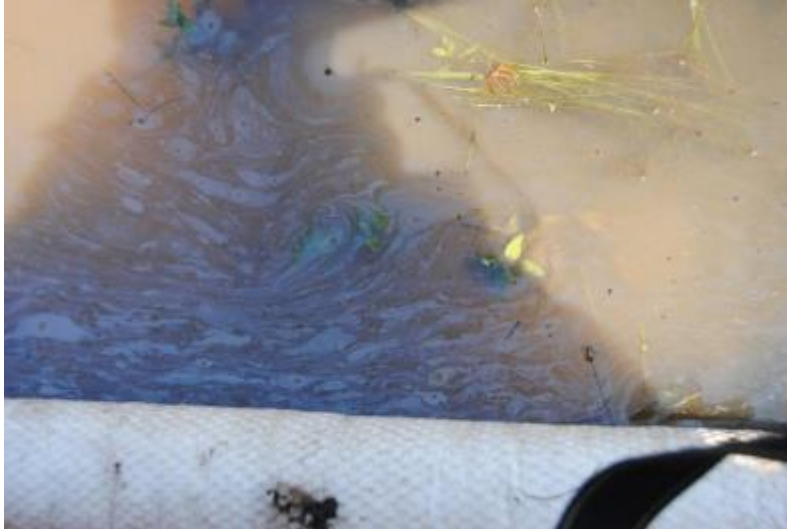
Surface : Streamers of non-brittle silver gray sheen with oil spots (<0.5-inch wide)
0-6 inches : Streamers of non-brittle silver gray sheen with oil spots (<0.5-inch wide)
6-12 inches : Streamers of non-brittle silver gray sheen with oil spots (<0.5-inch wide)

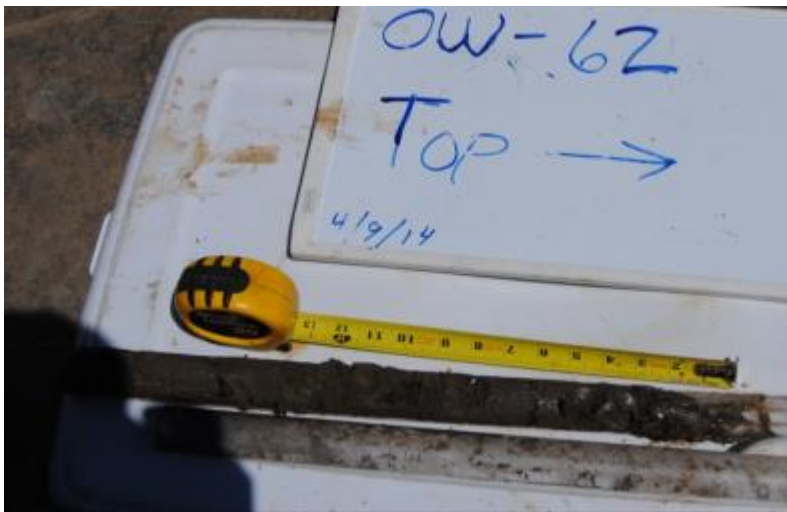
0-12 inches : Gray silty clay (CL), soft

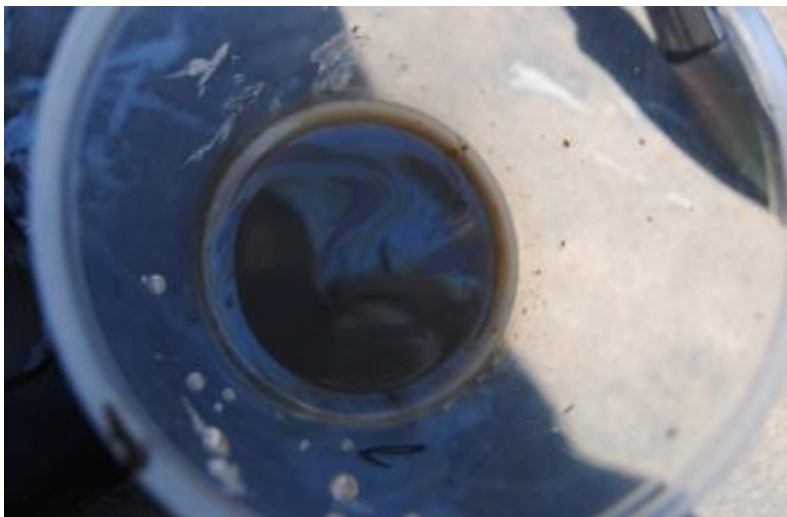
0-6 inches : Streamers of rainbow sheen (Heavier)

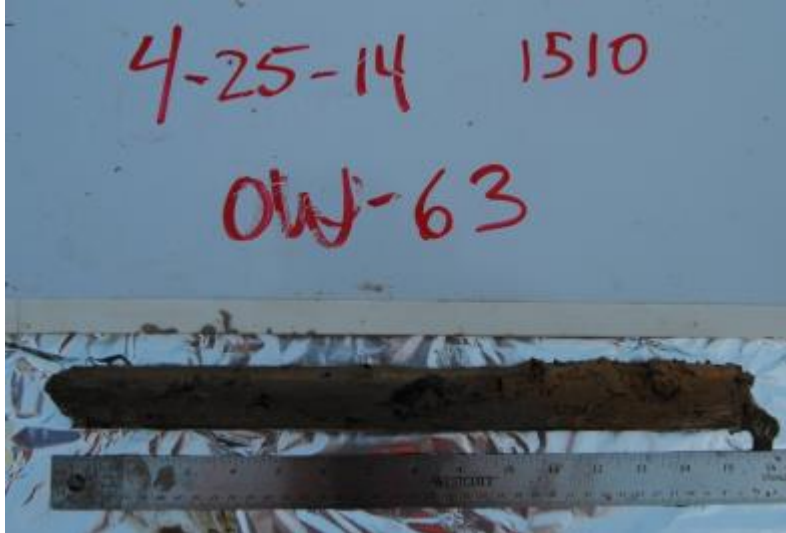
0-6 inches : Brownish gray sandy silt loam
with organic material and roots
6-12 inches : Grayish brown clay loam

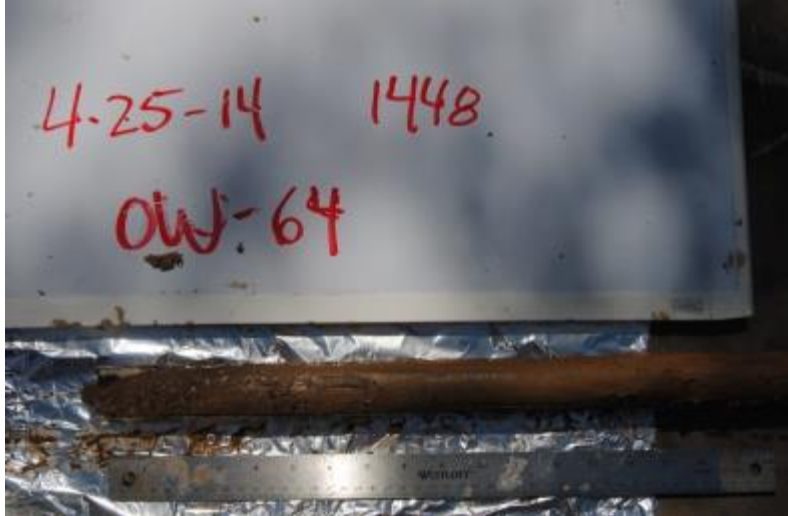
0-6 inches : Brown silt loam with organic material
6-12 inches : Grayish brown clay sand loam

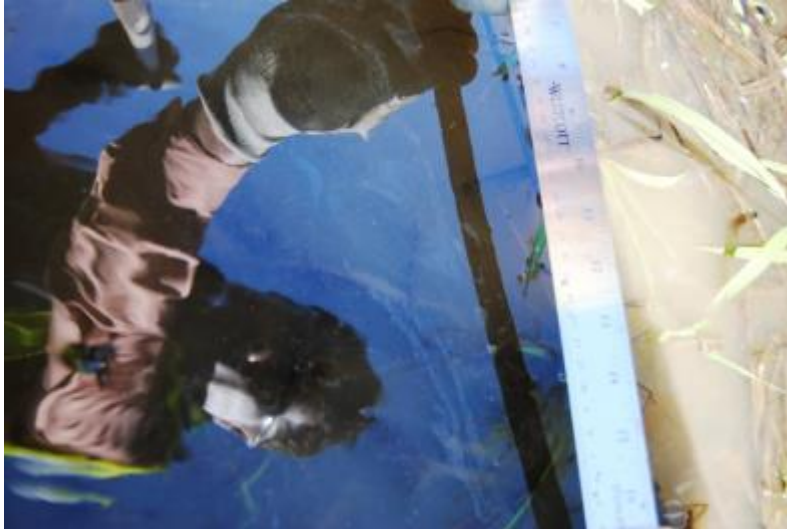
6-12 inches : Streamers of non-brittle silver gray sheen

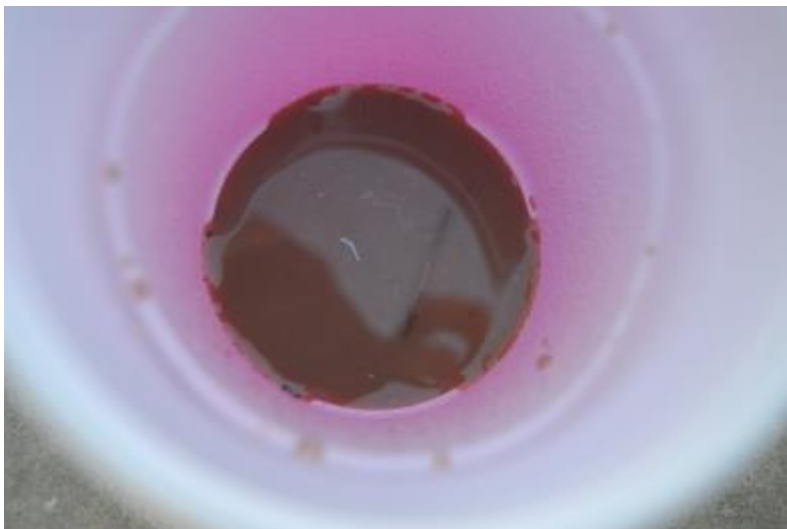
6-12 inches : Streamers of silver gray sheen (Lighter)

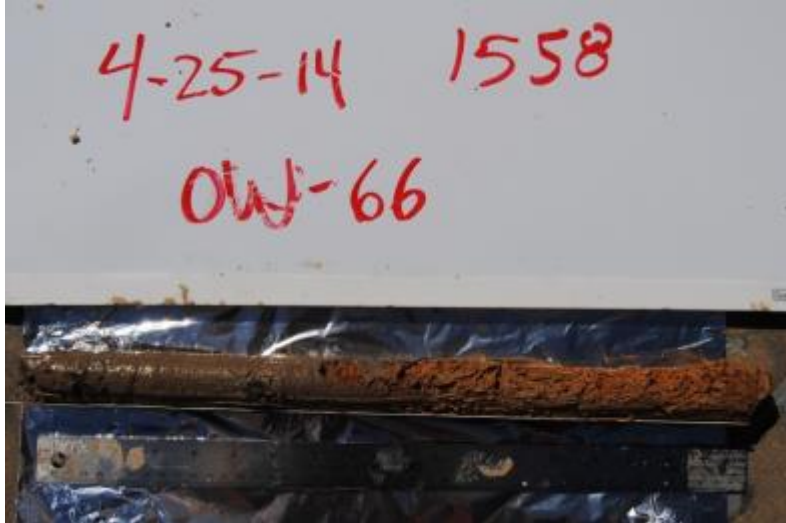
0-6 inches : Gray clay loam with redox
6-12 inches : Light brown silt loam, friable

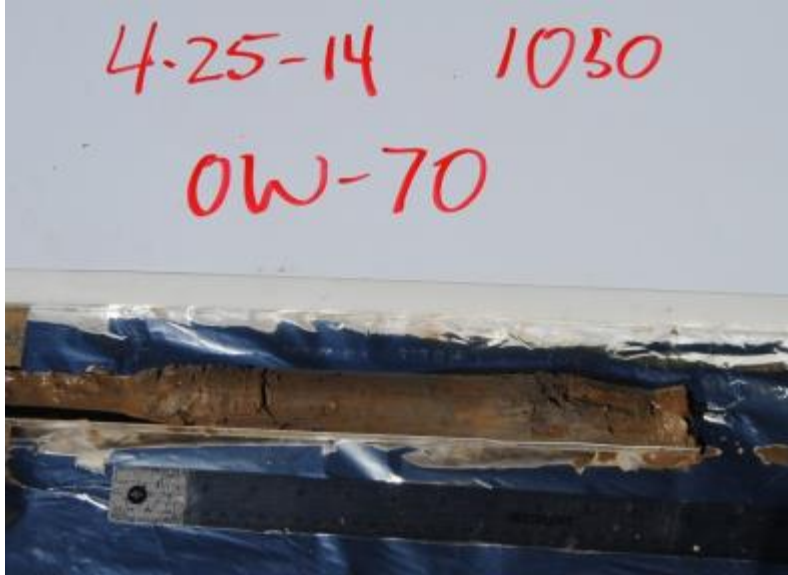
0-6 inches : Gray clay loam with rootlets
6-12 inches : Gray clay loam

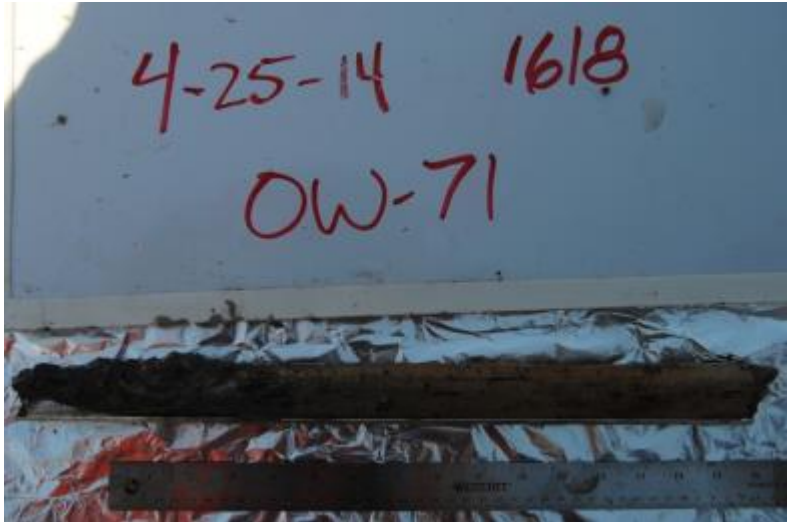
0-6 inches : Brownish gray silt loam, some sheen at 0-4"
6-12 inches : Brown silt-clay loam, friable

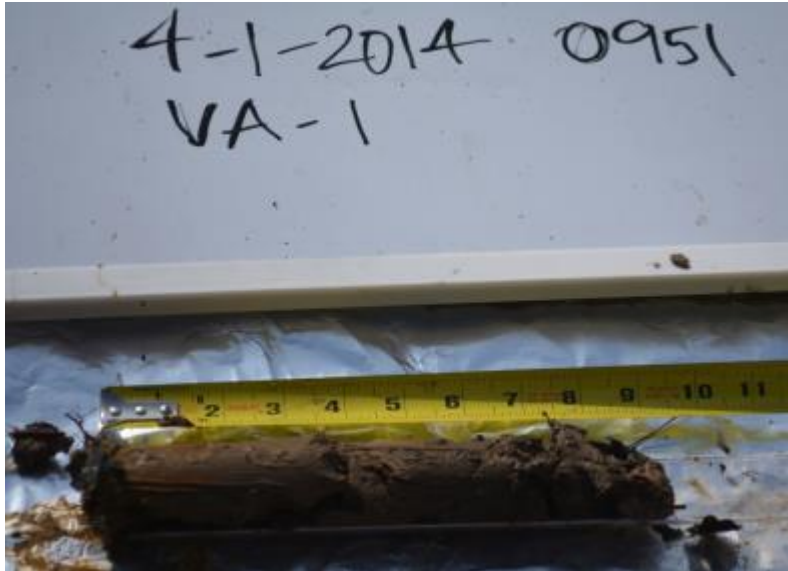
0-0.1 inches : Humic material with organics
0.1-6 inches : Reddish brown clay, no plasticity

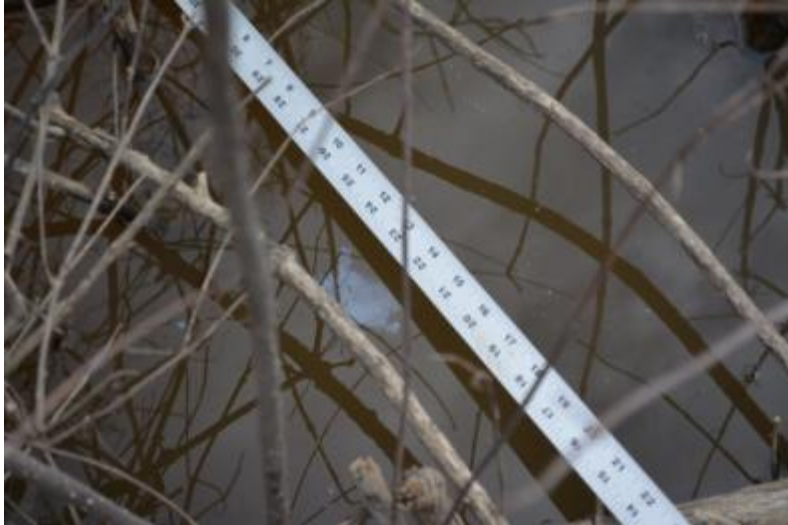
Patches of brittle silver gray sheen

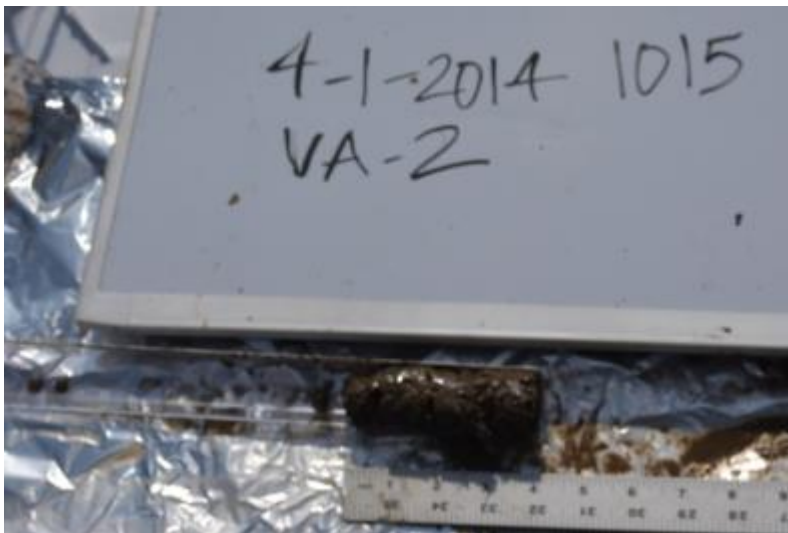
No description

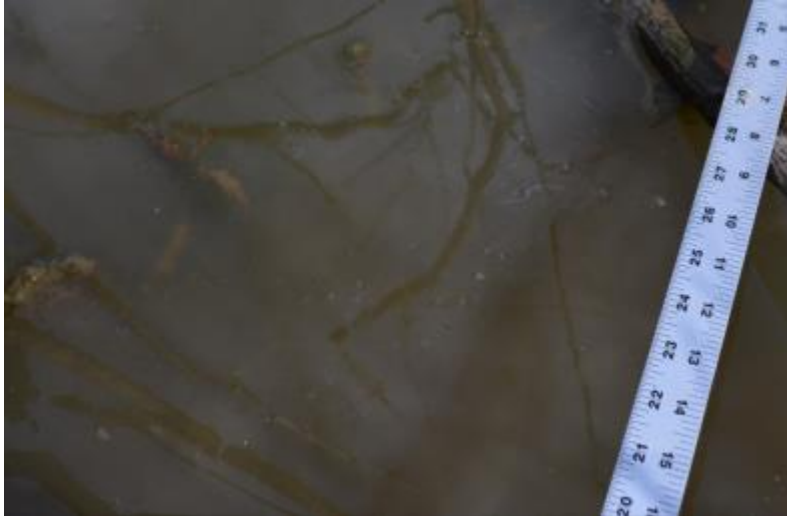
Surface : Patches/streamers of non-brittle silver gray sheen (light sheen)
0-6 inches : Patches/streamers of non-brittle silver gray sheen (light sheen)

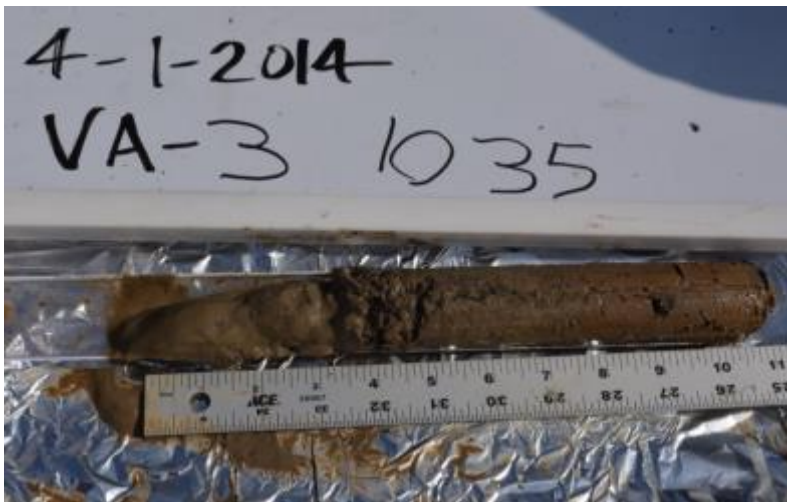
0-0.1 inches : Humic material with organics
0.1-6 inches : Brown silty clay with rootlets

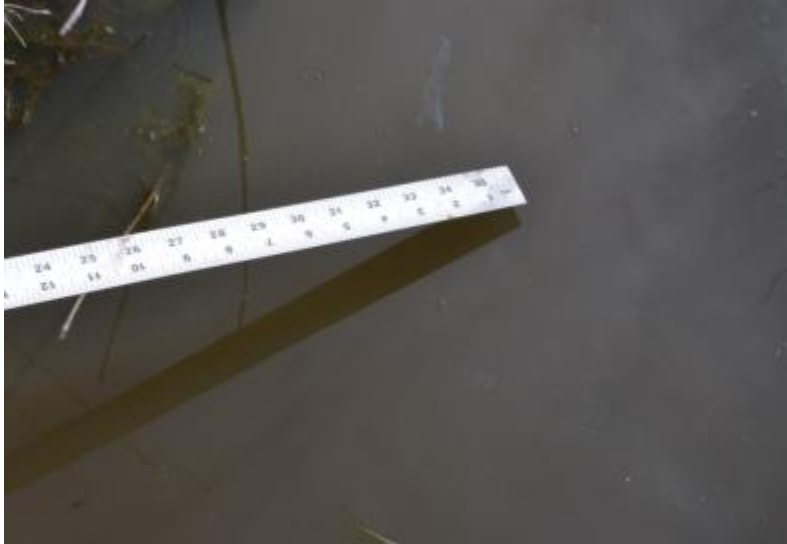
Patches of non-brittle silver gray sheen

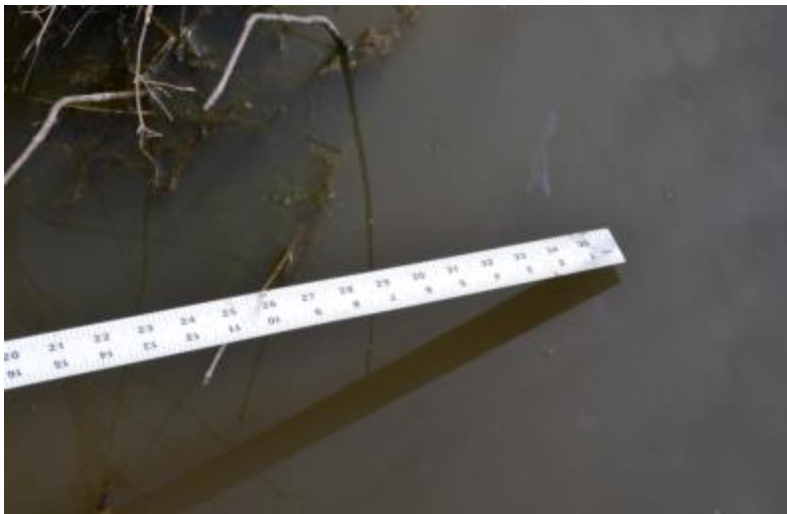
0-6 inches : Streamer (< 6") of non-brittle silver gray sheen
6-12 inches : Streamer (< 6") of non-brittle silver gray sheen (light sheen)

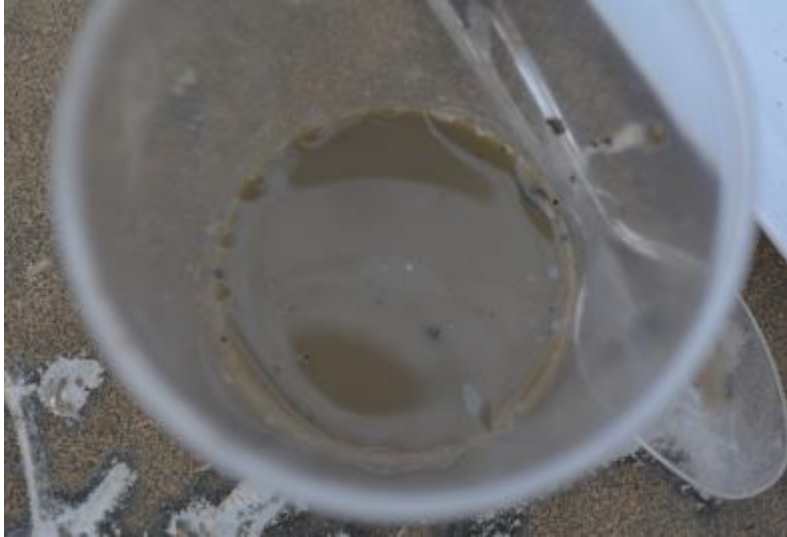
0-0.1 inches : Patches of silver gray sheen
(Lighter)

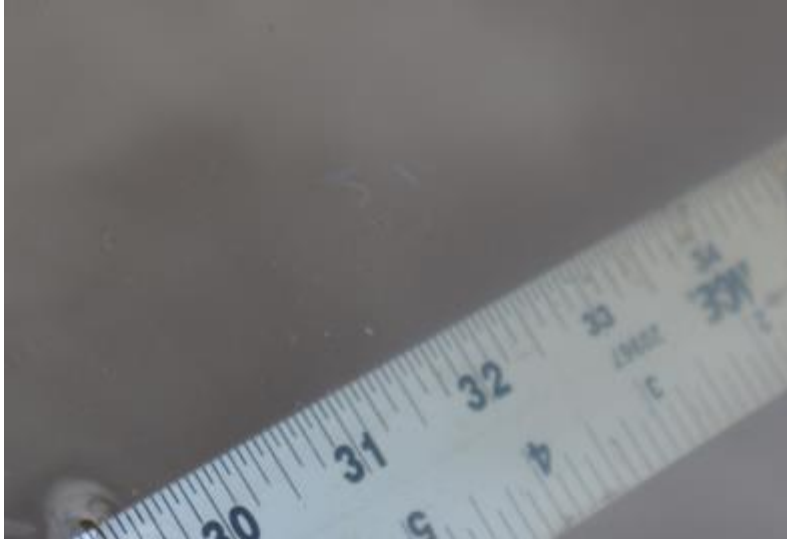
6-12 inches : Patch (< 1") of non-brittle silver gray sheen

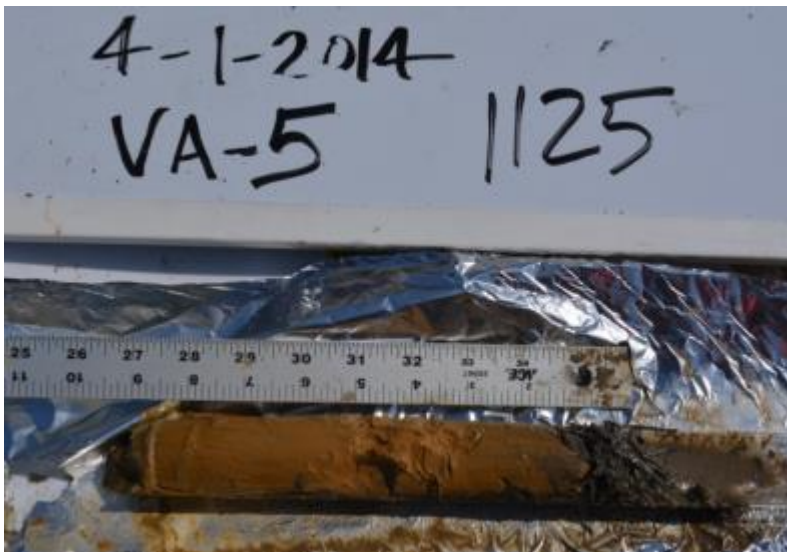
0-0.1 inches : Humic material with twigs
0.1-6 inches : Reddish brown clay, soft

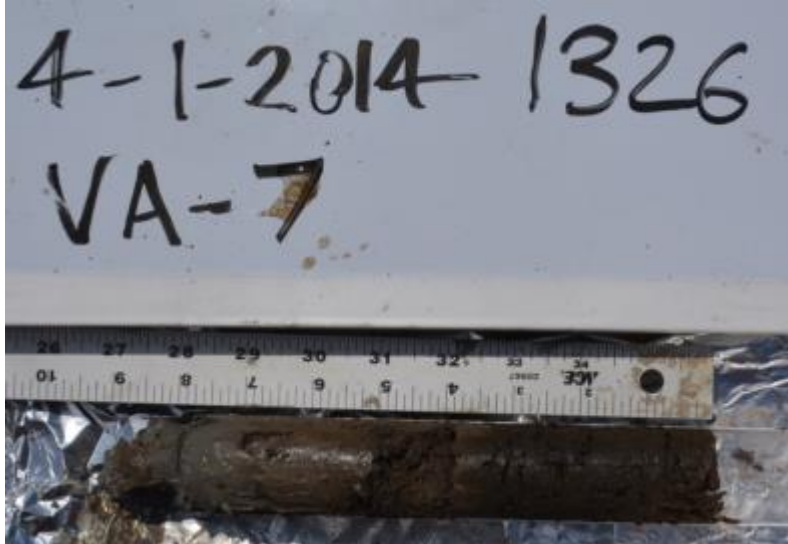
0-0.1 inches : Humic material
0.1-6 inches : Gray clayey silt

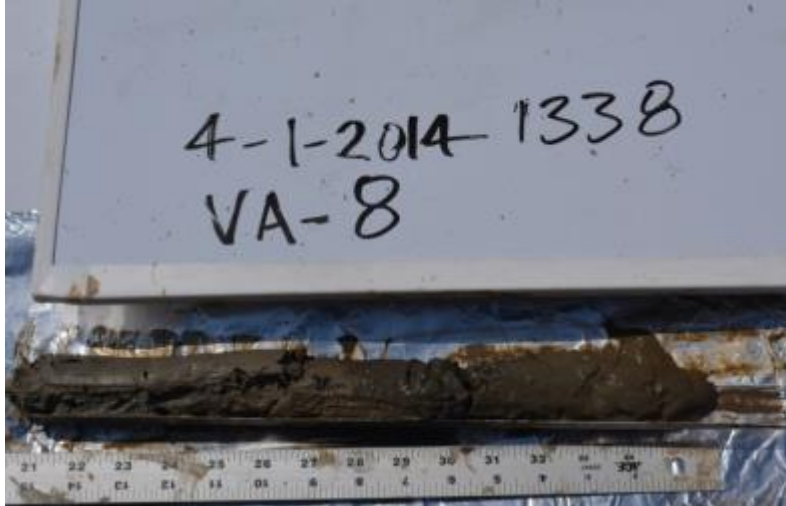
0-0.1 inches : Brown silt
0.1-6 inches : Silt with humic material, some clay

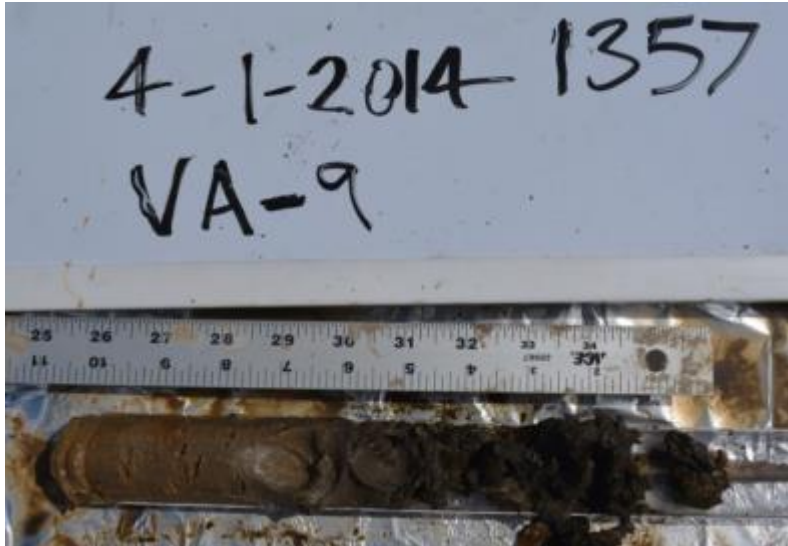
0-0.1 inches : Silt, organic matter (light sheen observed)
0.1-6 inches : Silty clay, soft

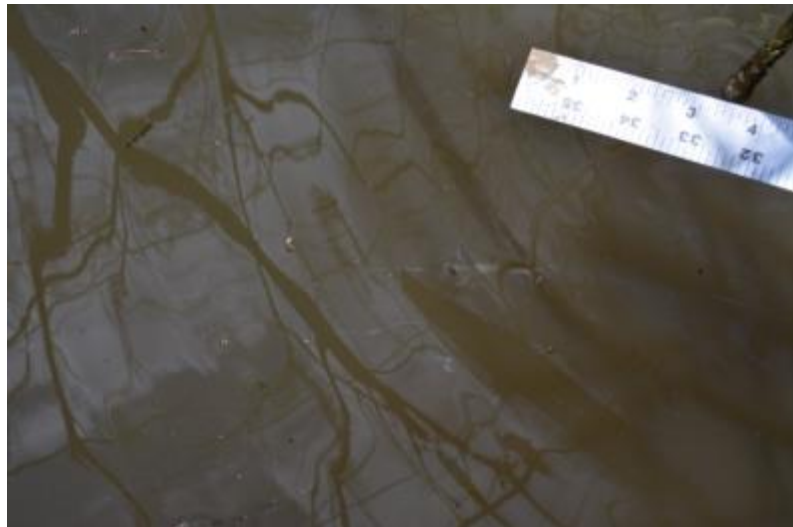
Streamer of non-brittle silver gray sheen with four oil spots (<0.1-inch)

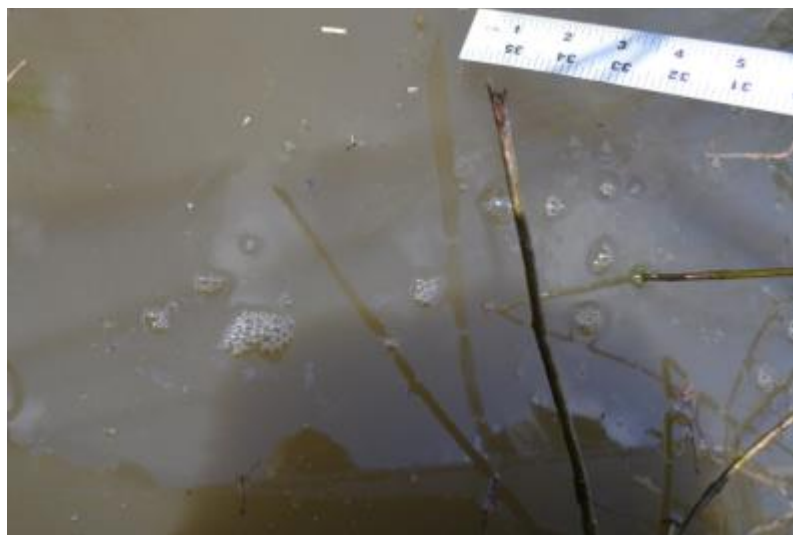
Surface : Patches/streamers of non-brittle silver gray sheen
0-6 inches : Patches/streamers of non-brittle silver gray sheen
6-12 inches : Patches/streamers of non-brittle silver gray sheen

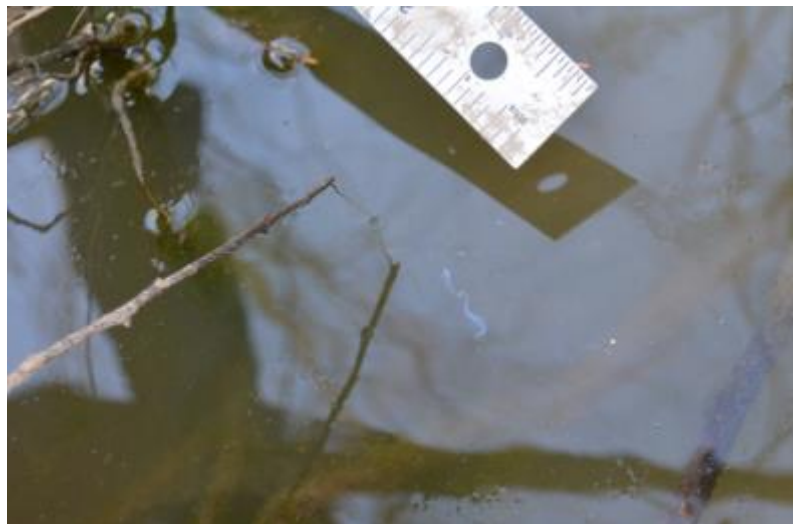
Patches/streamers of non-brittle silver gray sheen

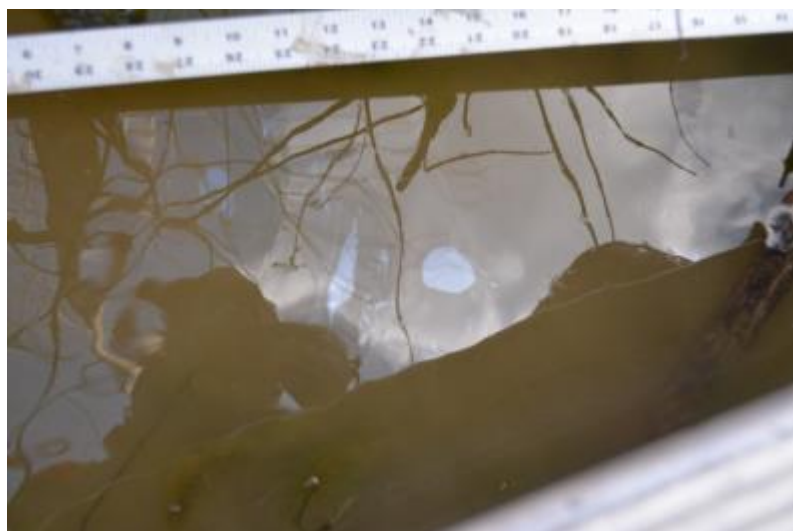
Surface : Patches/streamers of non-brittle silver gray sheen
0-6 inches : Patches/streamers of non-brittle silver gray sheen (light sheen)
6-12 inches : Patches/streamers of non-brittle silver gray sheen
