**Downstream Areas Pre-Design
Study**

**Pre-Design Study – Revision 1
Mayflower Pipeline Incident Response, Mayflower, Arkansas**

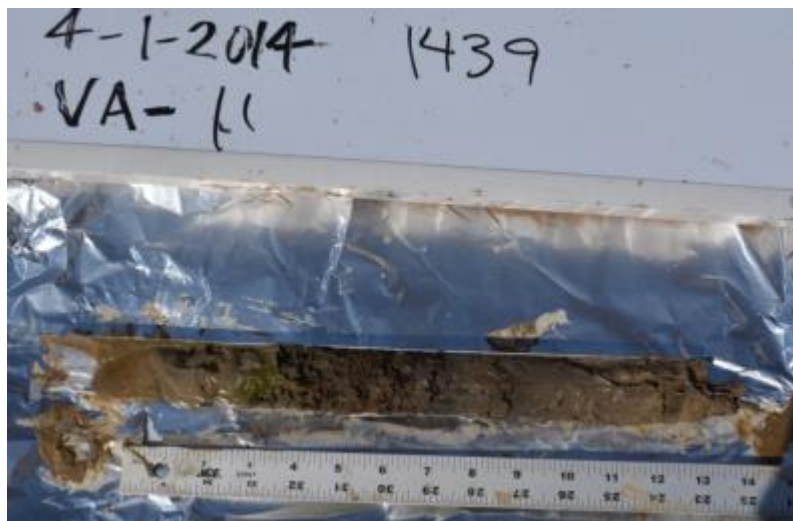
0-0.1 inches : Brown silt, very little visible sheen
0.1-6 inches : Silt, humic material, roots, very little sheen in 0.1-4"

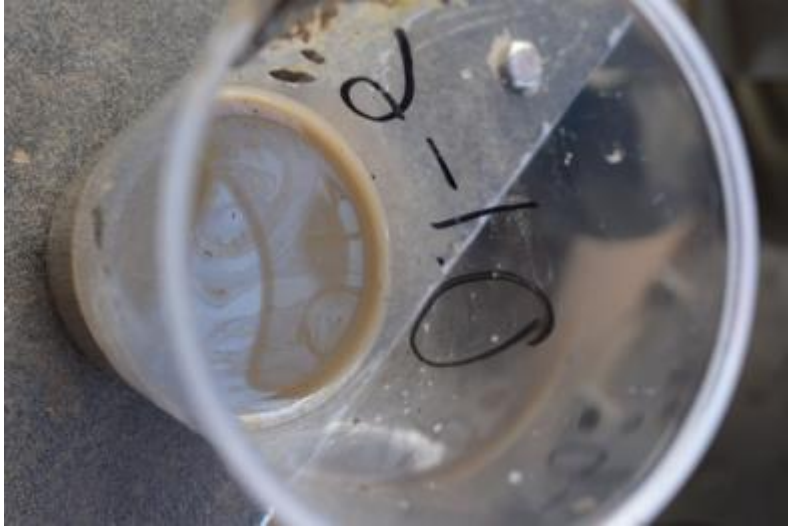
0.1-6 inches : Streamers of silver gray sheen
(Medium)

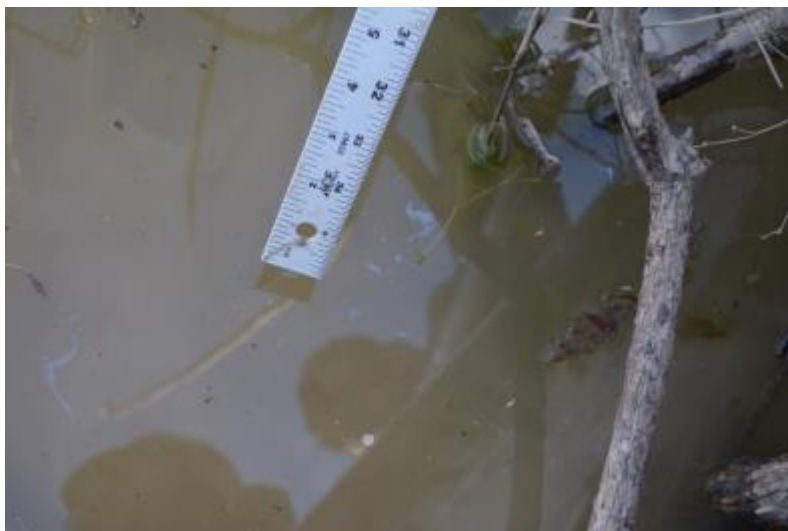
Surface : Patches/streamers of non-brittle silver gray sheen

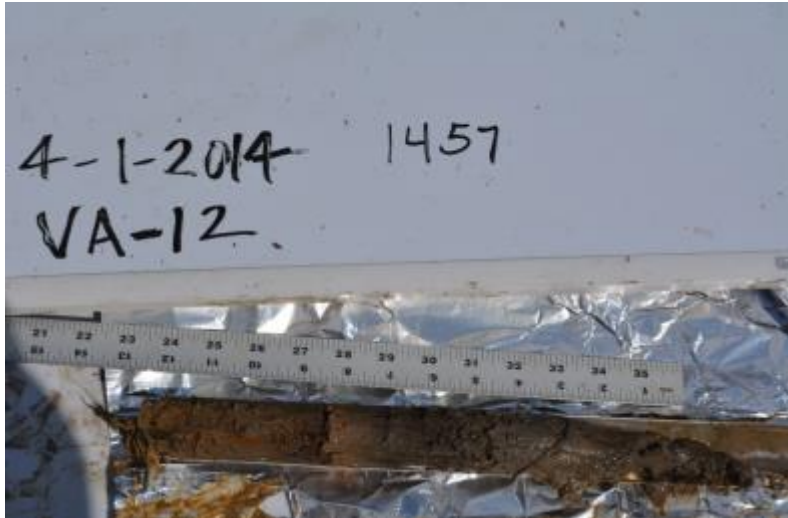
0-0.1 inches : Dark brown silt, very little sheen
0.1-6 inches : Brown silty clay

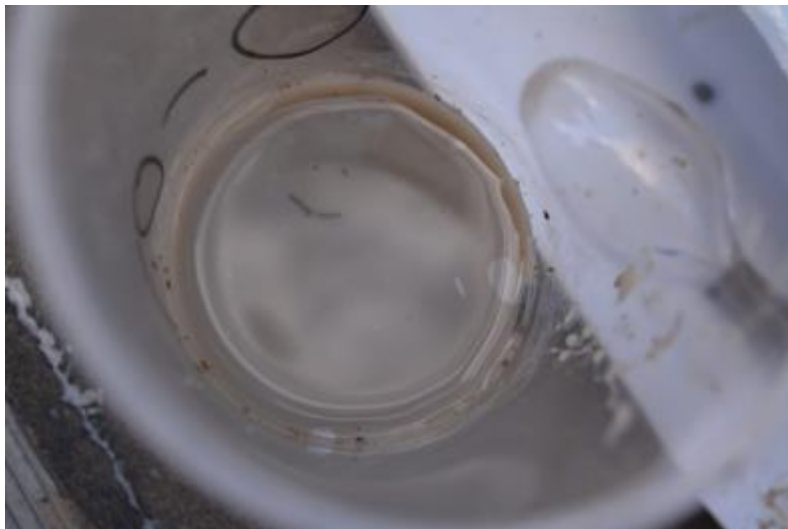
0-0.1 inches : Patches of silver gray sheen
(Lighter)

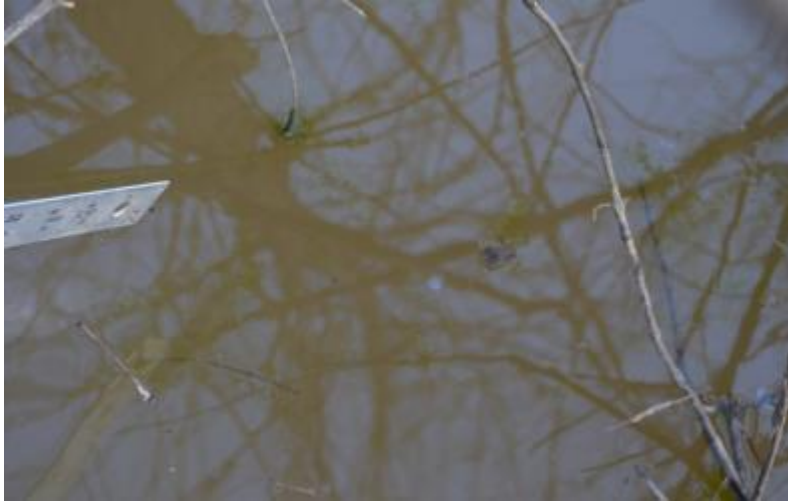
Patches of non-brittle silver gray sheen

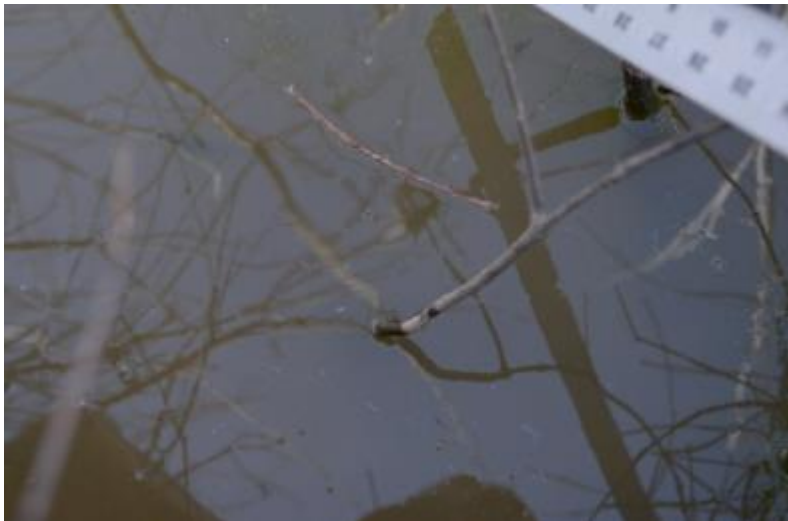
Surface : Patches of non-brittle silver gray sheen
0-6 inches : Patches of non-brittle silver gray sheen
6-12 inches : Patches/streamers of non-brittle silver gray sheen

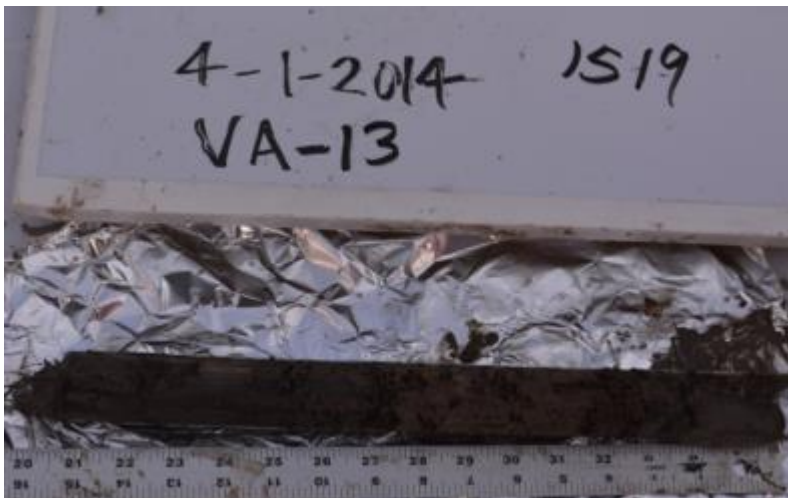
0-0.1 inches : Humic material with organics
0.1-6 inches : Clayey silt with roots

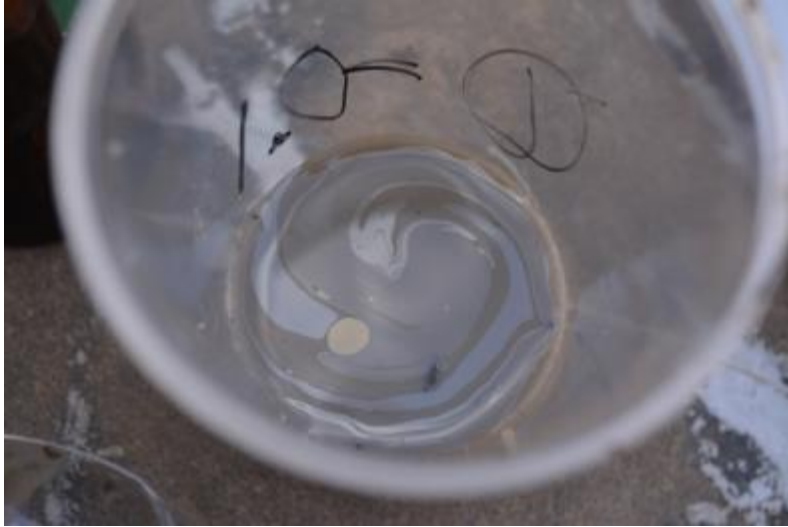
0-0.1 inches : Streamers of silver gray sheen with occasional oil spots (Heavier)

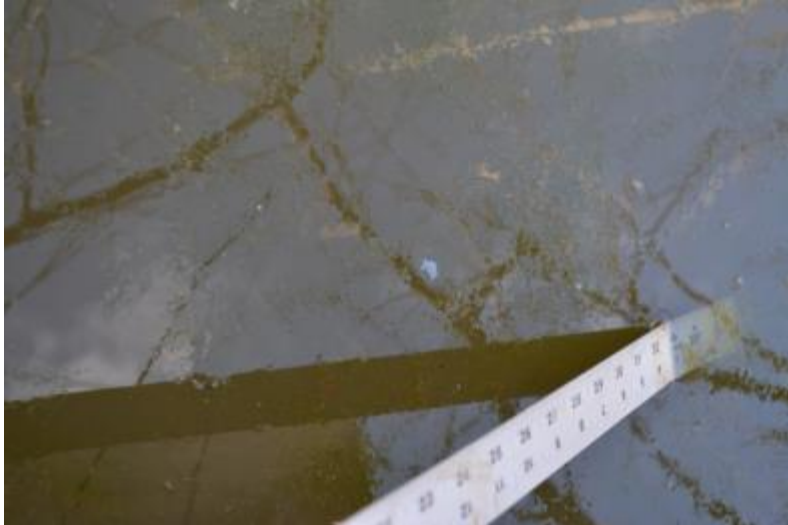
Patches/streamers of non-brittle silver gray sheen (three to four patches, one streamer)

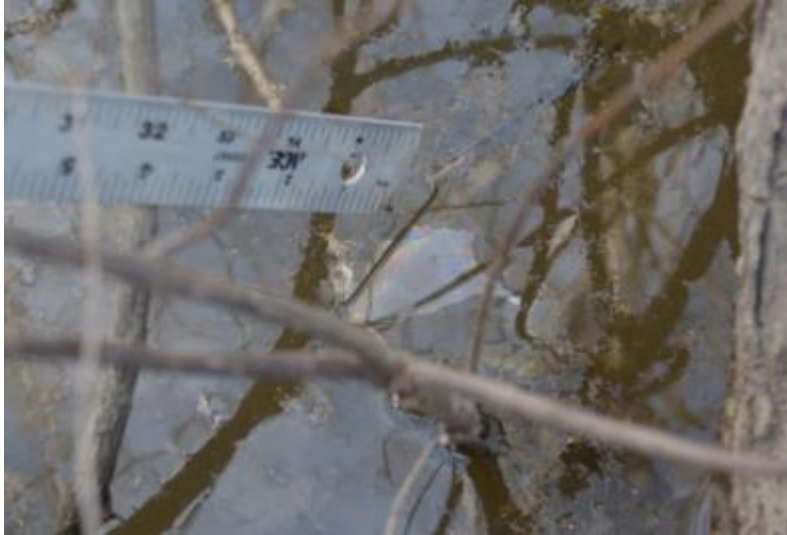
Patch of non-brittle rainbow sheen with one oil spot (0.25-inch wide)

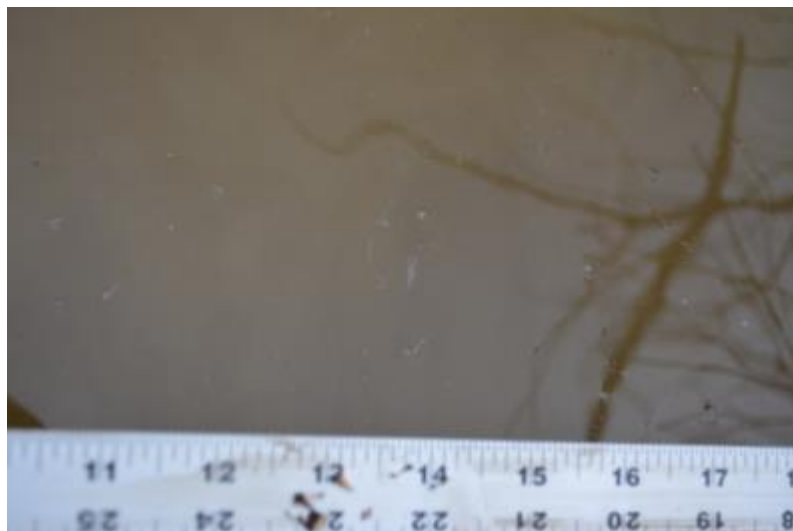
Surface : Patches of non-brittle silver gray sheen

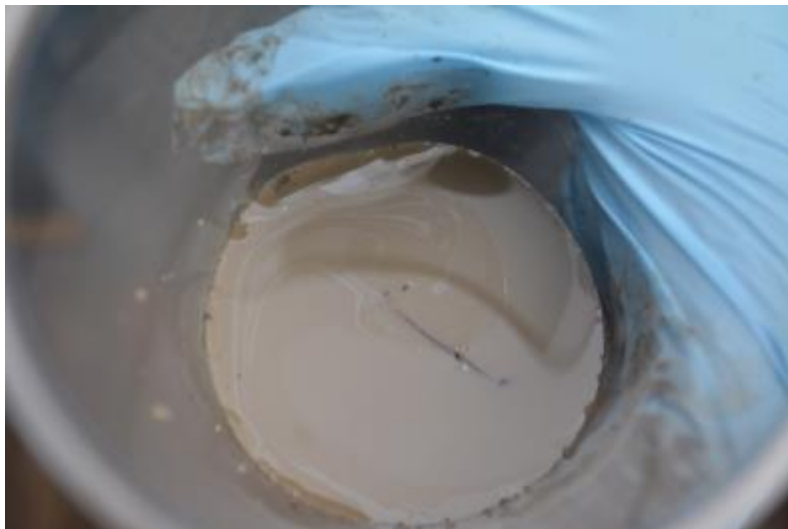
0-0.1 inches : Streamers of silver gray sheen
(Medium)

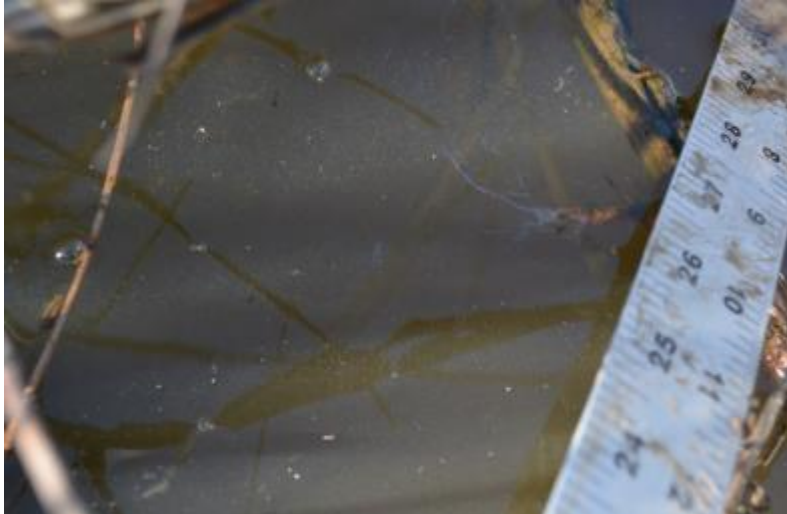
Streamers of non-brittle silver gray sheen

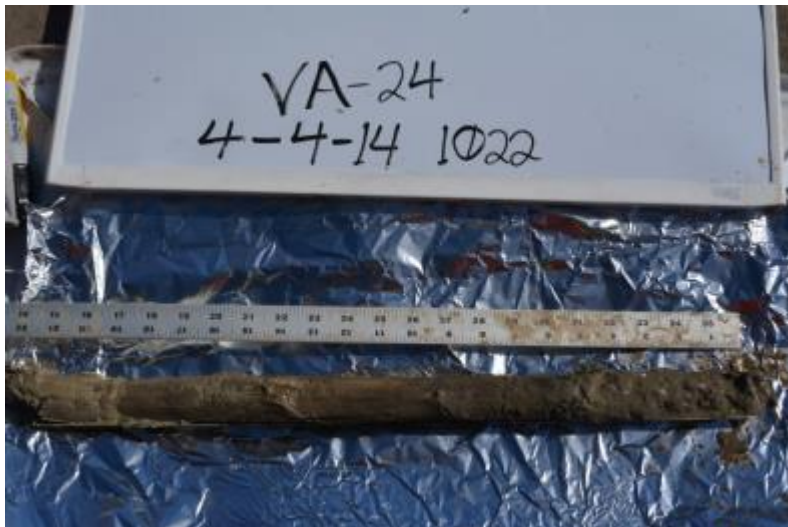
0-0.1 inches : Patches of rainbow sheen with one oil spot (0.25-inch wide; Heavier)

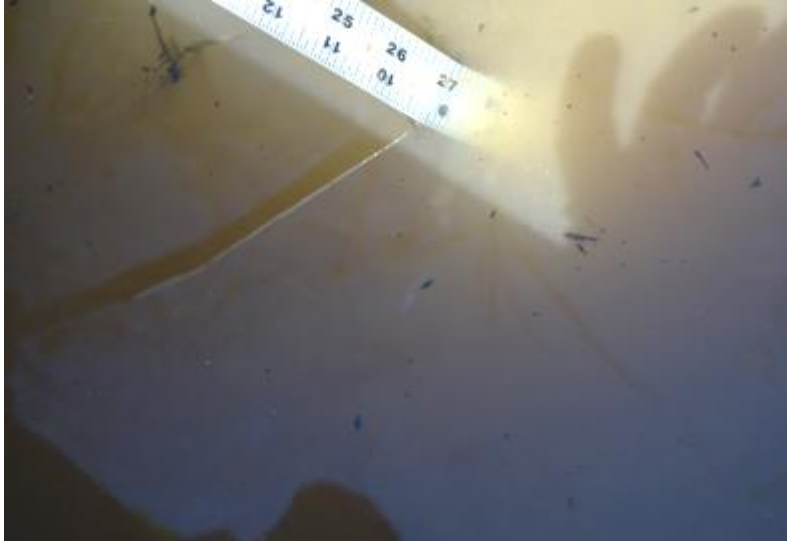
Surface : Patches/streamers of non-brittle silver gray sheen with one oil spot (0.25-inch wide)
6-12 inches : Patches/streamers of non-brittle silver gray sheen with four oil spots (0.1-inch wide)

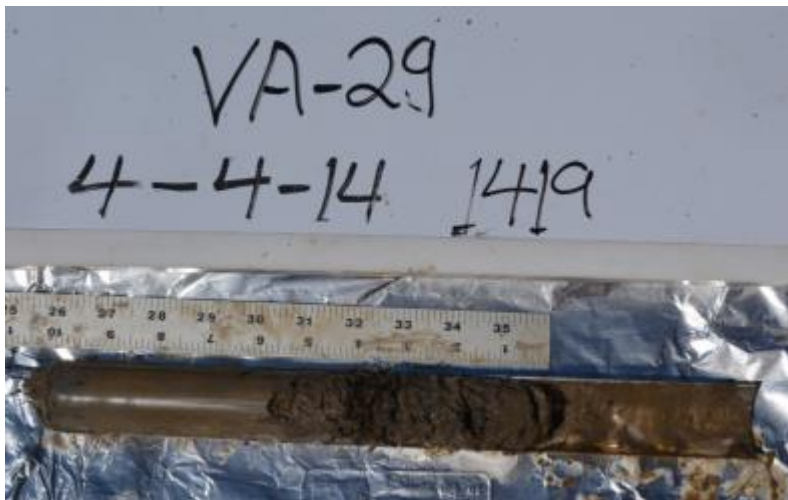
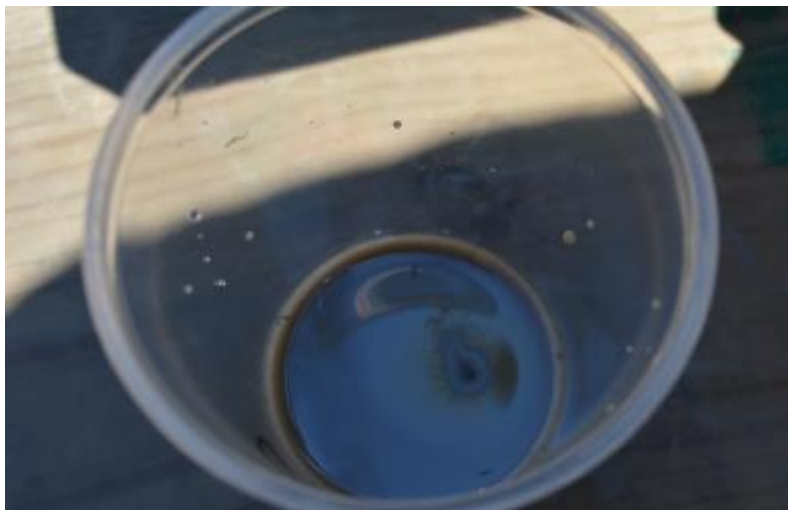
0-6 inches : Humic material with silt

0-0.1 inches : Patches/streamers of silver gray sheen with oil spots (0.25-inch wide; Medium)

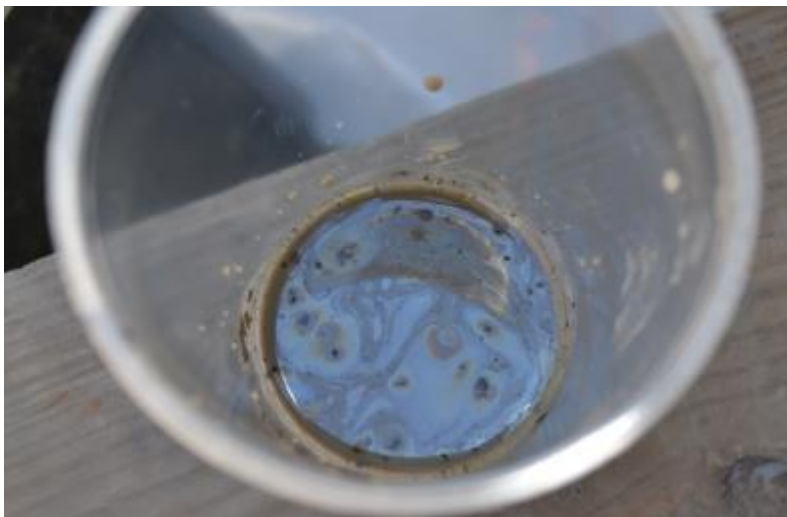
0-0.1 inches : Brown silt, soft, light sheen at 0-0.1"
0.1-6 inches : Brown silt, roots, light sheen at 0.1-3"

0-0.1 inches : Patches/Streamers of rainbow sheen with 10 oil spots (Heavier)

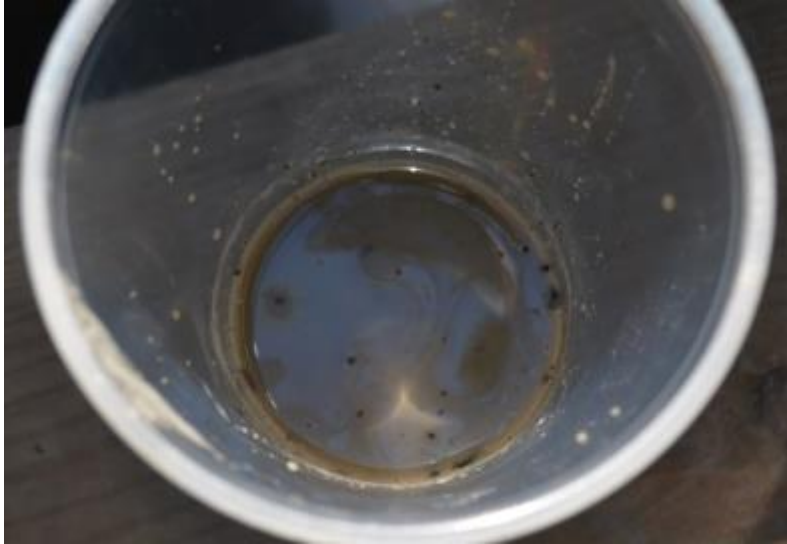
Heavier

0.1-6 inches : Patches/Streamers of rainbow sheen with five oil spots (Medium)

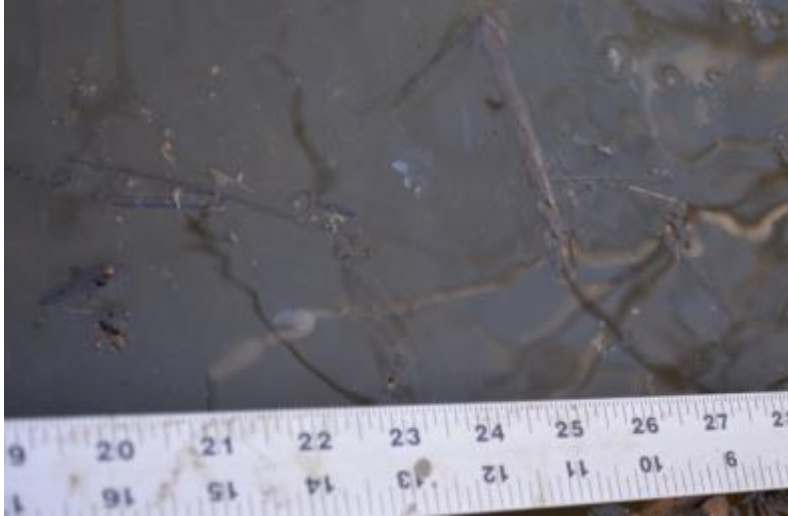
Lighter

Patches/streamers of non-brittle silver gray sheen

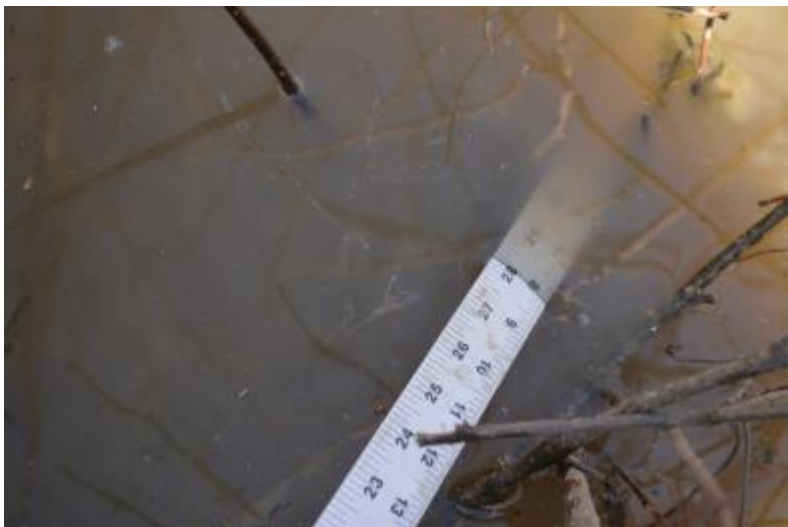
0-6 inches : Patches/streamers of non-brittle rainbow sheen
6-12 inches : Patches/streamers of non-brittle rainbow sheen

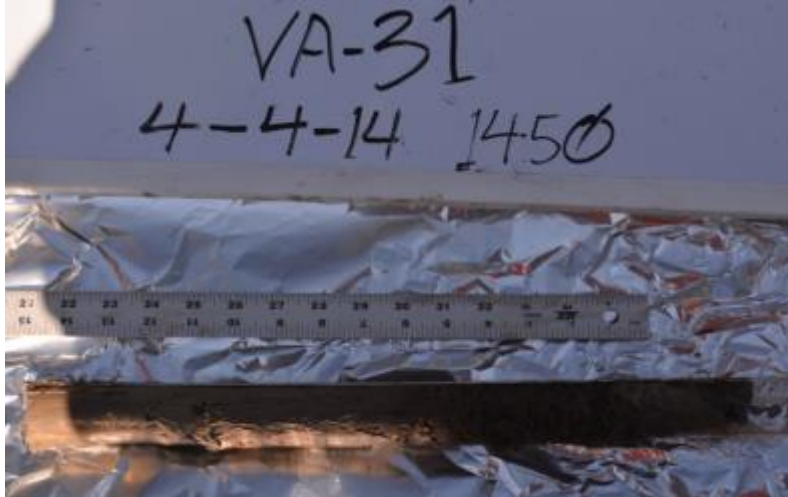
Lighter

0-0.1 inches : Brown silt, very light sheen
0.1-6 inches : Humic material, rootlets

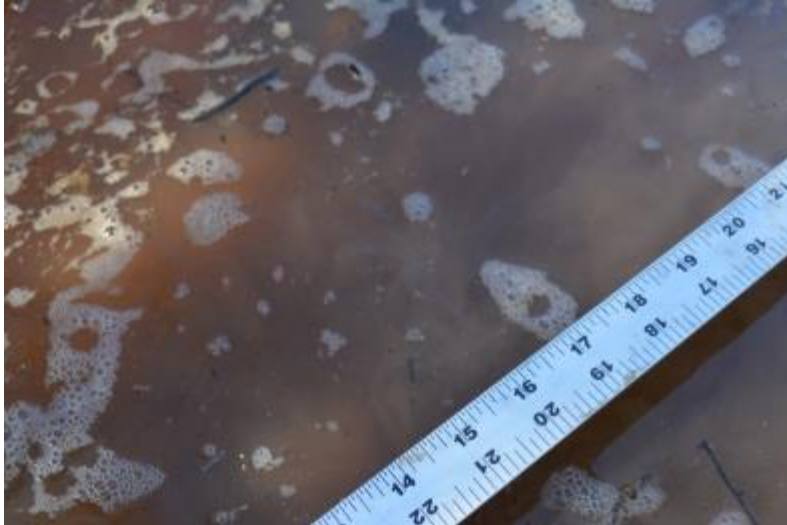
Lighter

6-12 inches : Streamers of non-brittle silver gray sheen

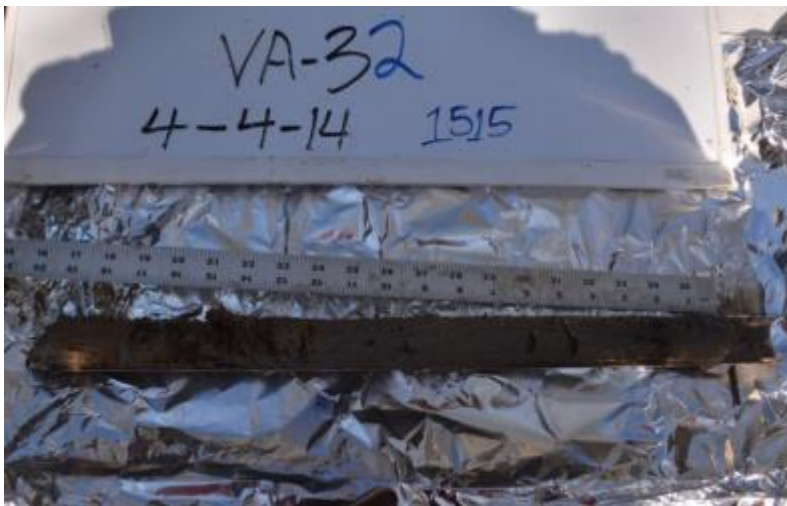
0-0.1 inches : Humic material, rootlets
0.1-6 inches : Brown silt, minor sheet spot at 5"

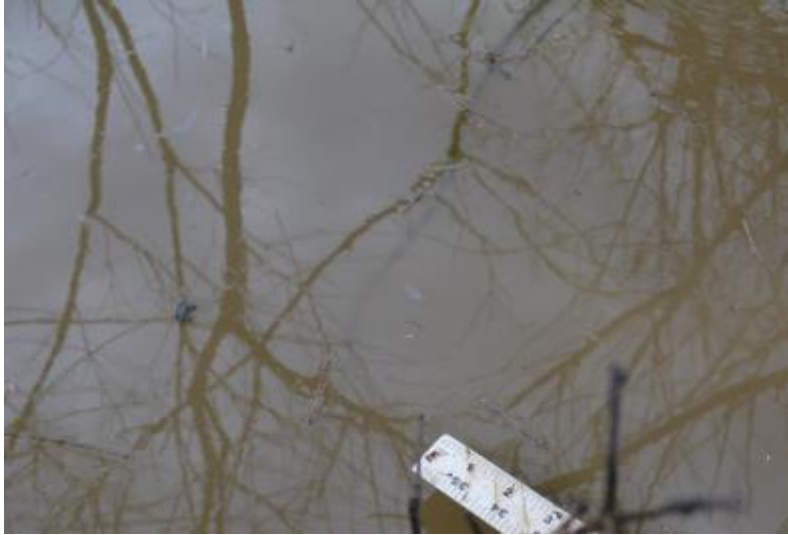
Lighter

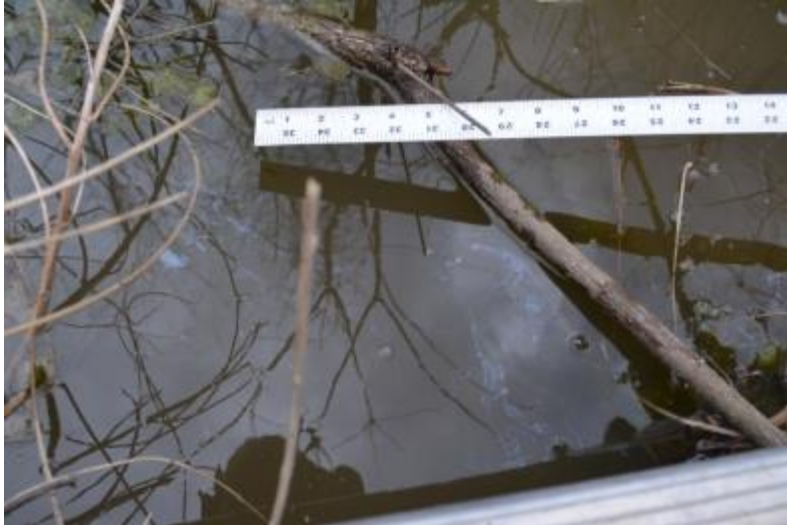
Lighter

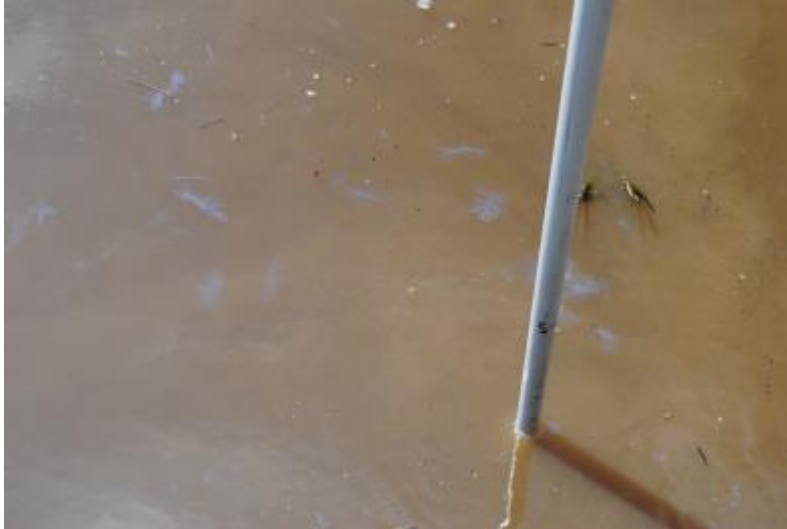
Lighter

0-6 inches : Patches/streamers of brittle and non-brittle silver gray sheen
