**RE: Hazardous Material Survey Report
54 E. Military Road
Marion, Arkansas**

Hazardous Materials Survey

54 E. Military Road

Project No. 251310.00

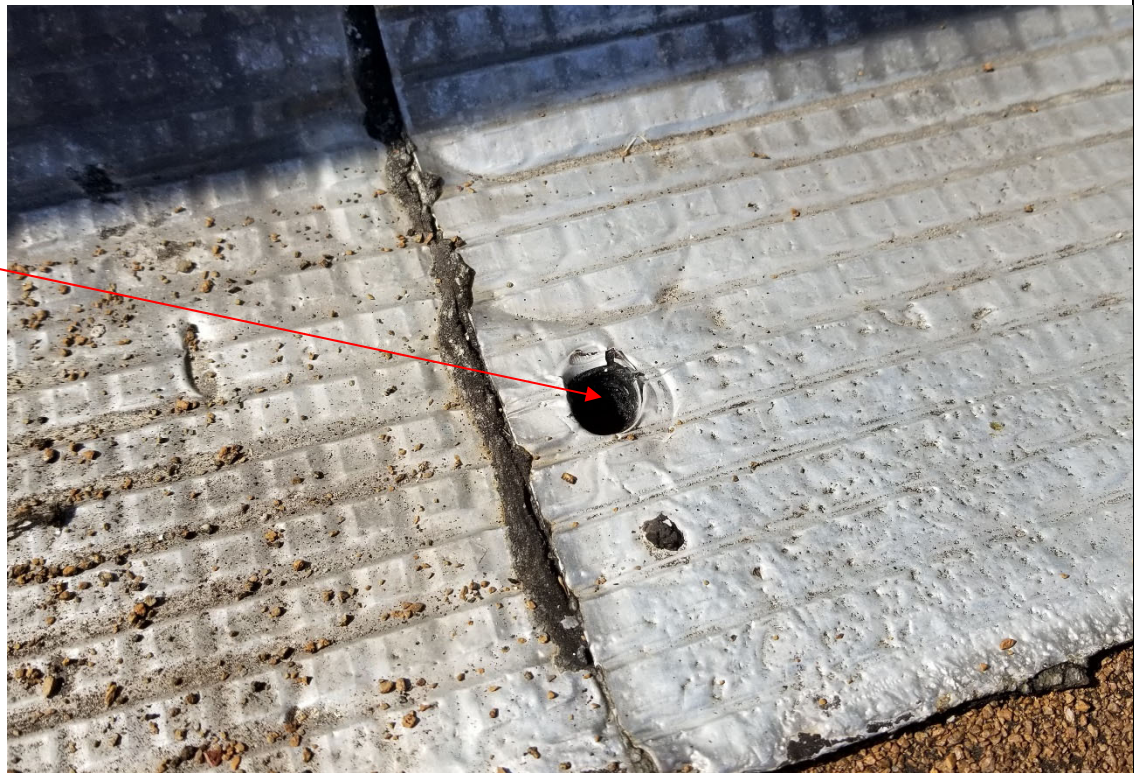
Sample: RC-01

Roofing Core

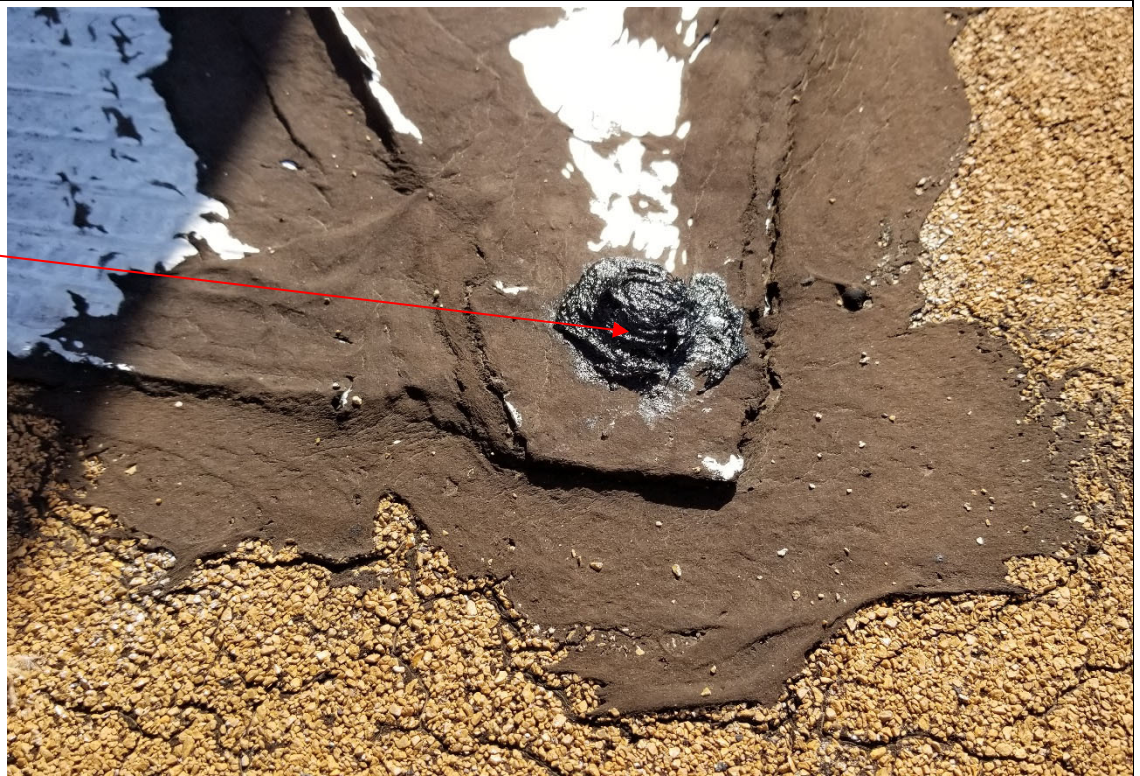
Sample: RC-02

Roofing Core
