**QUALITY ASSURANCE
PROJECT PLAN –
ASBESTOS AND LEAD-
BASED PAINT
ABATEMENT
REVISION 1**

MARION GYMNASIUM
MARION, ARKANSAS

FEBRUARY 2023

**RE: Hazardous Material Survey Report
54 E. Military Road
Marion, Arkansas**

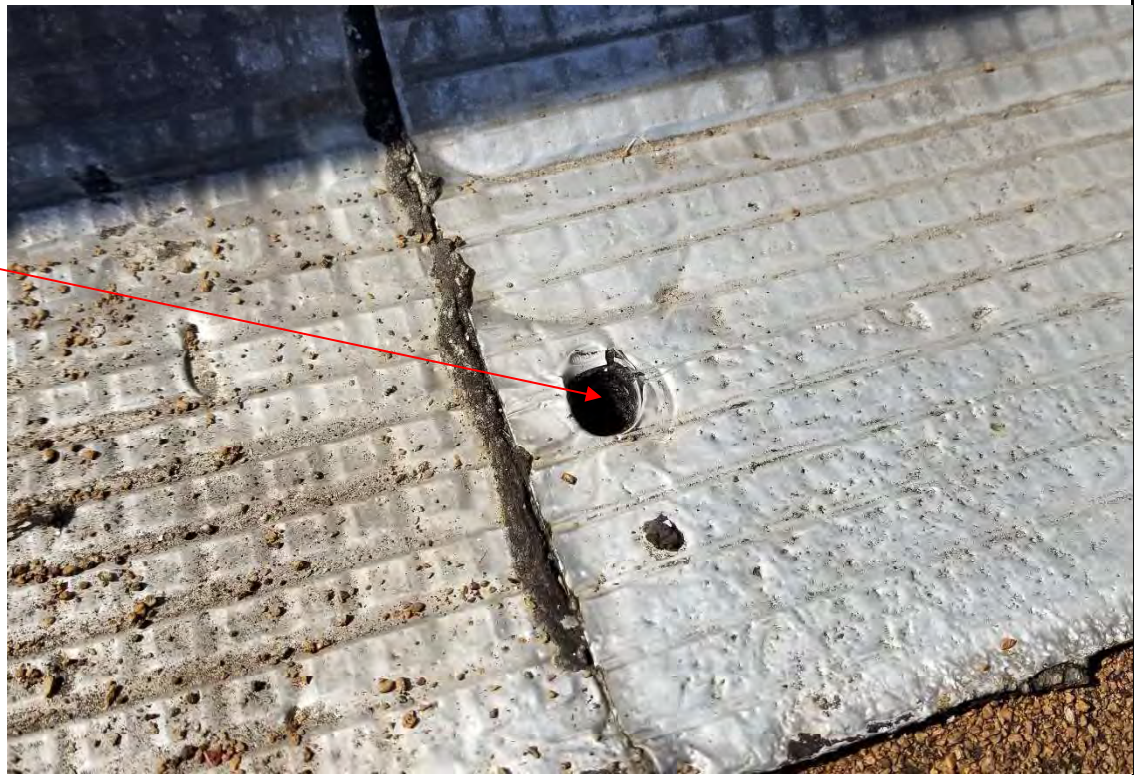
Sample: RC-01

Roofing Core

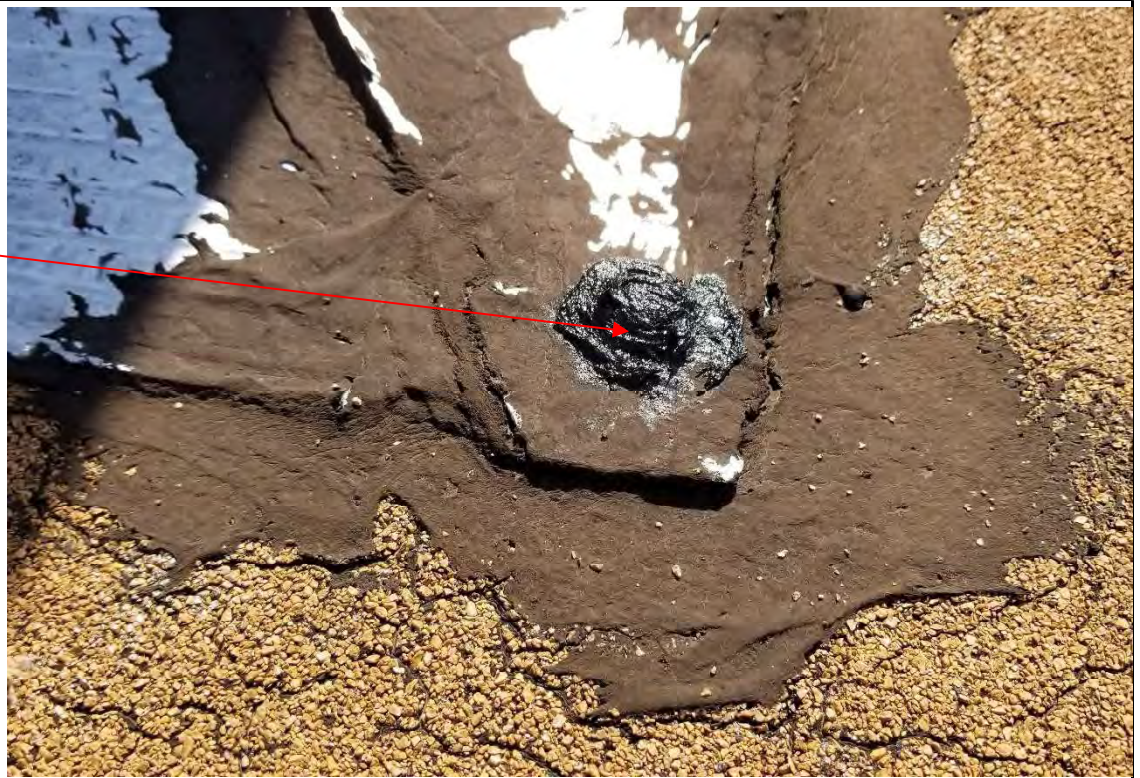
Sample: RC-02

Roofing Core

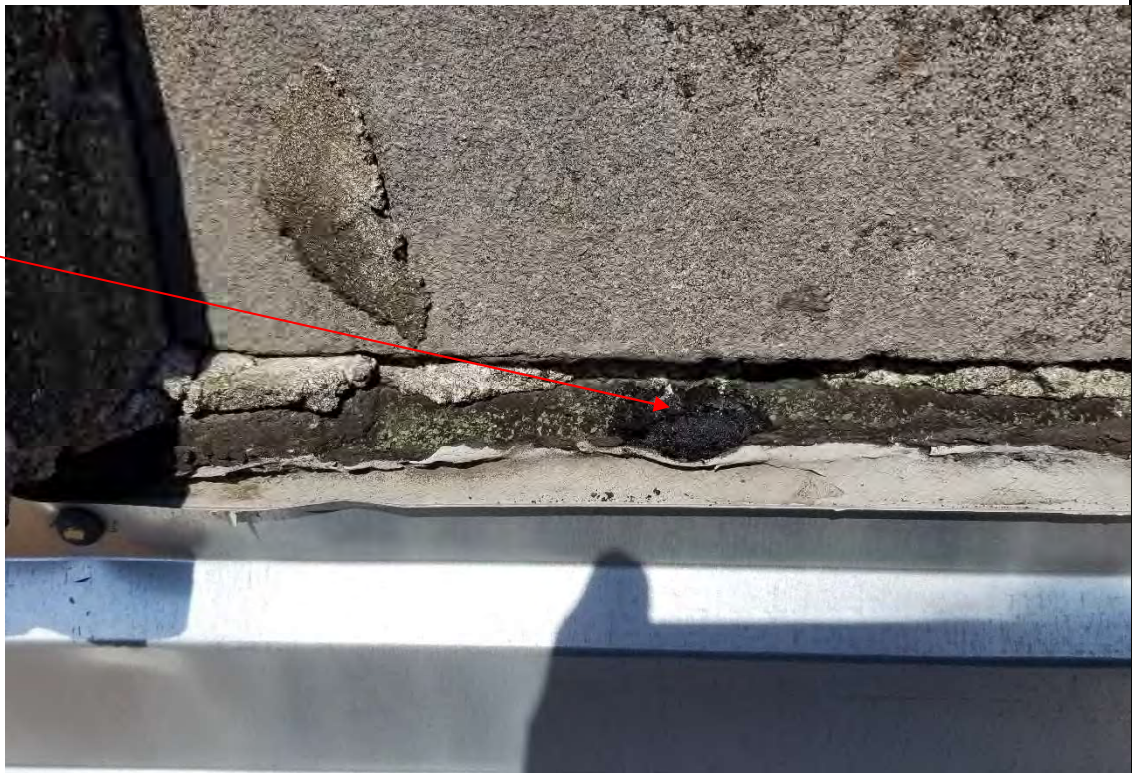
Sample: M-01

Black Roof Mastic

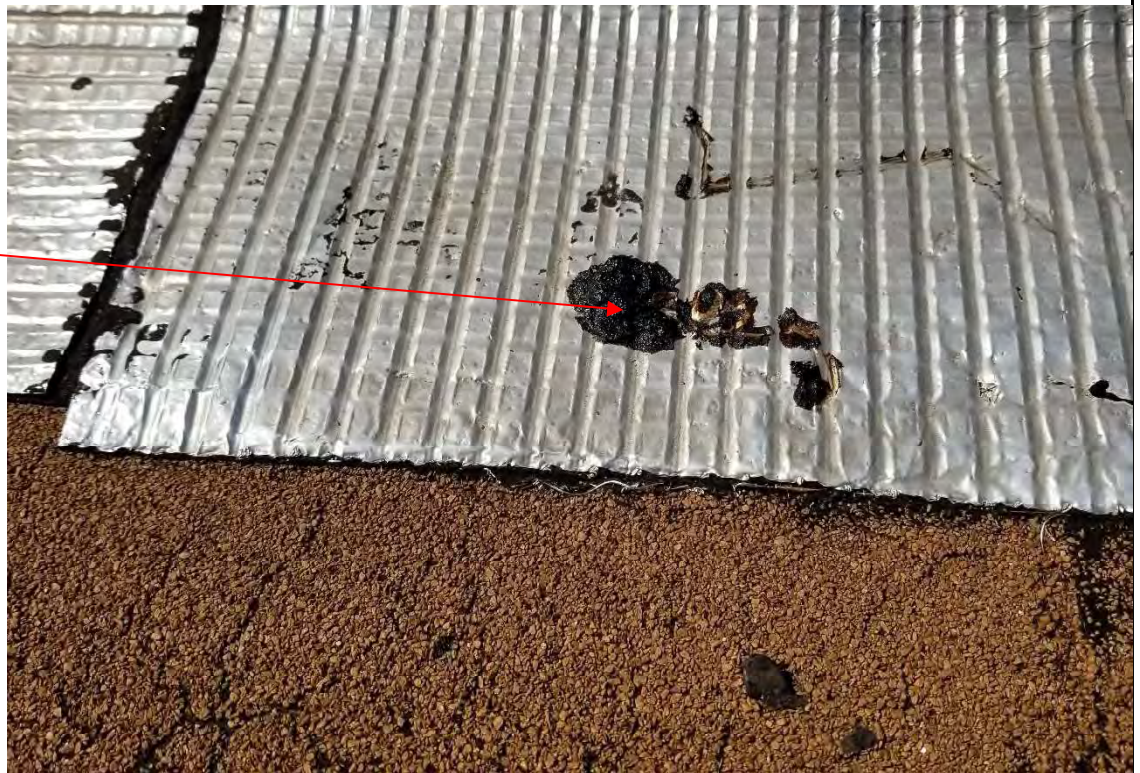
Sample: RC-03

Roof Core

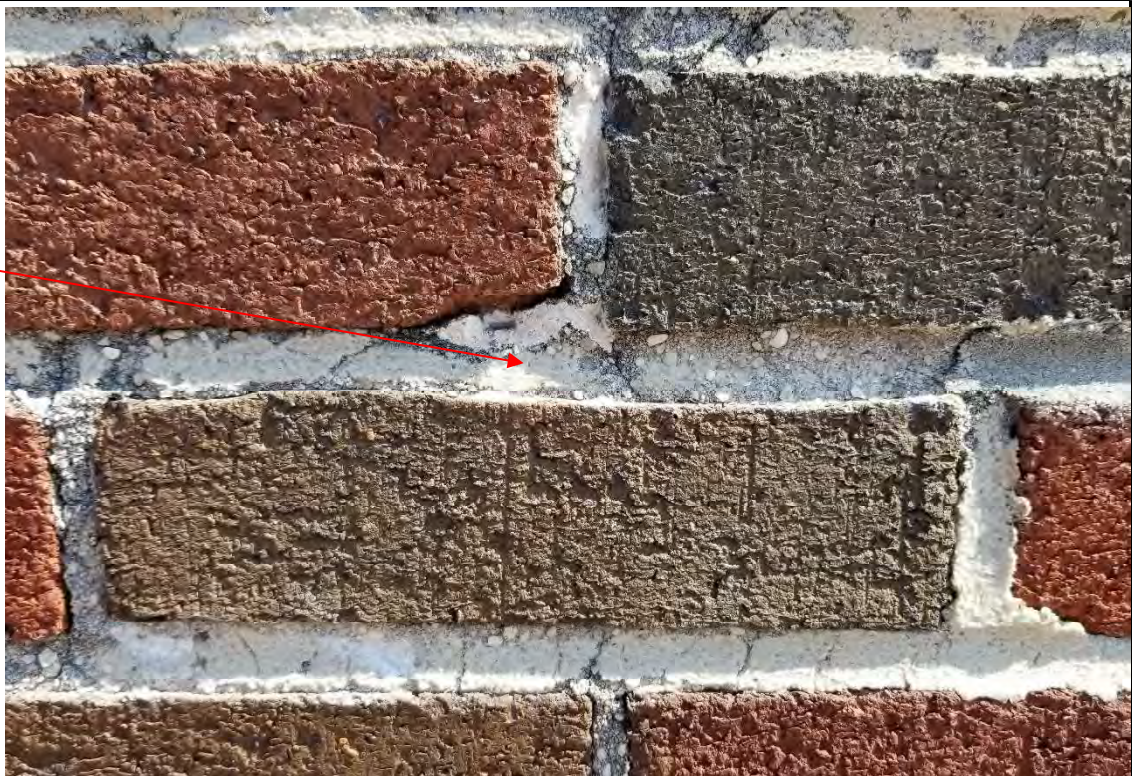
Sample: BM-01

Brick Mortar

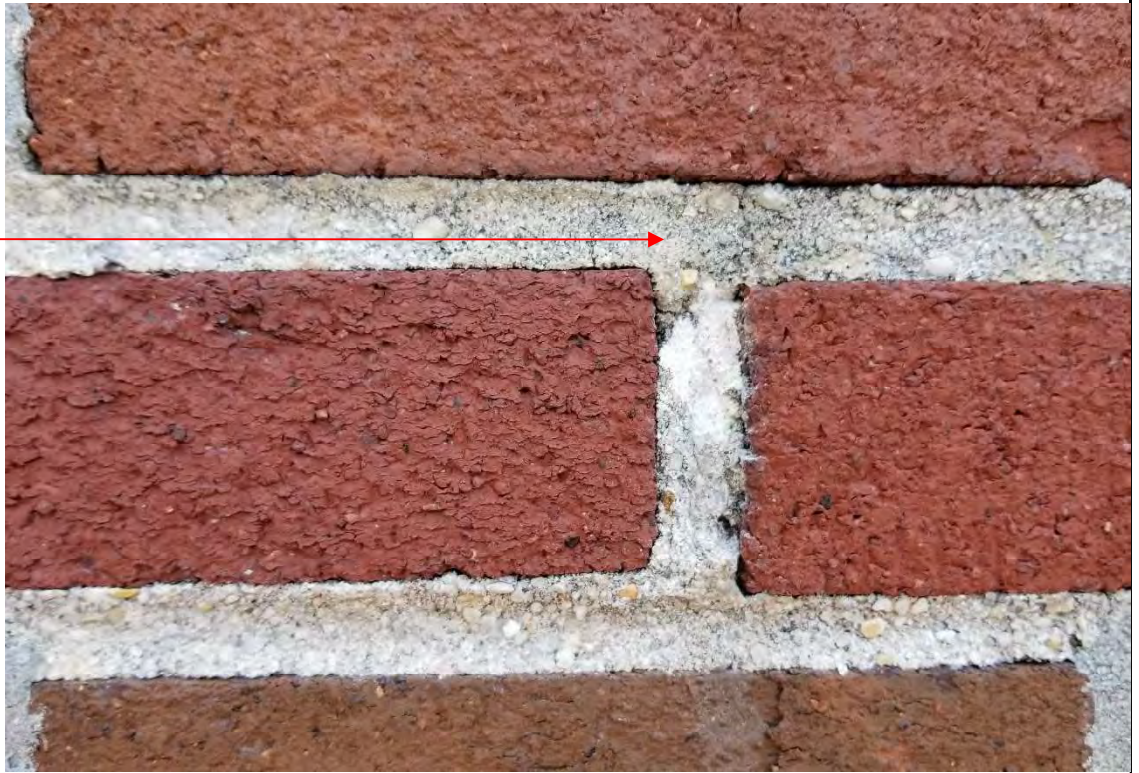
Sample: BM-02

Brick Mortar

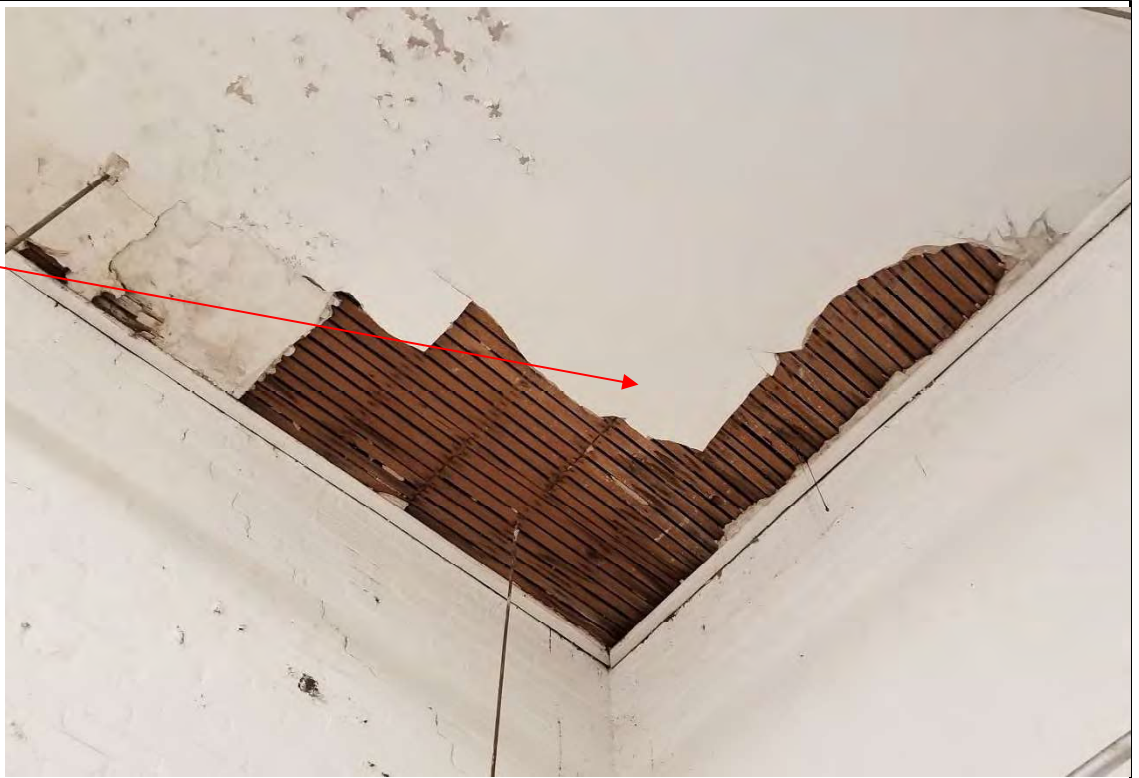
Sample: P-01

Ceiling Plaster

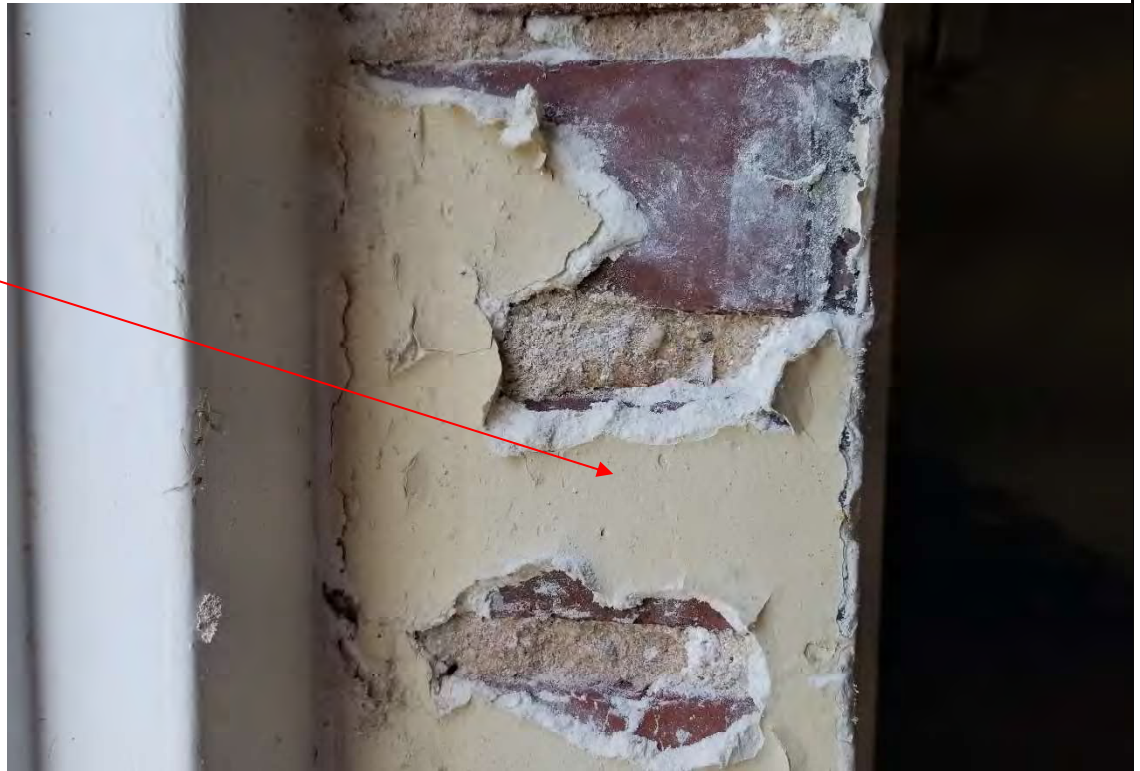
Sample: P-02

Wall Plaster

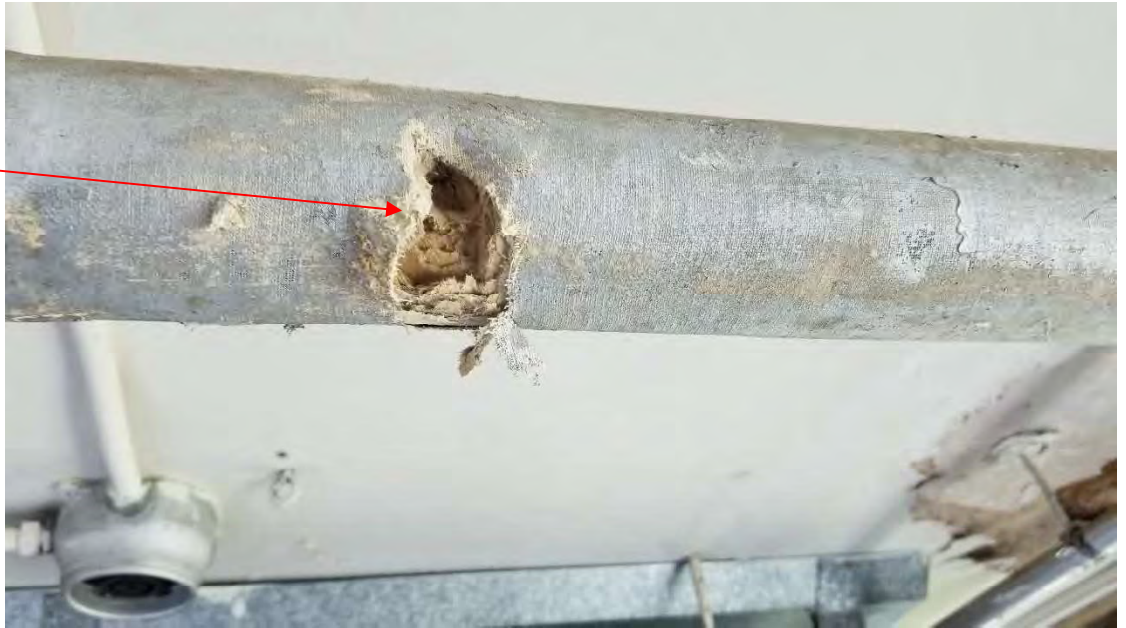
1' TSI Pipe Insulation

Tested Positive for
Asbestos

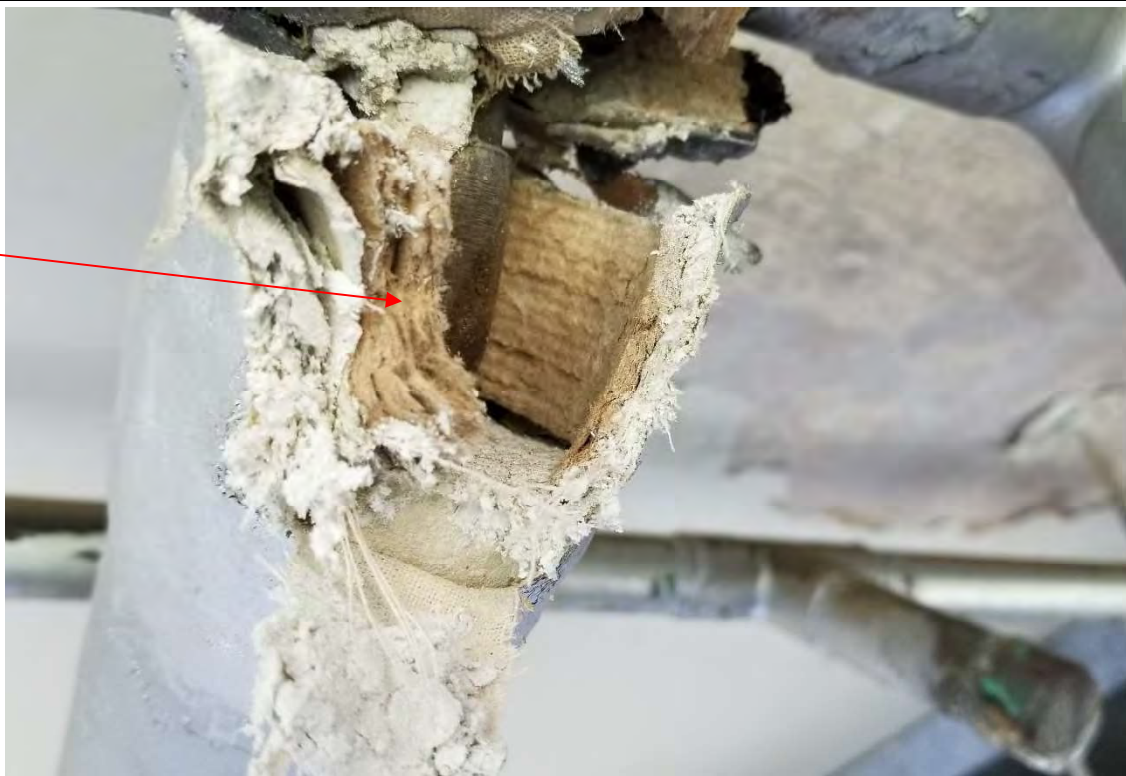
Photo #
22

2" TSI Pipe Elbow

Tested Positive for
Asbestos

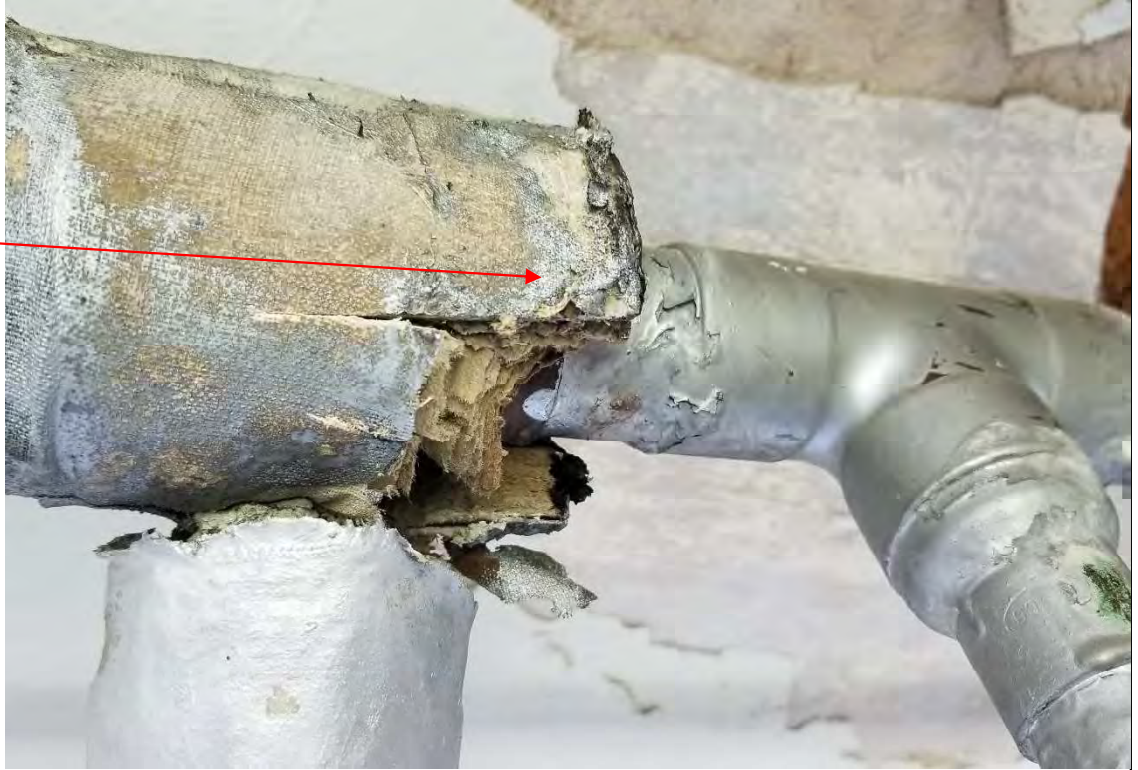
Sample: PW-04

2" TSI Pipe Insulation

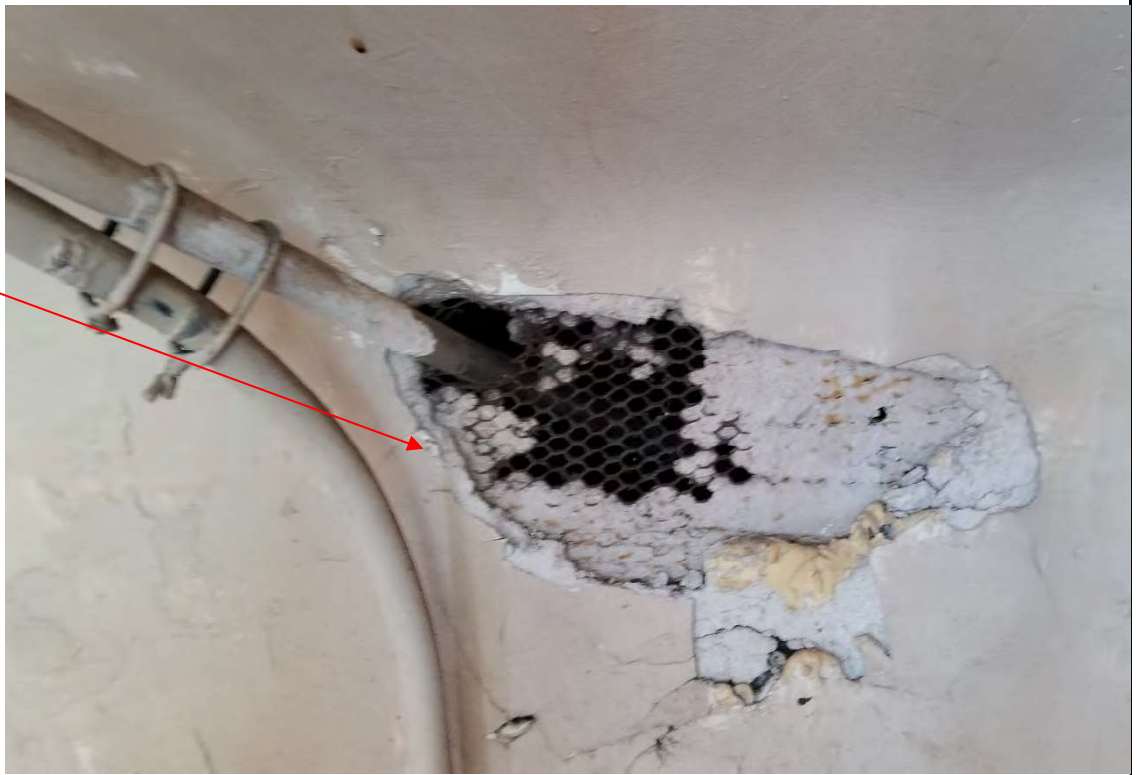
Sample: P-04

Wall Plaster

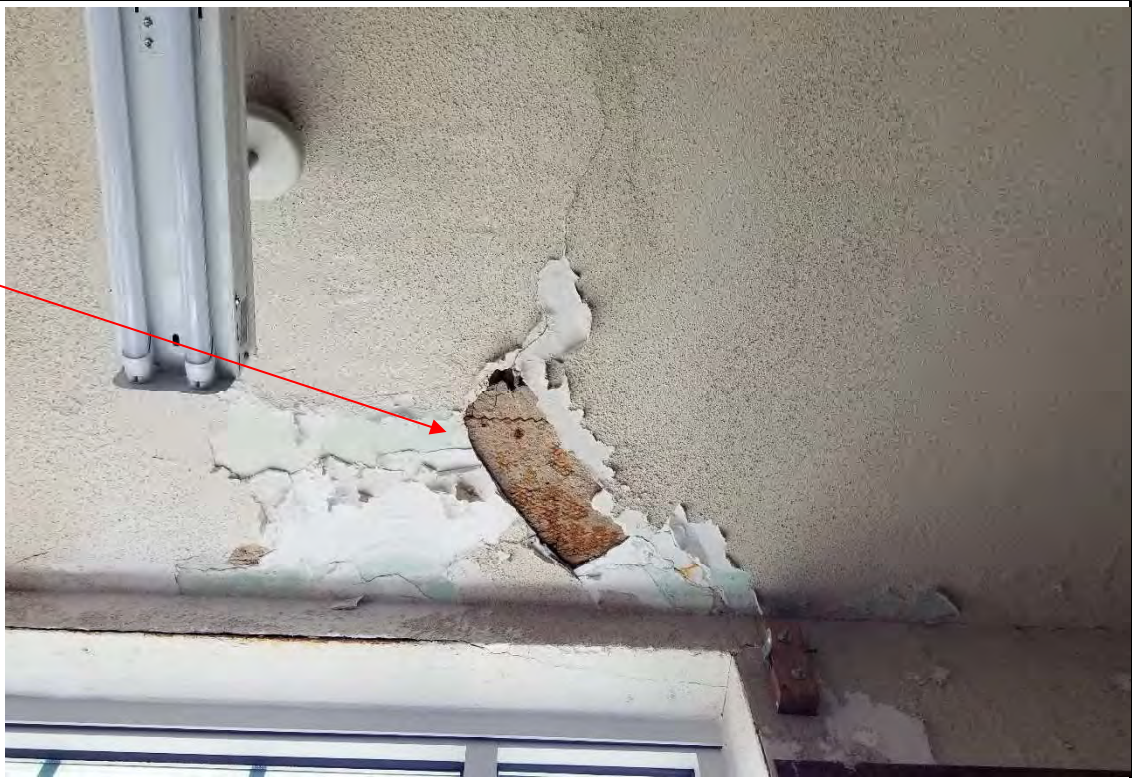
Sample: P-05

Ceiling Plaster
(With Texture)

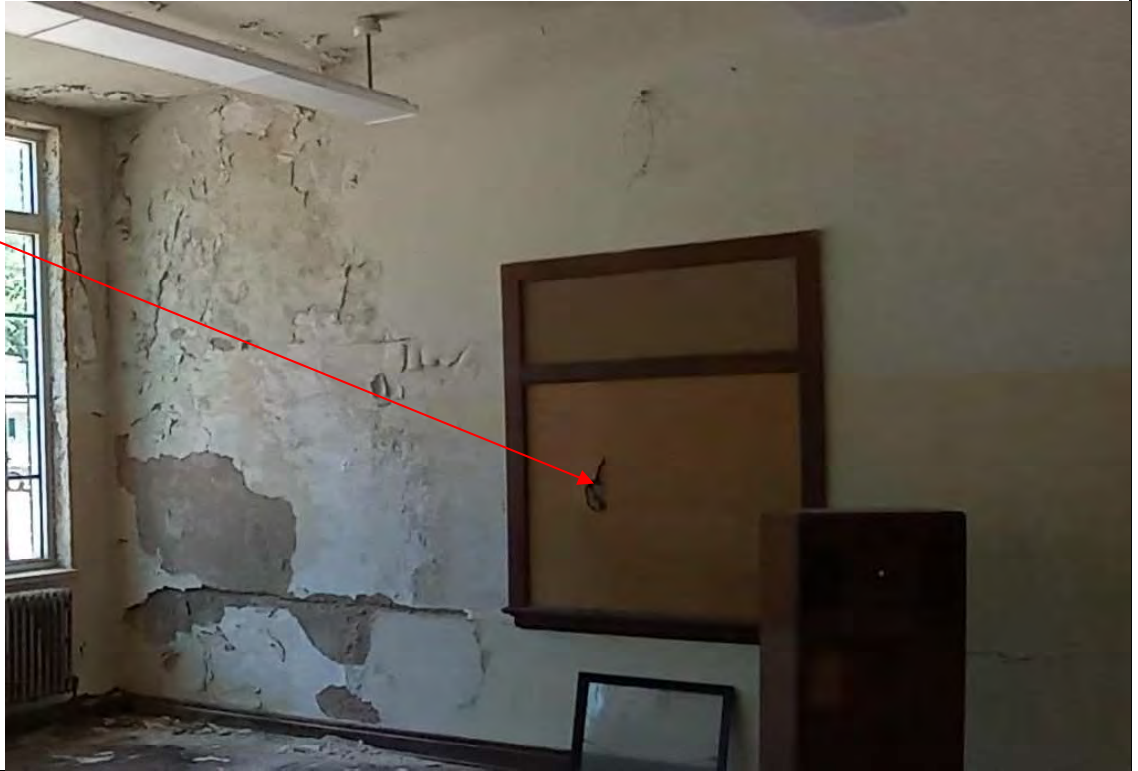
Chalk Board Mastic

Tested Positive for
Asbestos

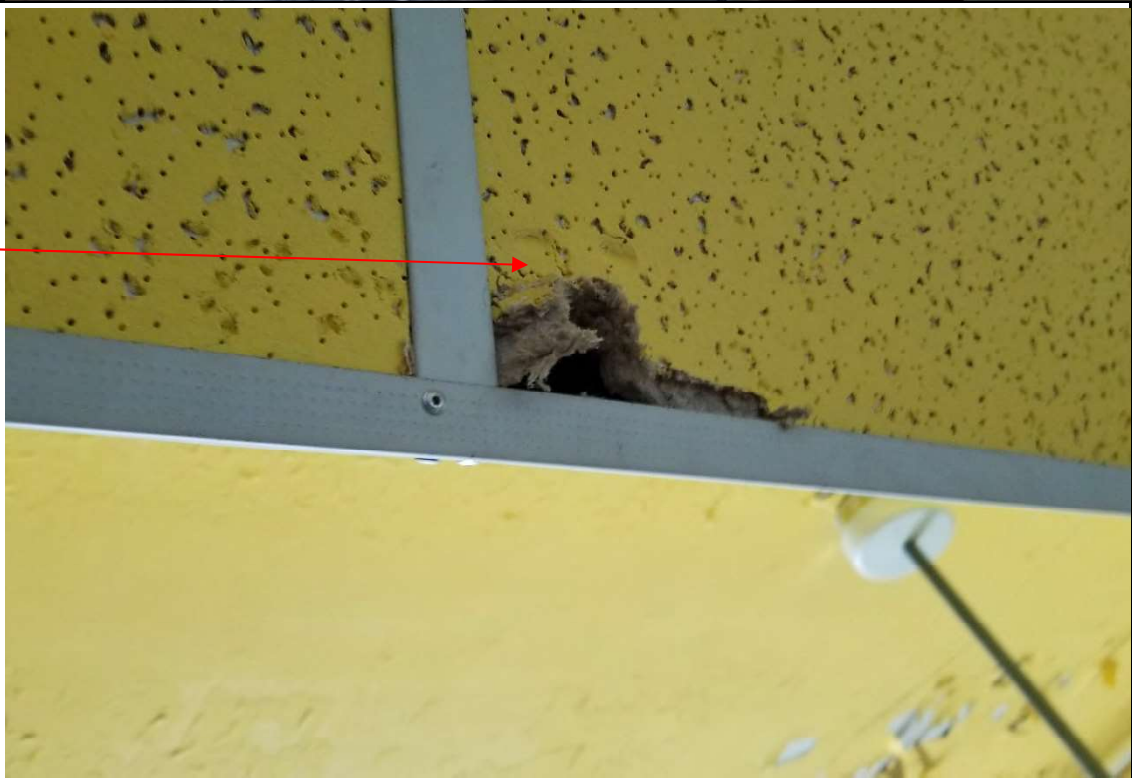
Sample: CT-01

Yellow Ceiling Tile

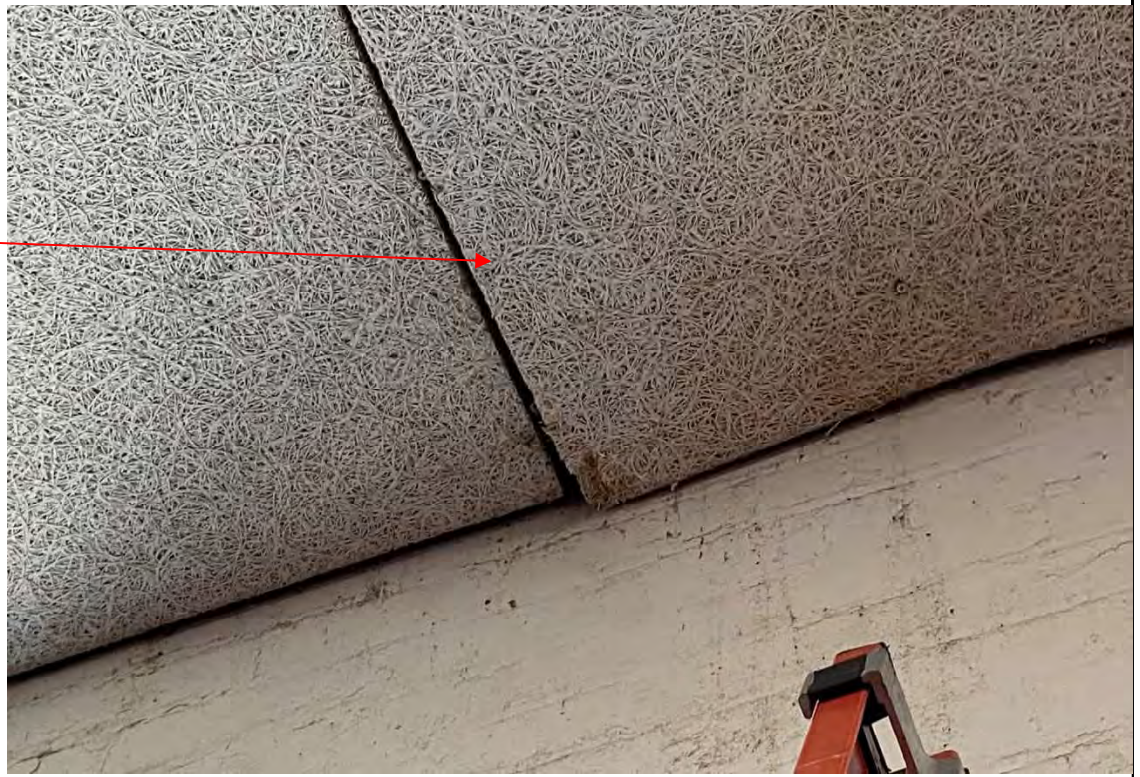
Sample: AC-01

Acoustic Ceiling Tile

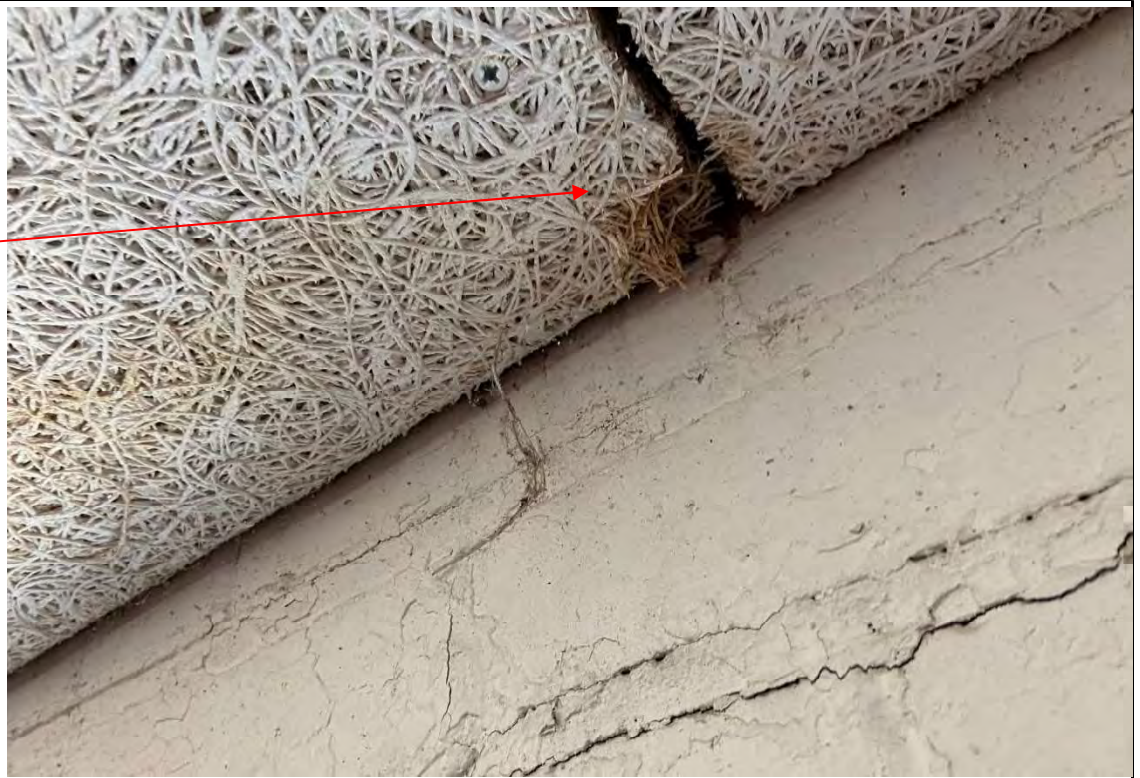
Sample: AC-02

Acoustic Sieling Tile

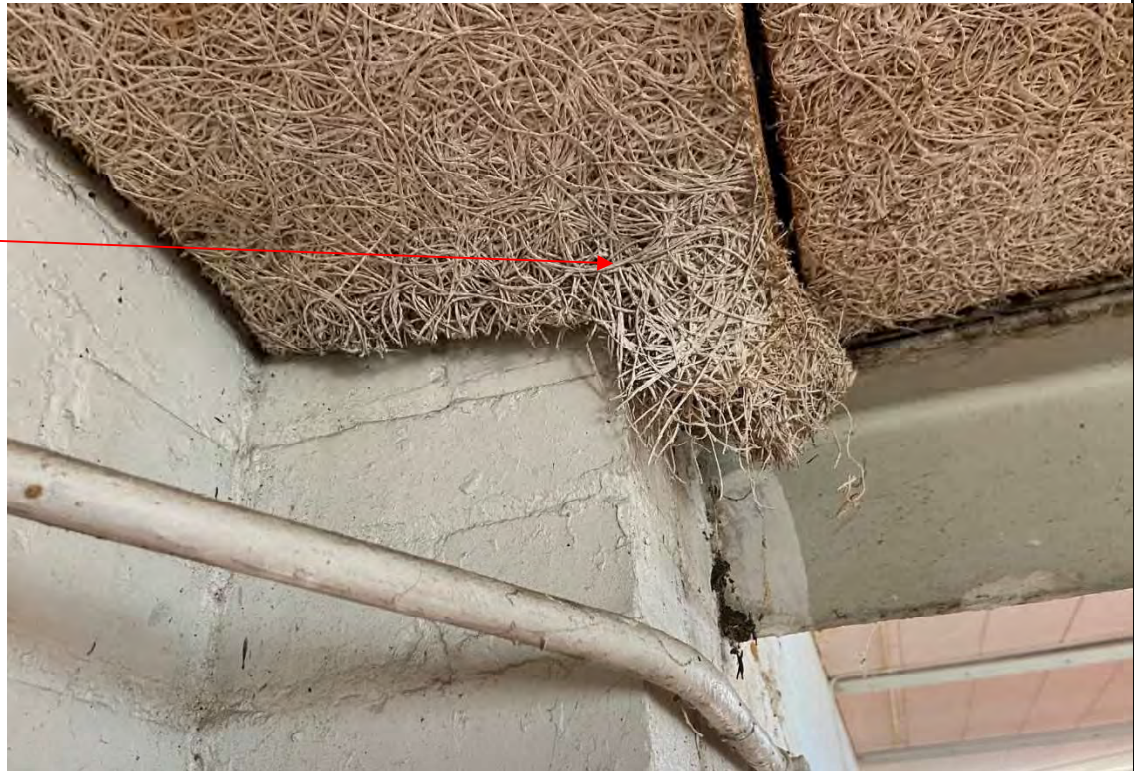
Sample: AC-03

Acoustic Ceiling Tile
